FIGURE 1
Construction Site Plan
Closure of Nike Missile Silo
Defense Battery BU-34/35
East Aurora, NY

Figure 2
1958 Aerial Image of Launch Area
Defense Battery BU-34/35
East Aurora, NY

FIGURE 3
SILLO 6 Soil Borings, Wells, and Test Pits
Defense Battery BU-34/35
East Aurora, NY

**Defense Battery BU-34/35
East Aurora, NY**

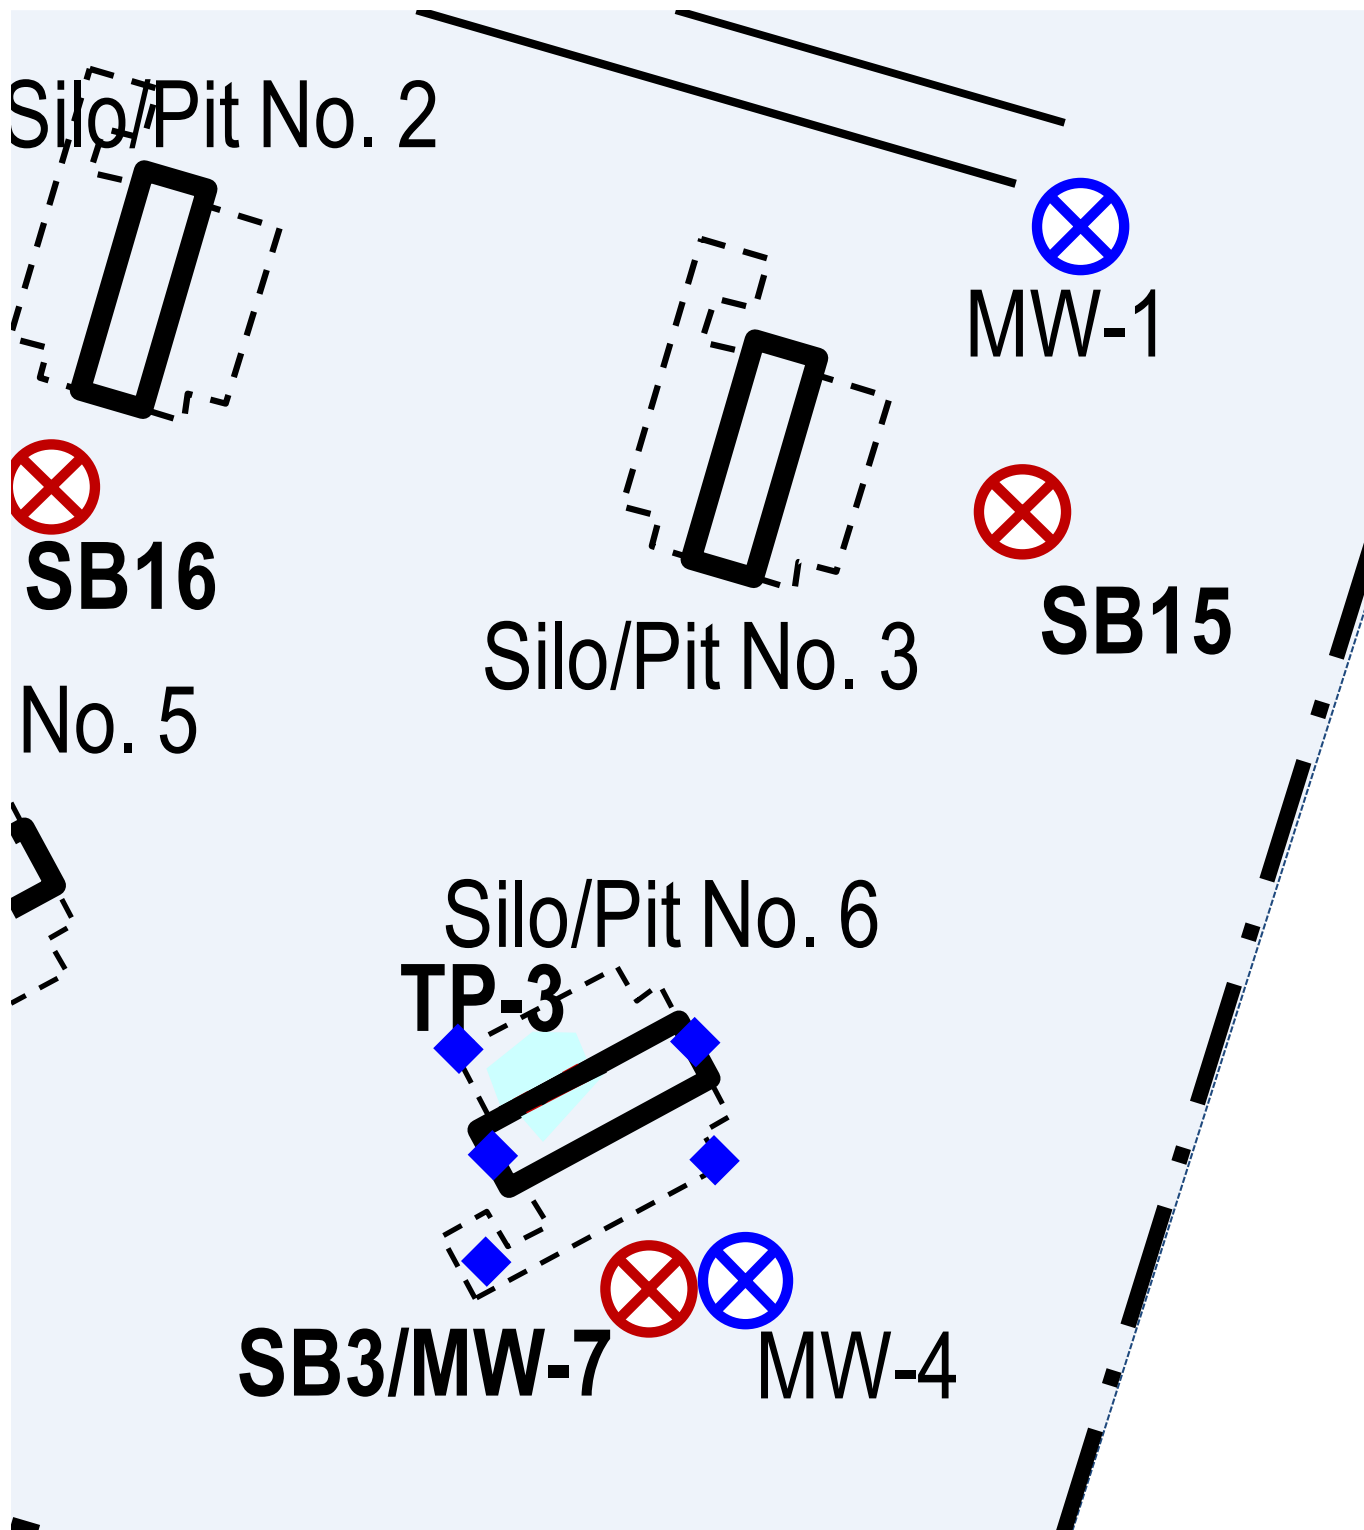
Launch Area in 1958

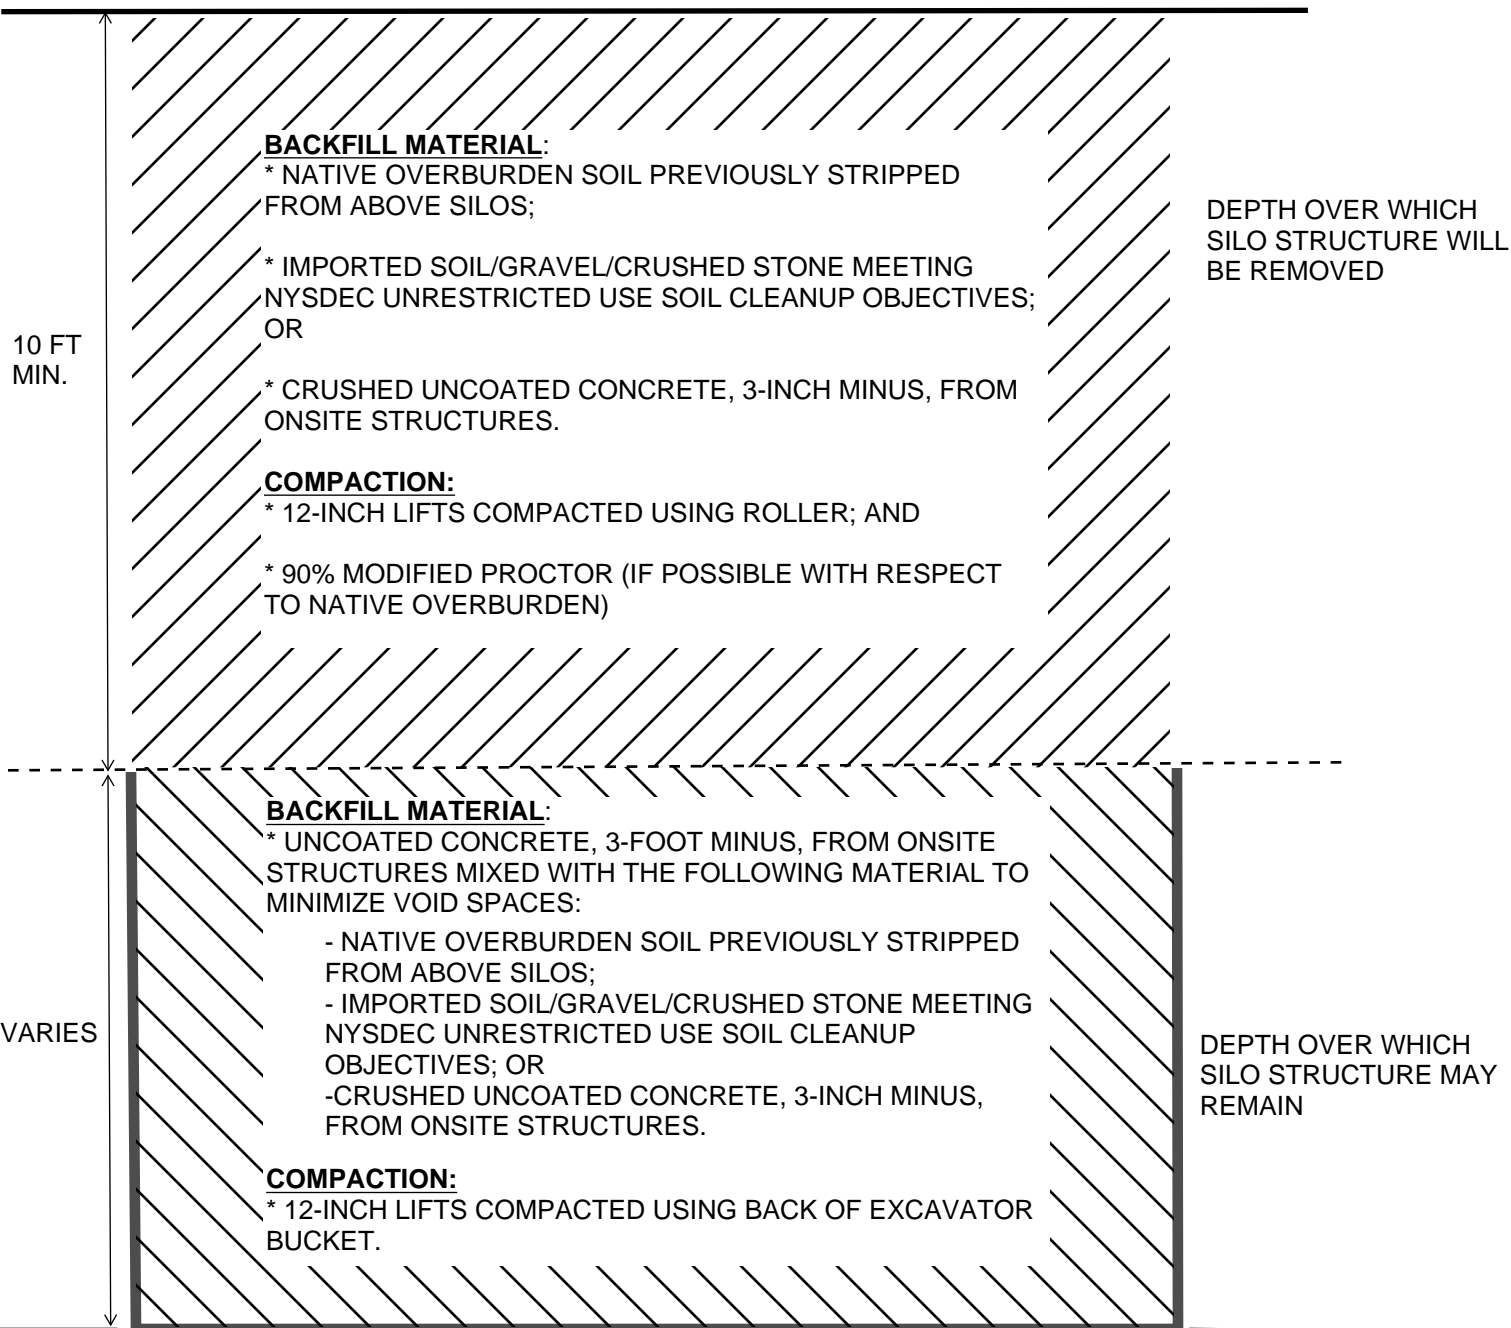
FIGURE 4

NOTE: CONCRETE REMOVED FROM SILO STRUCTURES THAT HAS RETAINED ITS WATERPROOF COATING WILL BE SHIPPED OFFSITE AND DISPOSED OF AT CHAFFEE LANDFILL.

FINAL TYPICAL SILO CROSS-SECTION
