Table 1. Sequence of bubble and dredging tests with prevailing tide stage and number of bucket cycles recorded for each test.

Figure 1. a) Option areas of the S-NB-1 Contract area of the NY/NJ Harbor Deepening Project and b) bathymetry of S-NB-1 dredge contract area during the Pilot Study.

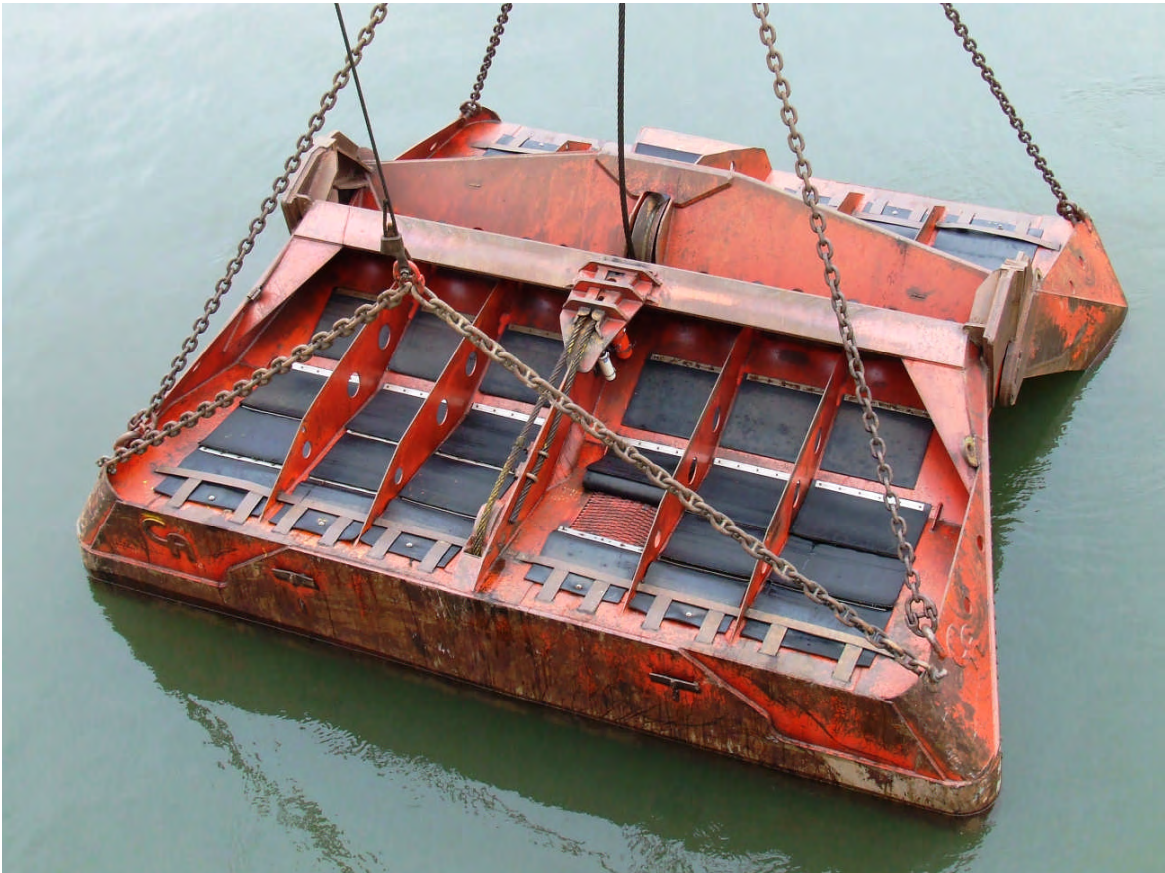
Figure 2. Cable Arm bucket in the open position. Note that the lowest row of vents has been closed by welding metal strips across the flaps.

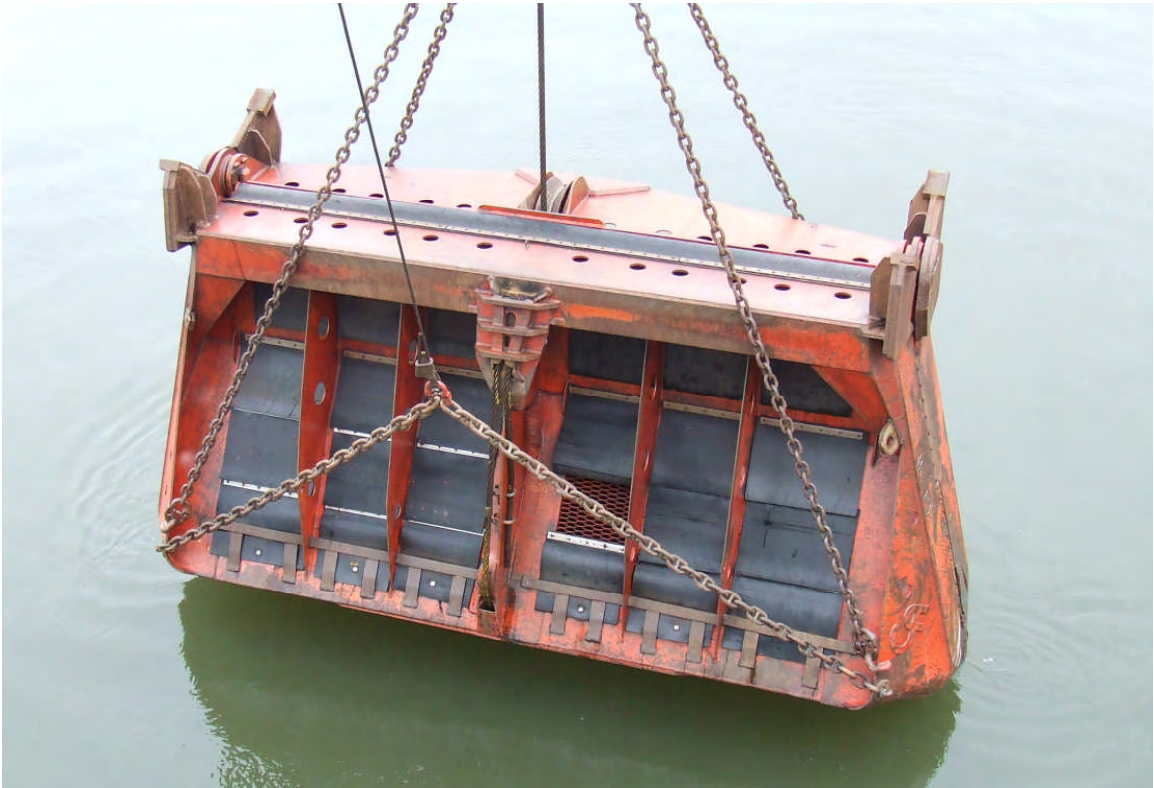
Figure 3. Cable Arm bucket in the closed position.

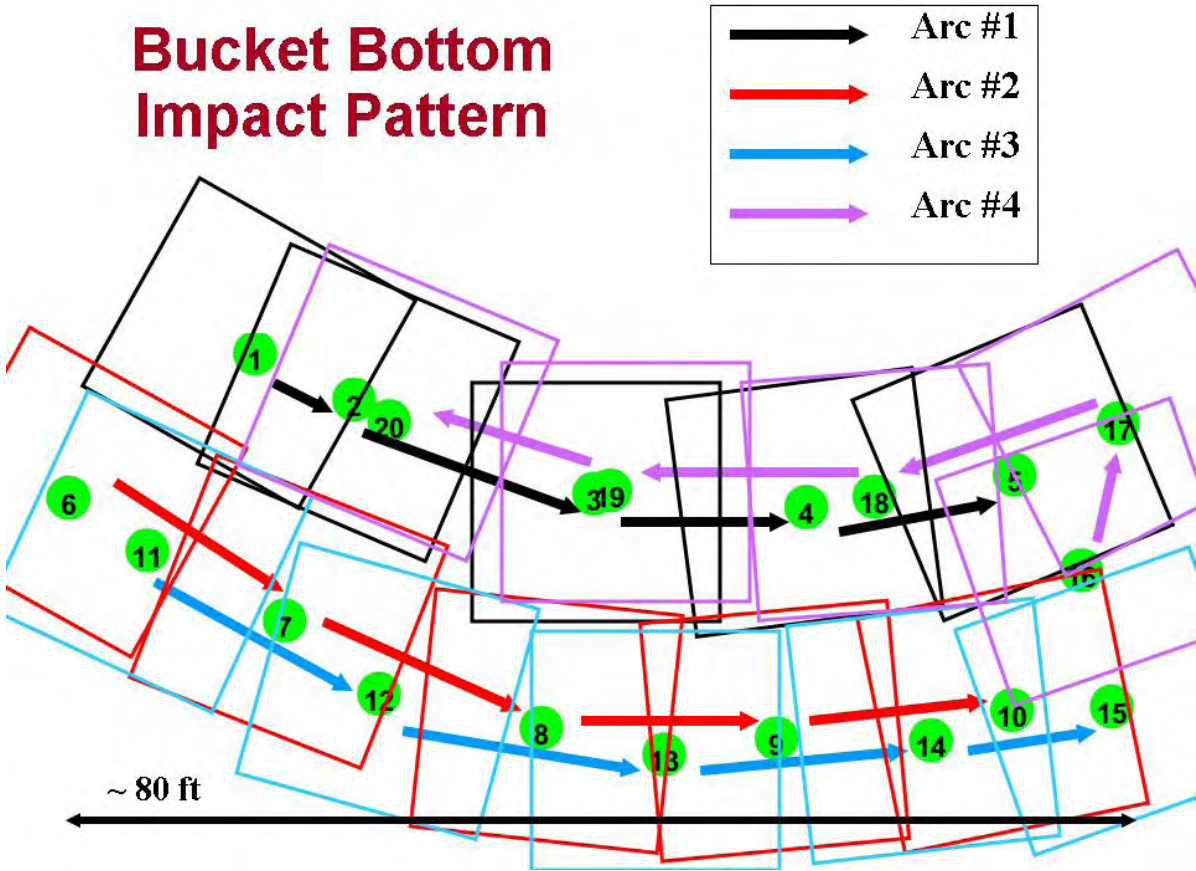
Bucket Bottom Impact Pattern

Figure 4. Bucket impact position for a typical series of four arcs conducted between advances of the dredge. A sequence of 20 bucket cycles is shown as numbered green dots. The example progression is based on an actual DGPS record of bucket impact points during a long-term test on January 30, 2008. The color coded rectangles centered on each dot represent the approximate plan-view dimensions of the bucket in the open position as it would come in contact with the bottom.

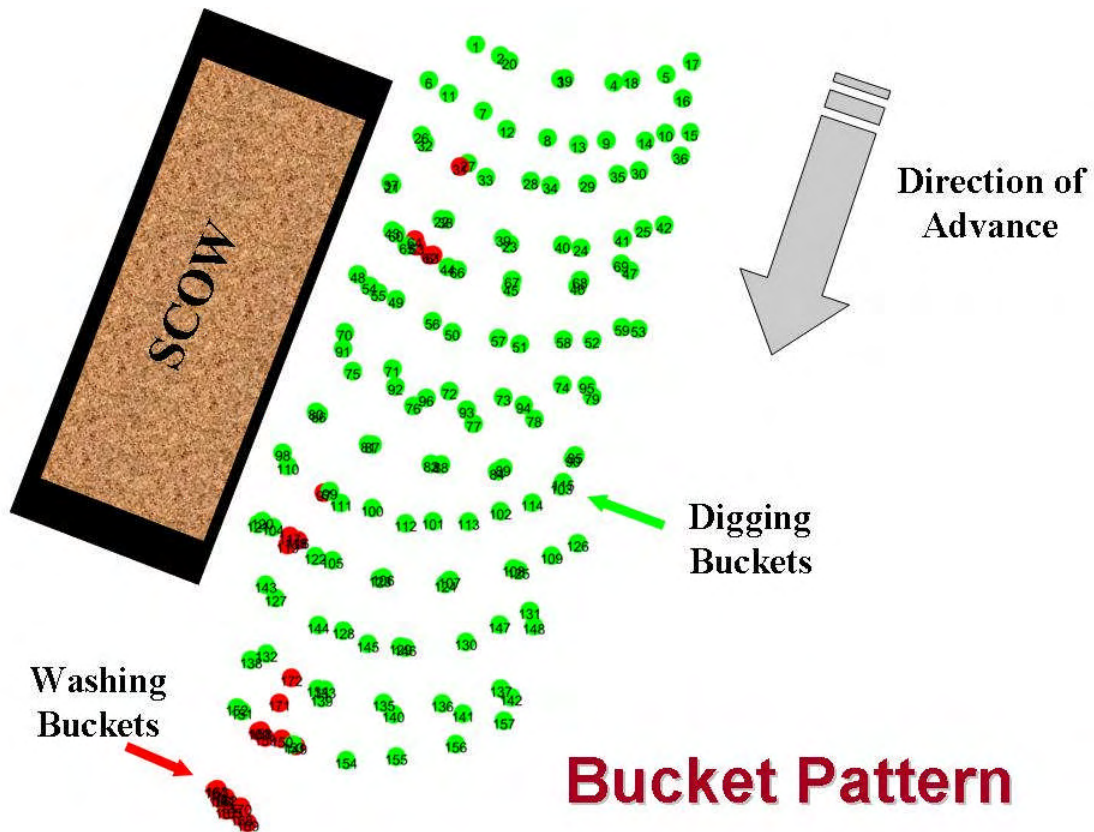
Figure 5. Plan-view distribution of bucket impact points on the bottom in relation to orientation of the receiving scow. Each numbered green dot represents a single bucket impact location based on DGPS offset data derived from a known reference point on the derrick. The scow is not drawn to scale. The numbered red dots represent non-digging bucket cycles used to collect water to wash the deck of the scow. Data from long-term dredging test on January 30, 2008.

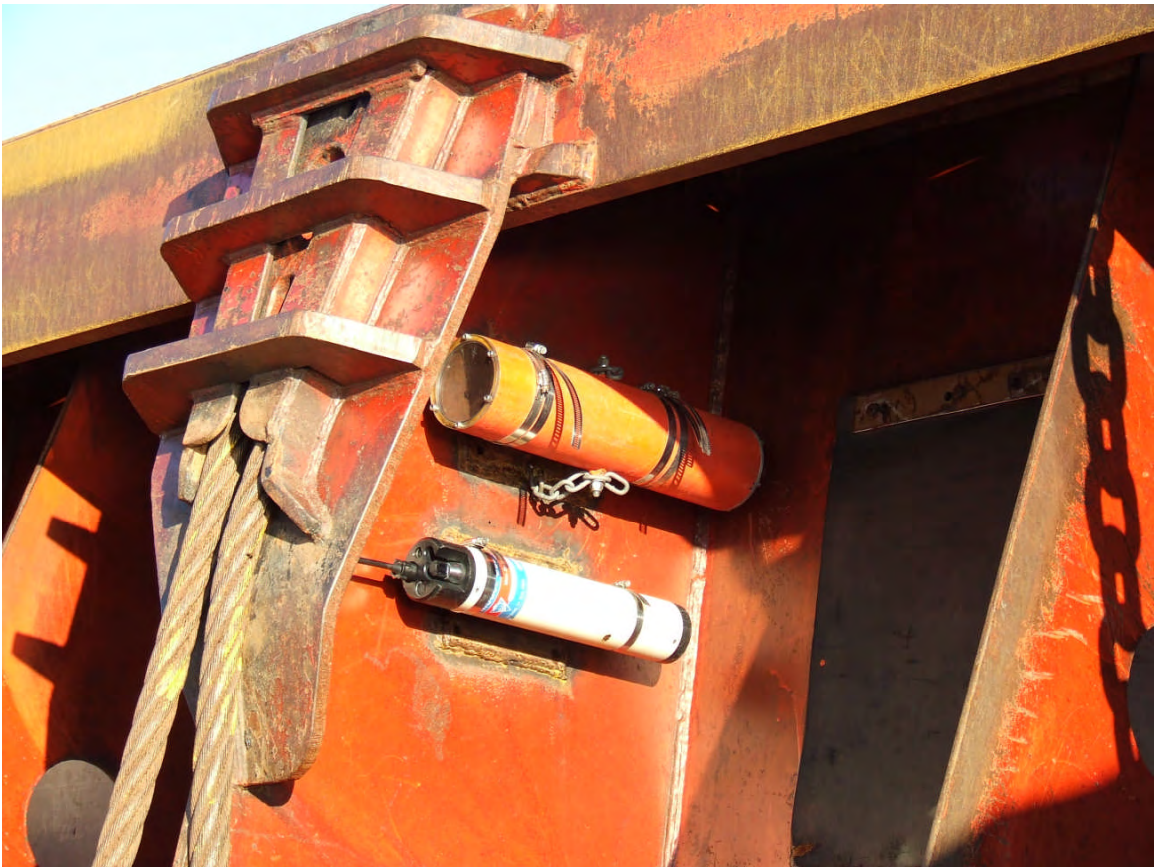
Figure 6. Instrumentation as mounted on the bucket. Upper orange canister contains an accelerometer array. Lower white and black unit is a battery-powered optical backscatter sensor (OBS-3A) with the sensor facing laterally outward from the central bucket support rib and outboard in relation to the bucket's internal axis. When the bucket was closed the instruments were oriented horizontally. When the bucket was open the instruments were oriented at an approximately 45 degree angle from the vertical.

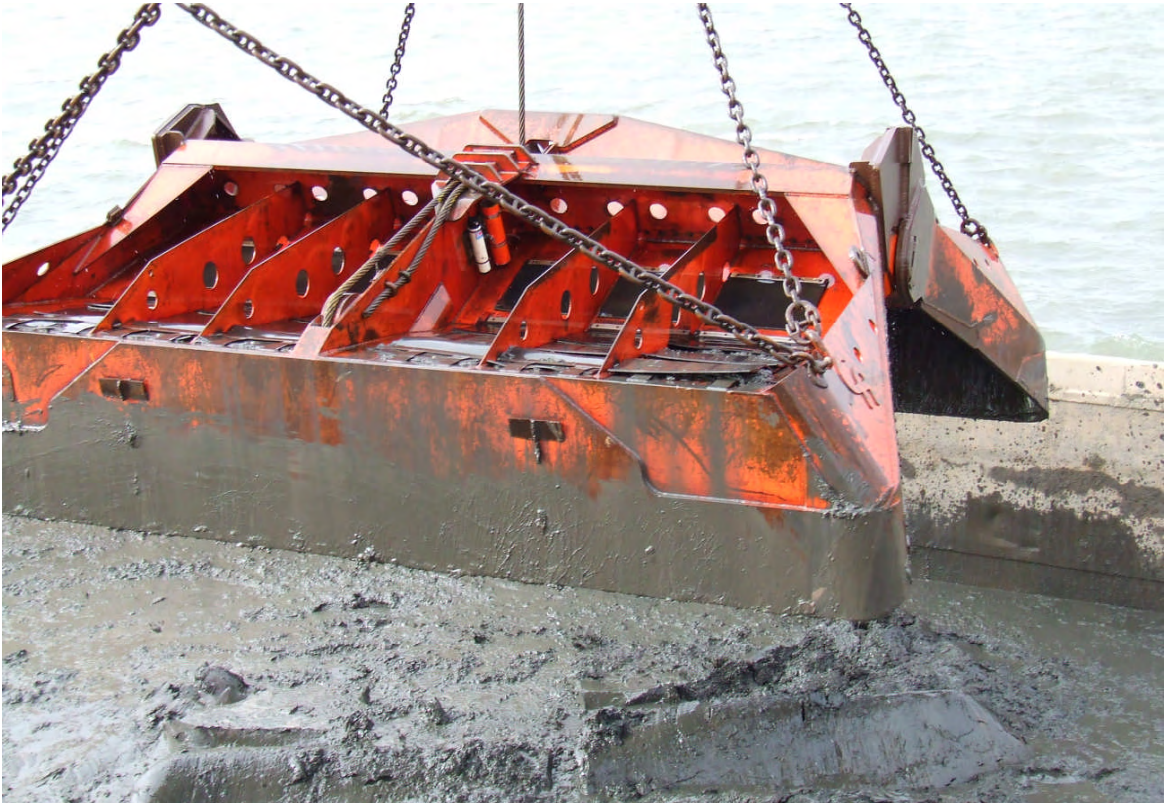
Figure 7. Sensor location. The orange accelerometer canister and white OBS housing are visible attached to the bucket's central support rib. This sensor array is on the "inboard" side of the bucket, which always faces the derrick and operator's cab.

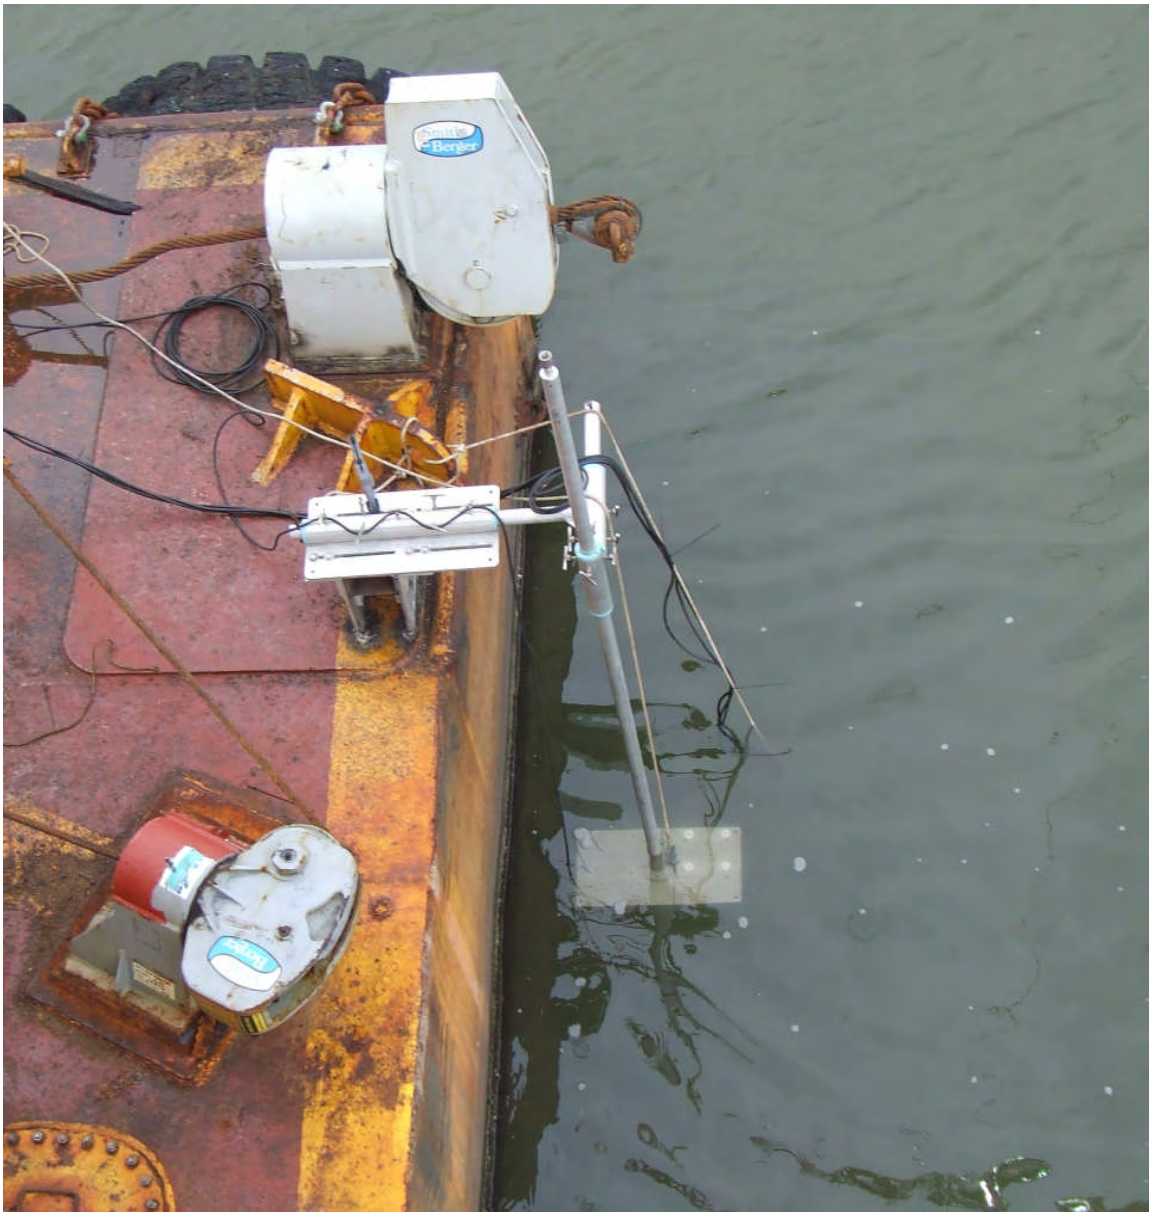
Figure 8. Location of sensors deployed from the dredge platform. The vertical tube supports the ADCP transducer assembly just below the water's surface. A string of three OBS units was deployed outboard from the ADCP mount.

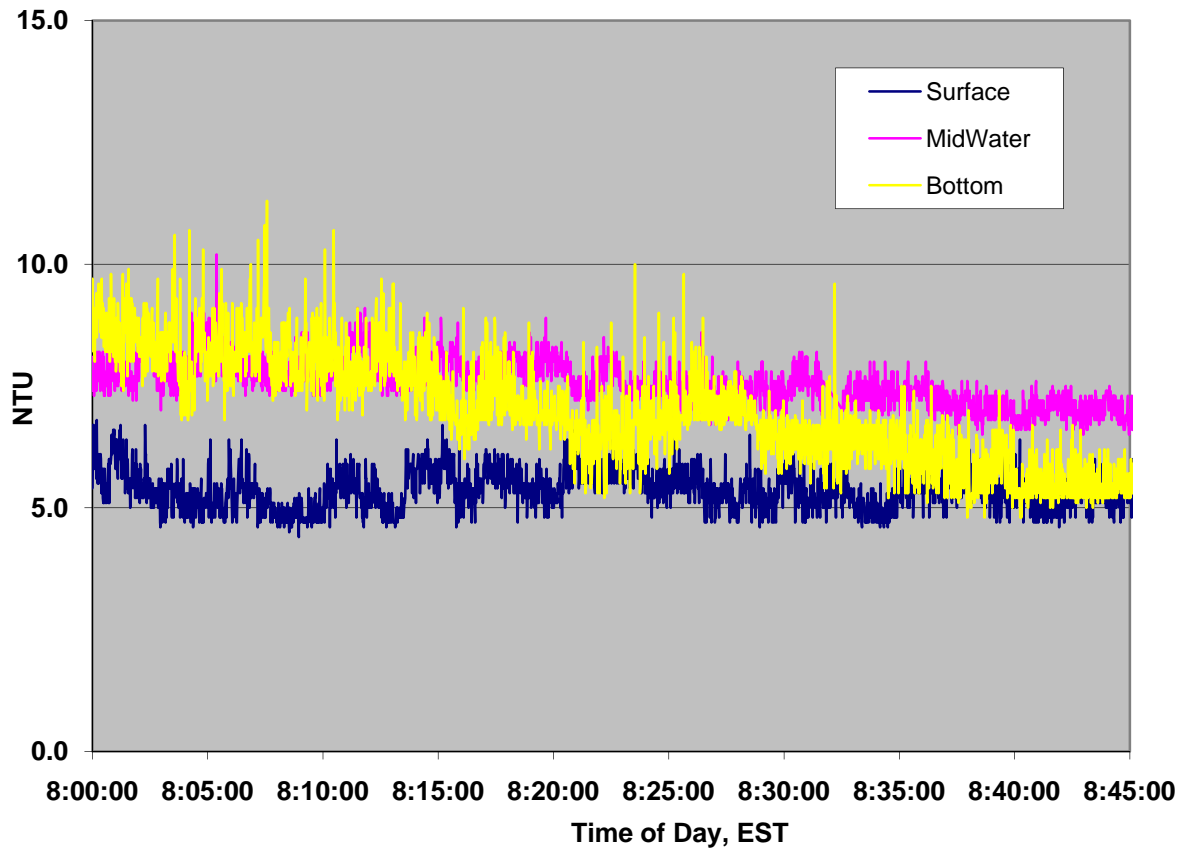
Figure 9. Example of ambient turbidity data collected by platform OBS units on January 31, 2008.

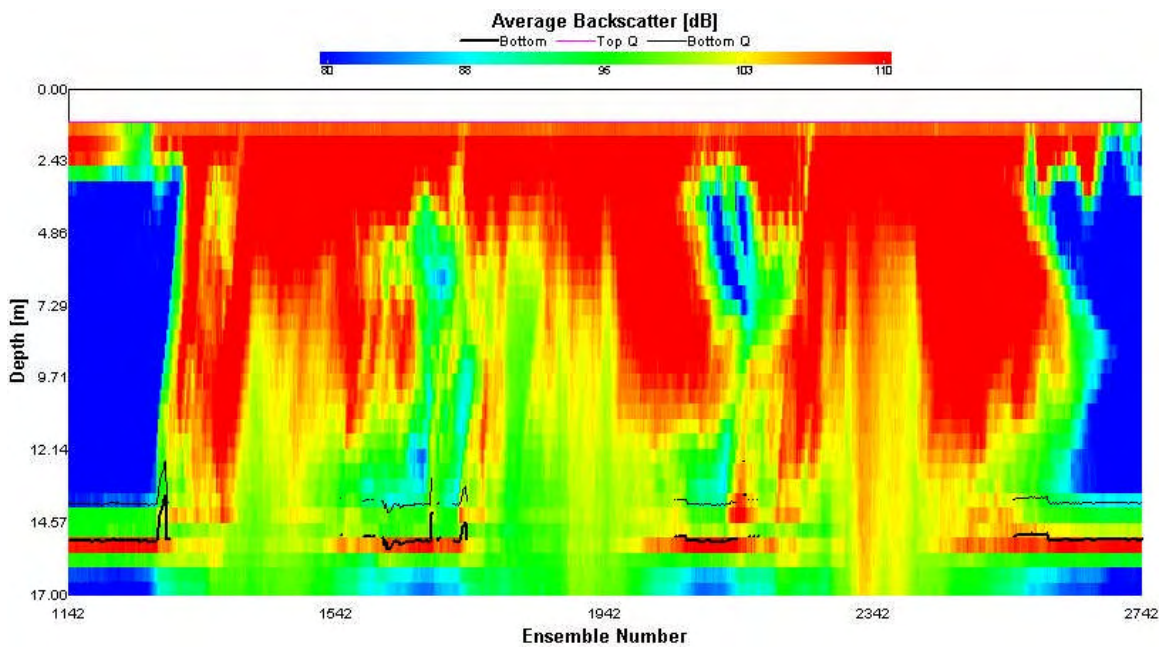
Figure 10. ADCP backscatter signal during the ebb tide bubble test on January 29, 2008.

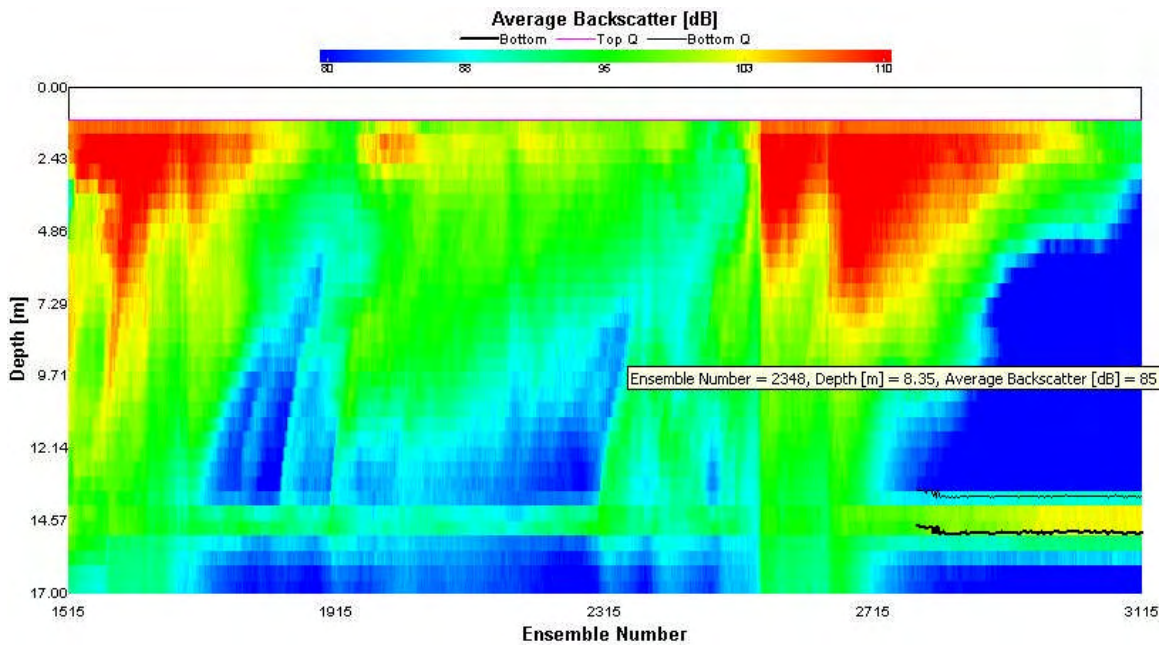
Figure 11. ADCP backscatter signal during the slack tide bubble test on January 29, 2008.

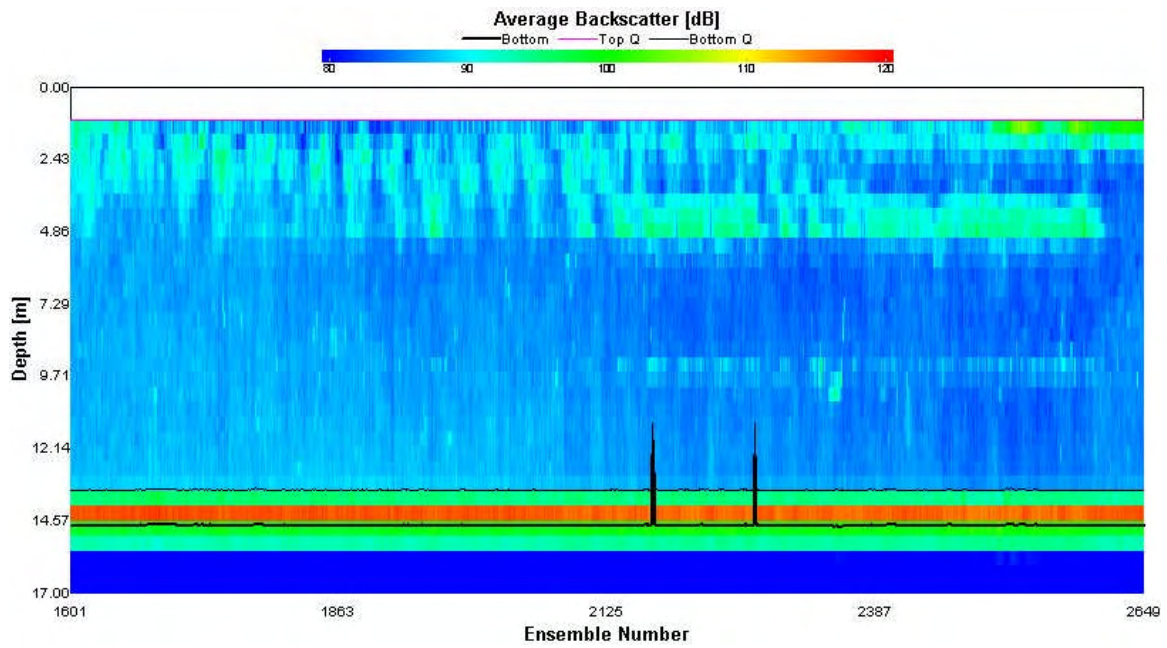
Figure 12. ADCP backscatter signal during the flood tide bubble test on January 29, 2008.

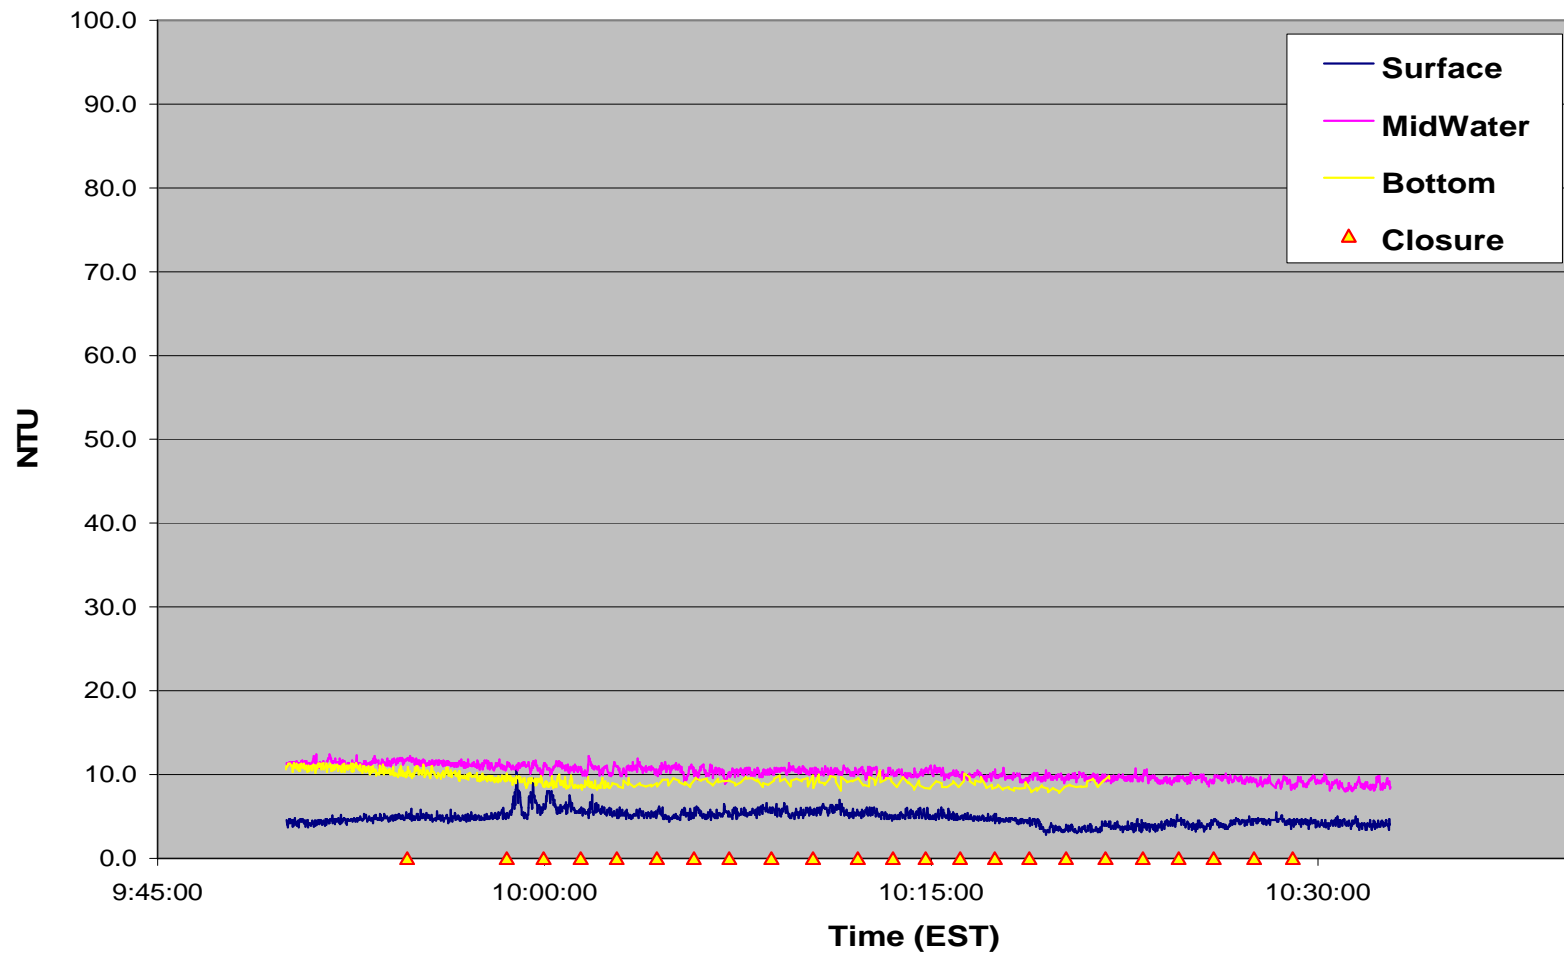
Figure 13. Turbidity measurements obtained by OBS instruments deployed from the dredge platform during the first bubble test, which occurred on a flooding tide on January 29, 2008.

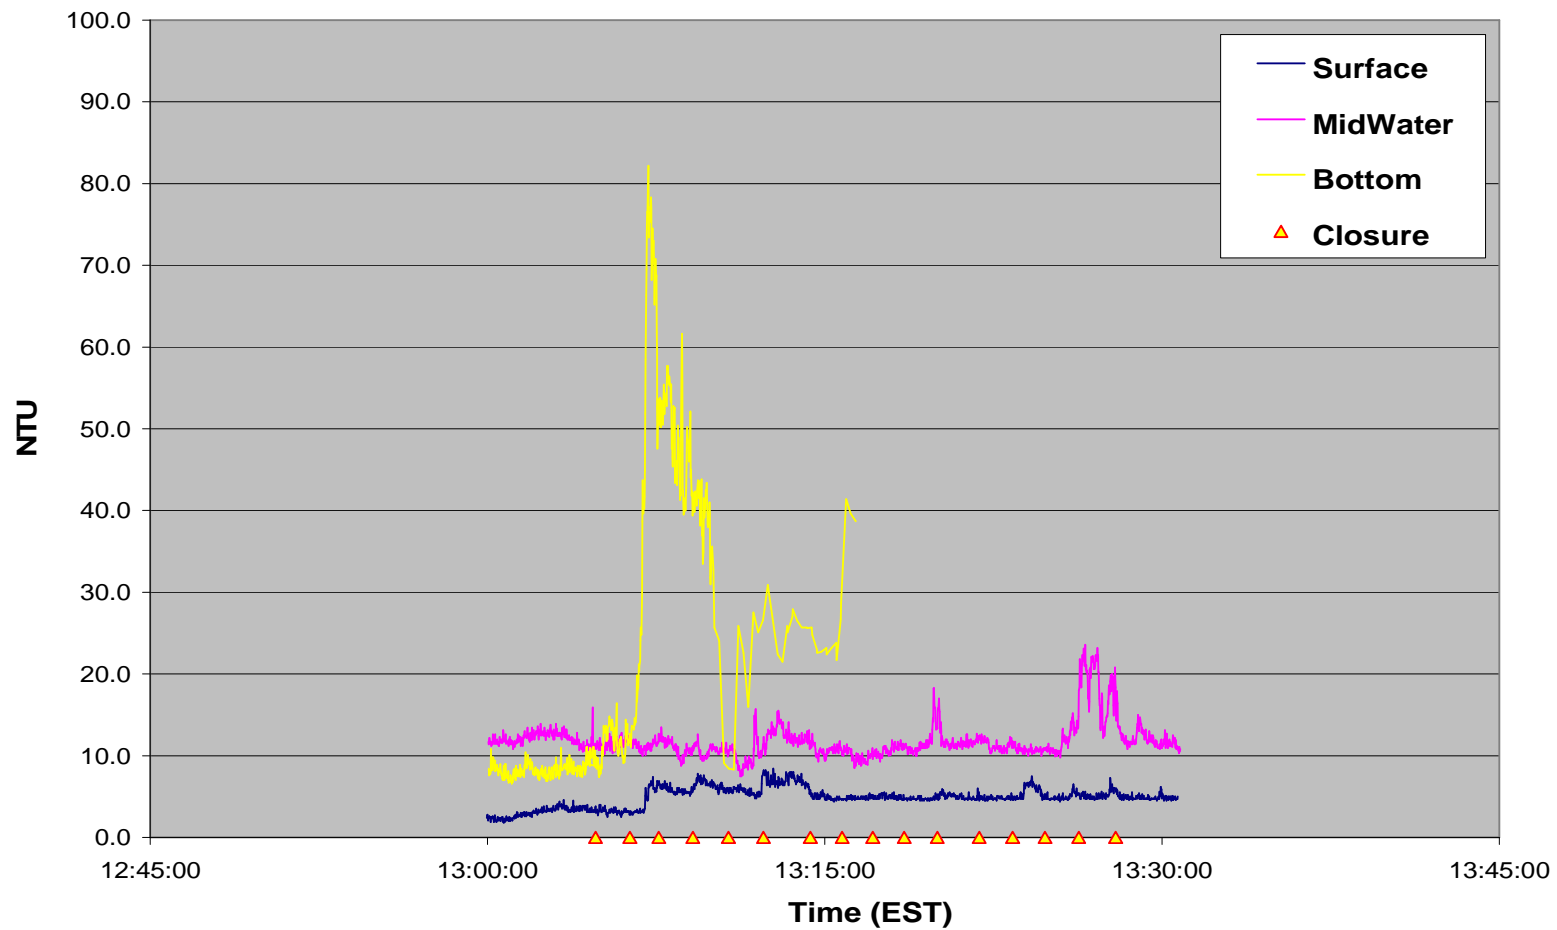
Figure 14. Turbidity measurements obtained by OBS instruments deployed from the dredge platform during the second bubble test, which occurred during slack tide on January 29, 2008.

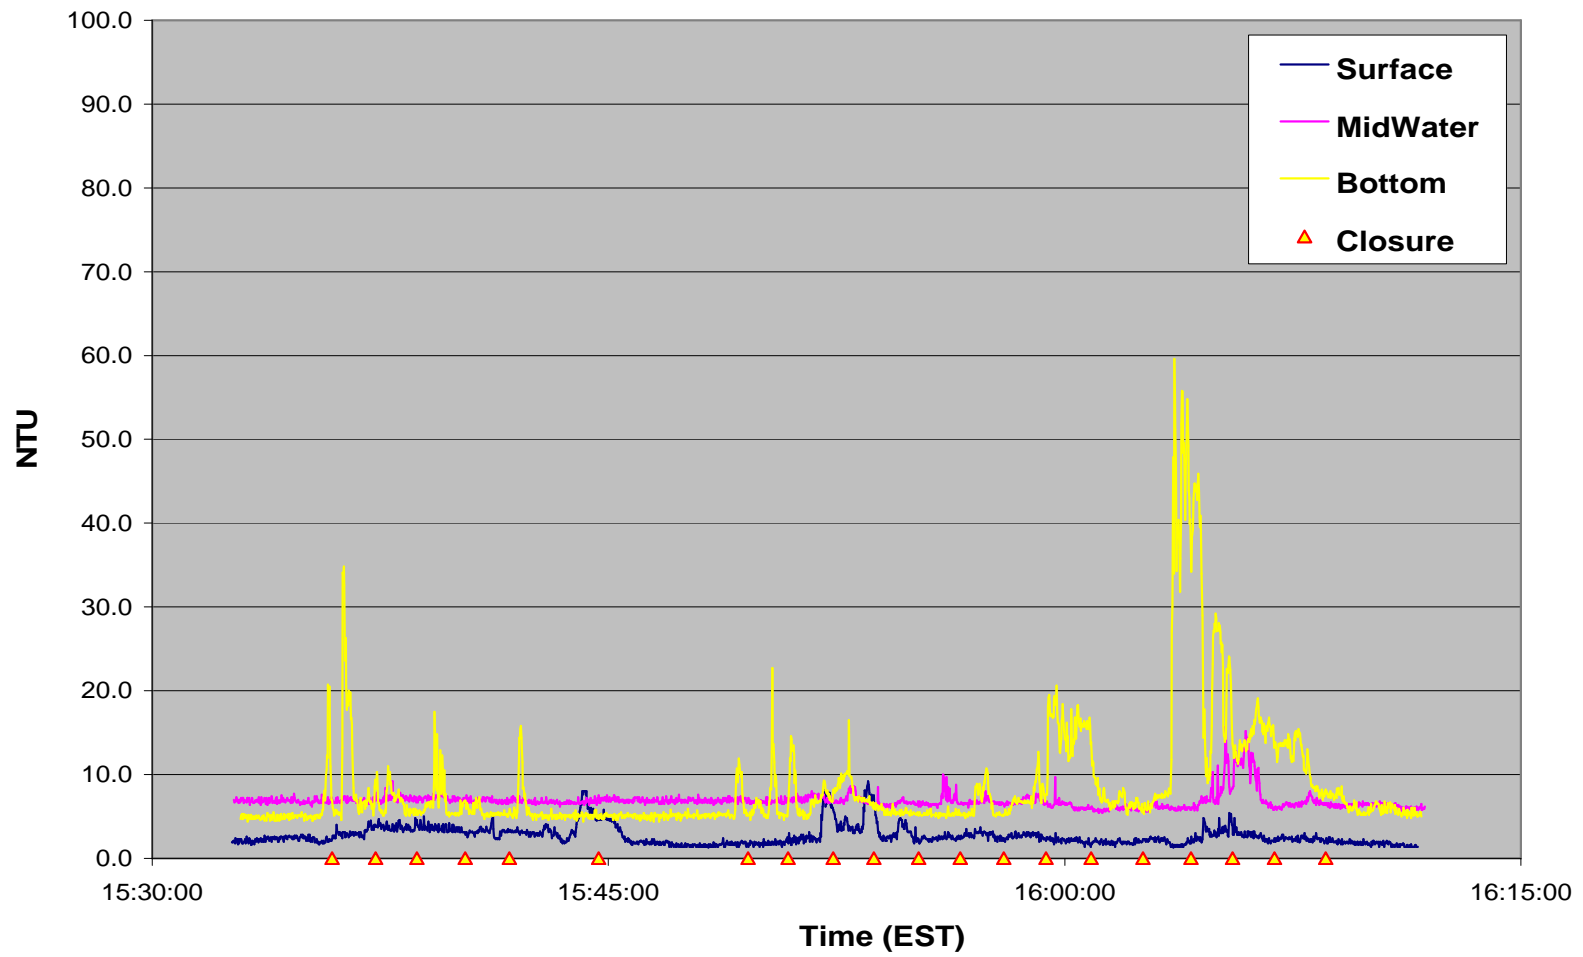
Figure 15. Turbidity measurements obtained by OBS instruments deployed from the dredge platform during the third bubble test, which occurred on an ebbing tide on January 29, 2008.

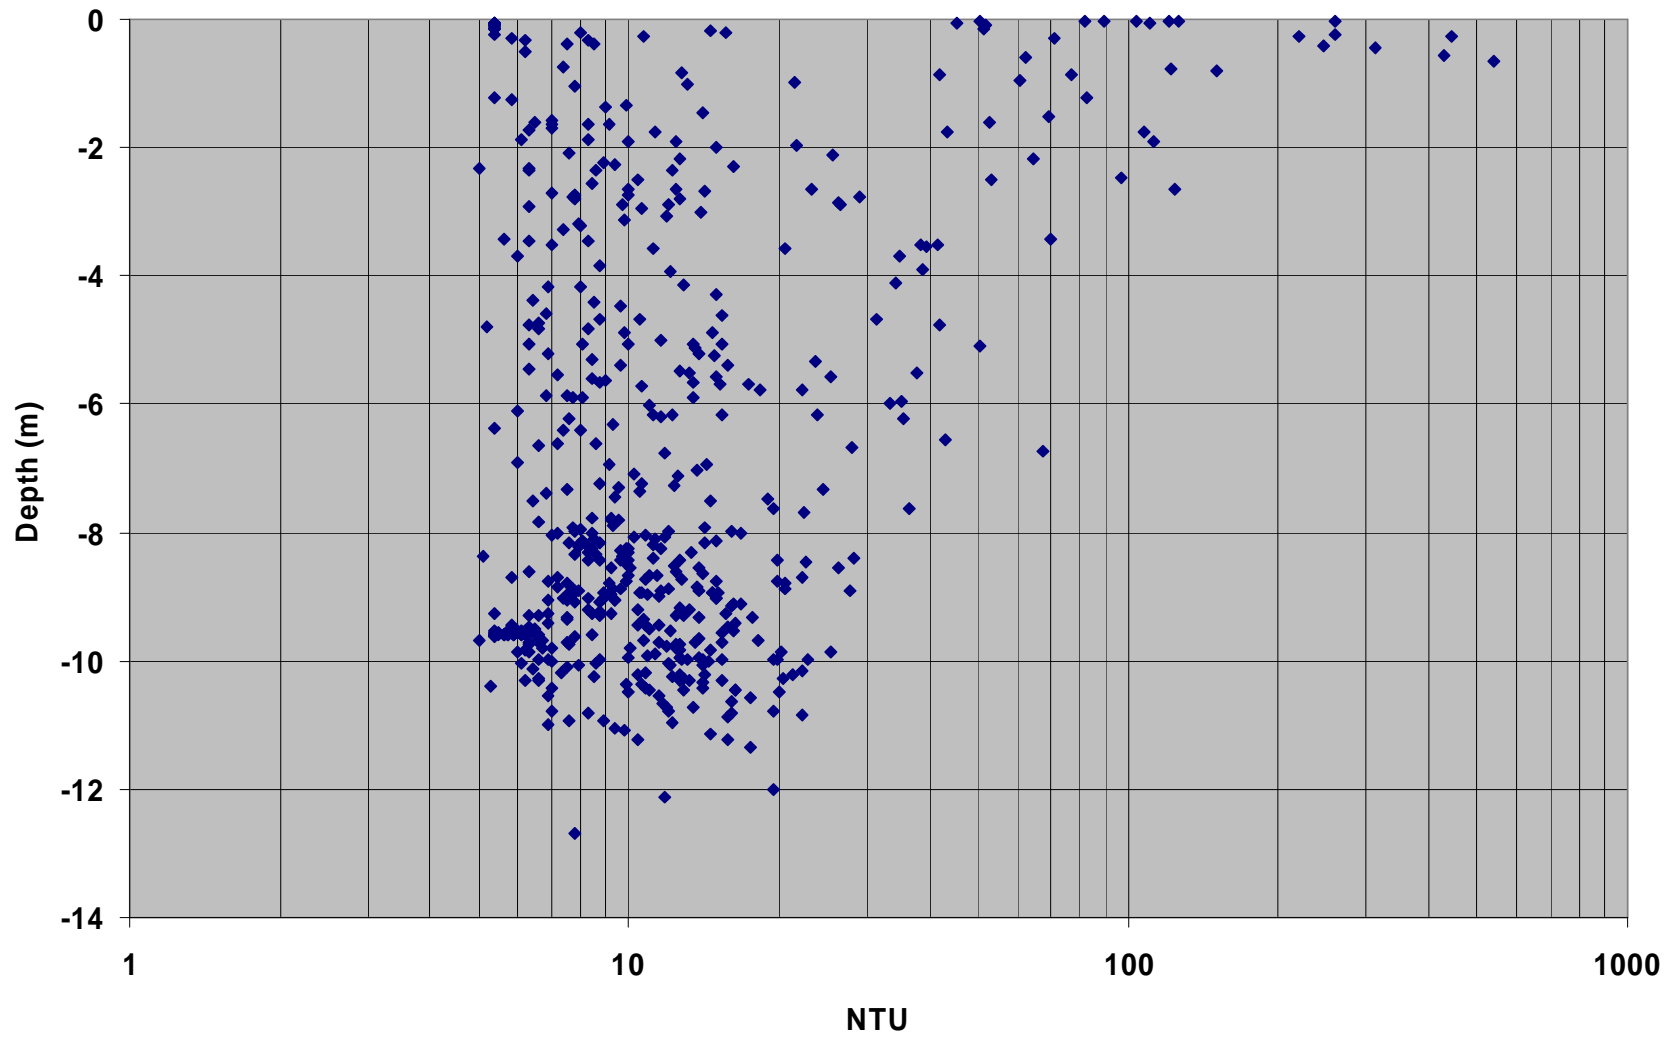
Figure 16. Turbidity data plotted against depth for bucket-mounted OBS instrument for all bubble tests. Note logarithmic scale of X-axis.

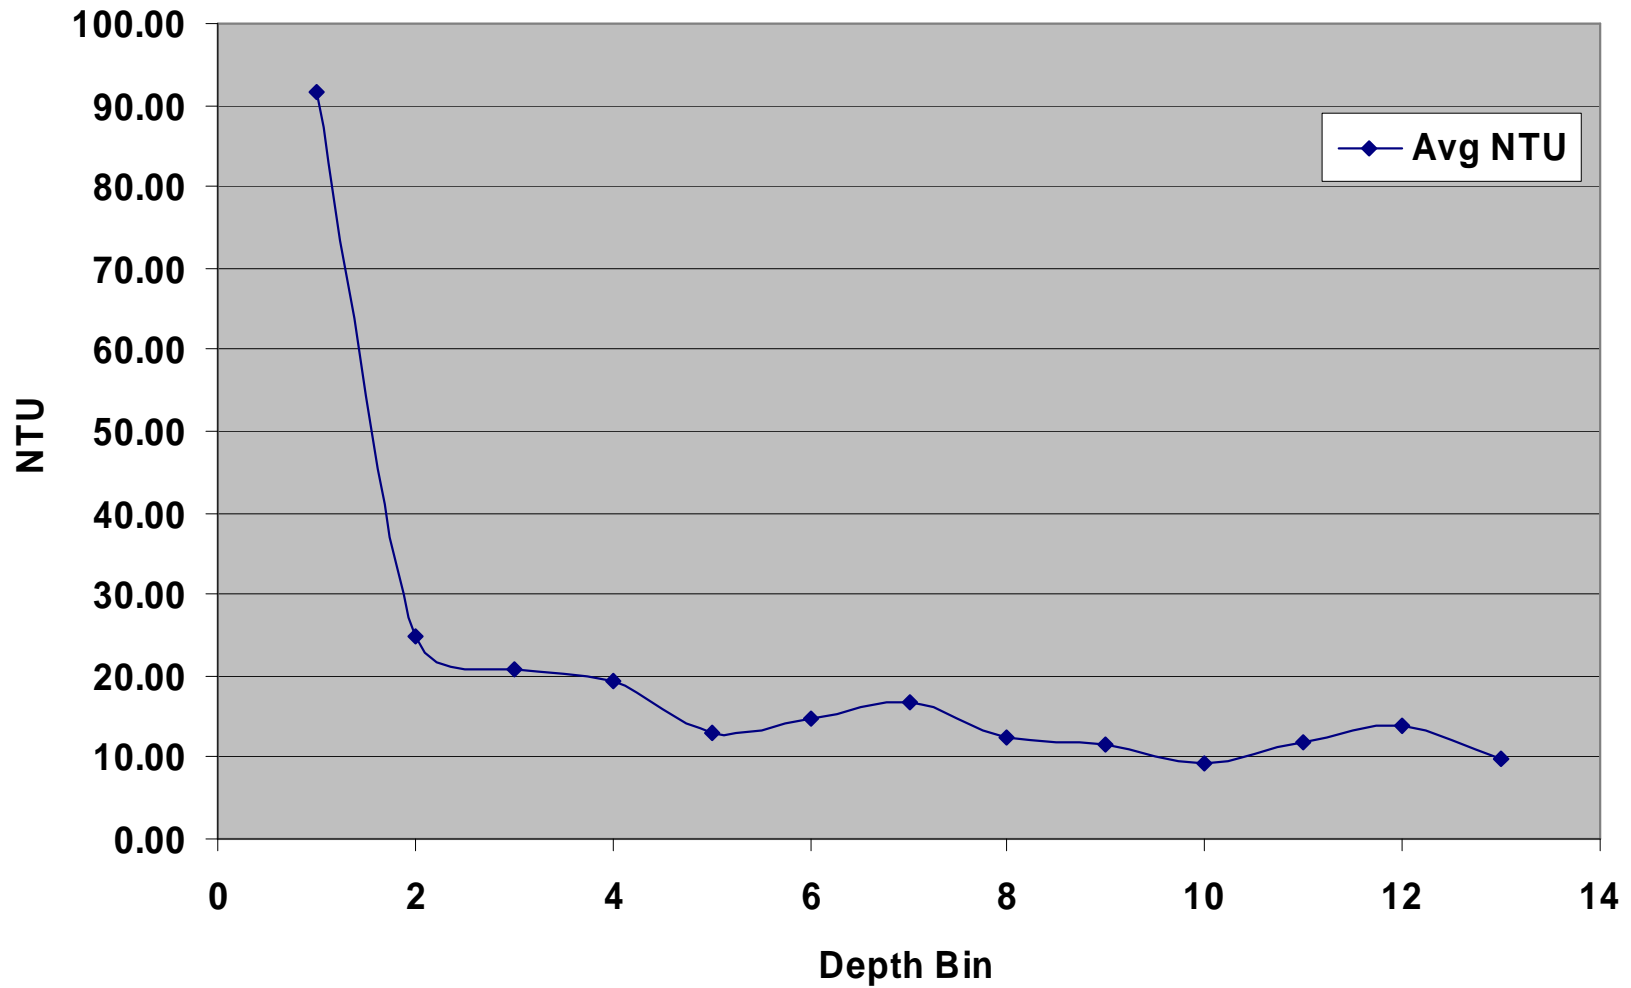
Figure 17. Average turbidity measurements by depth strata for a bucket-mounted OBS instrument during all bubble tests.

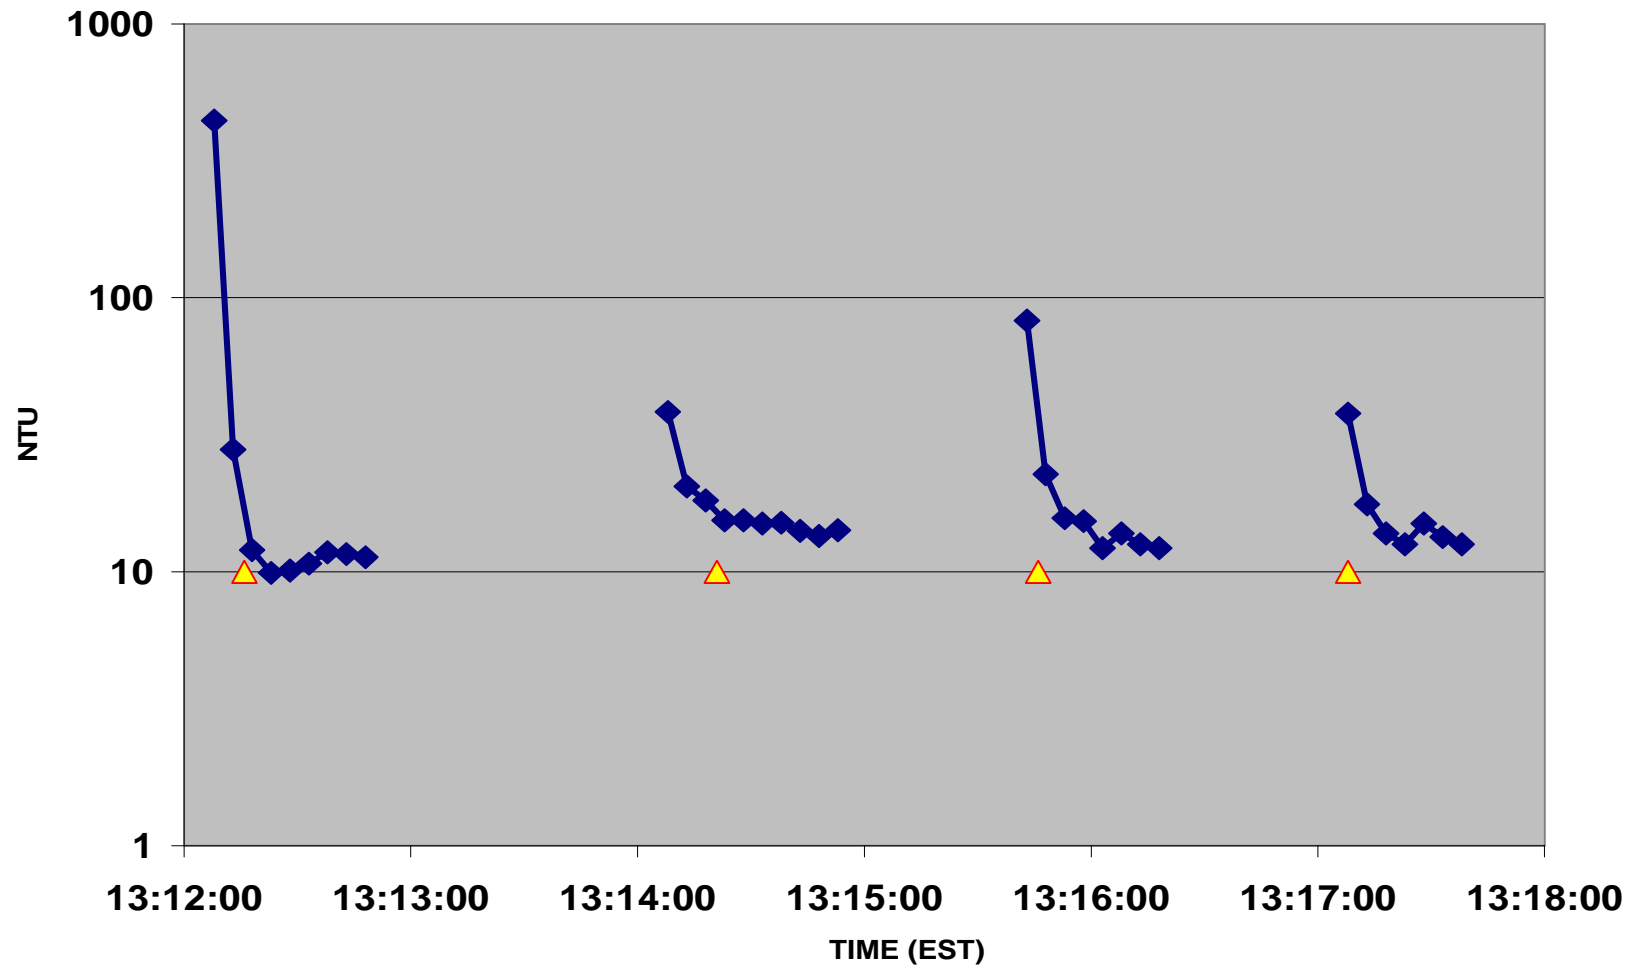
Figure 18. A typical series of turbidity measurements from a bucket-mounted OBS instrument during a bubble test. Yellow triangles represent synchronized bucket closure times. The gap between successive bucket cycles result from deletion of measurements made while the bucket was above the surface of the water.

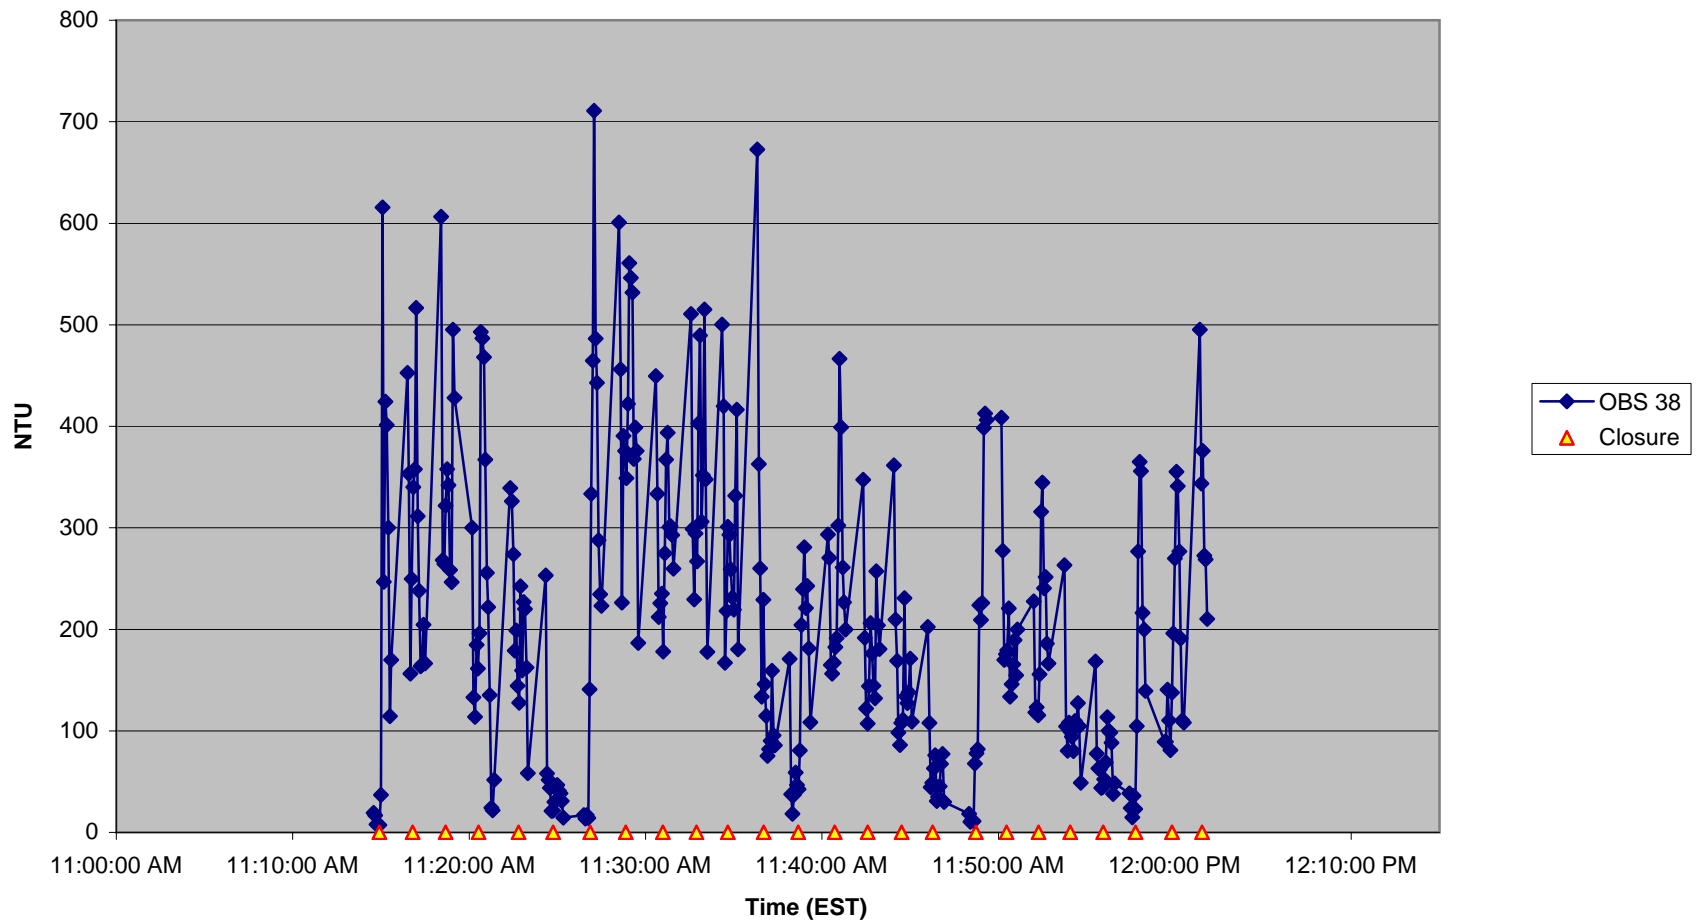
Figure 19. Turbidity measurements obtained from the bucket mounted OBS Unit during the first short-term duration dredging test (flood tide) on January 29, 2008.
