Table 1. Sequence of bubble and dredging tests with prevailing tide stage and number of bucket cycles recorded for each test.

Figure 1. a) Option areas of the S-NB-1 Contract area of the NY/NJ Harbor Deepening Project and b) bathymetry of S-NB-1 dredge contract area during the Pilot Study.

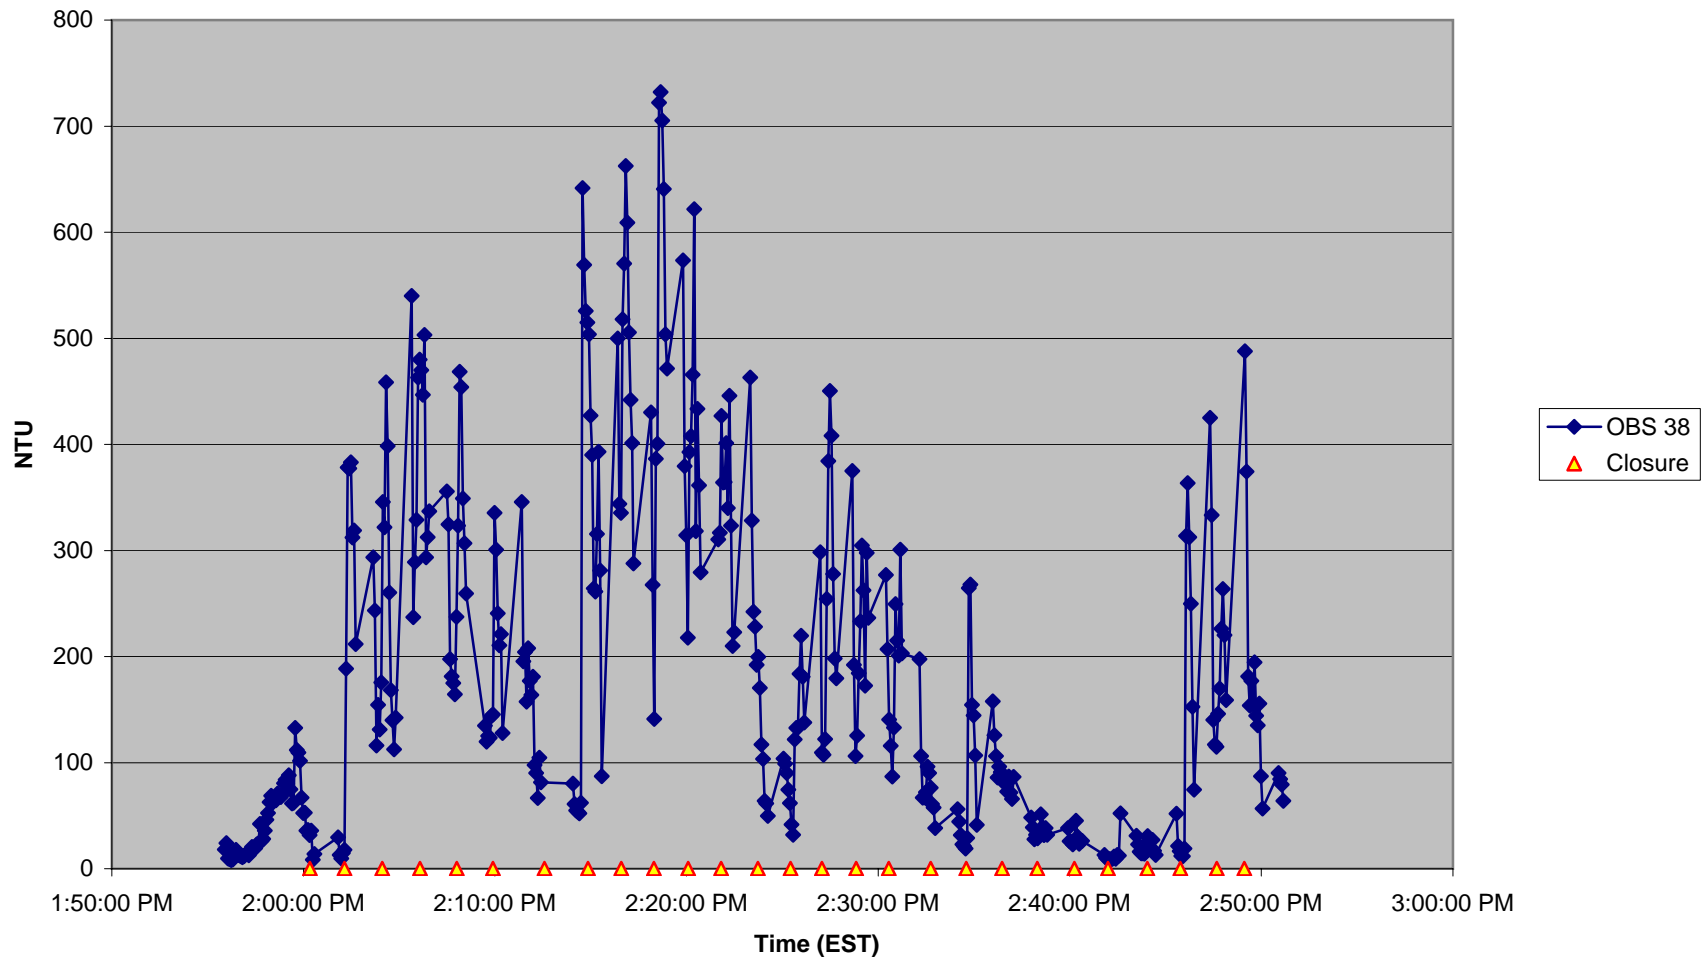
Figure 20. Turbidity measurements obtained from the bucket mounted OBS Unit during the second short-term duration dredging test (high slack tide) on January 29, 2008.

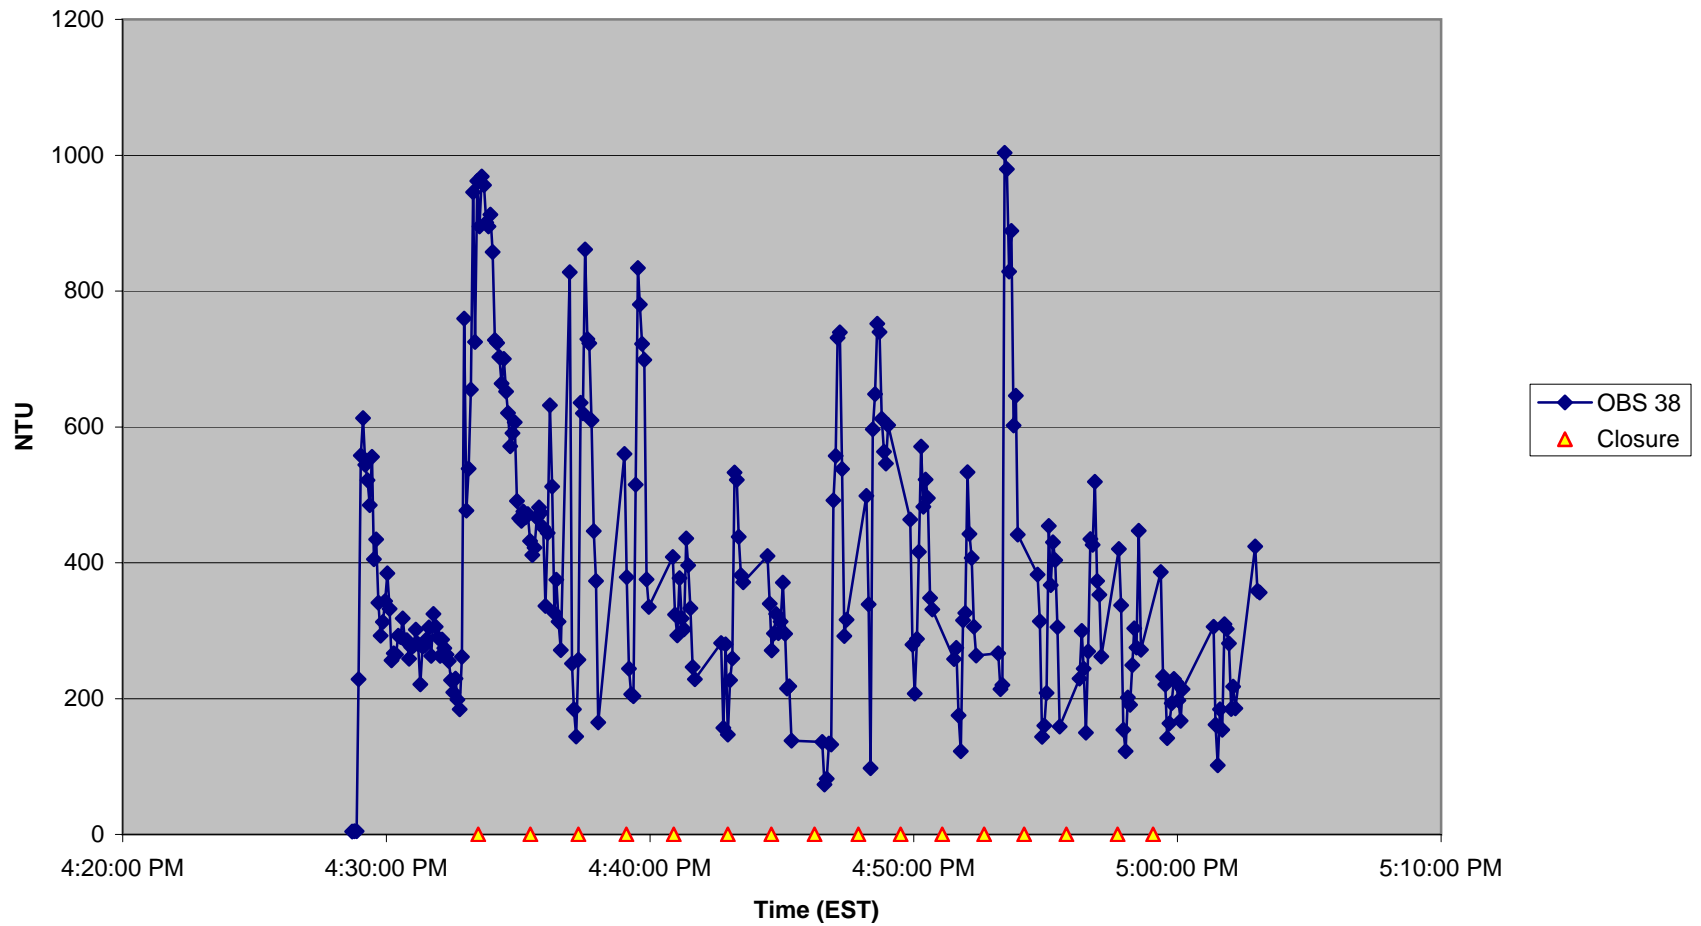
Figure 21. Turbidity measurements obtained from the bucket mounted OBS Unit during the third short-term duration dredging test (ebb tide) on January 29, 2008.

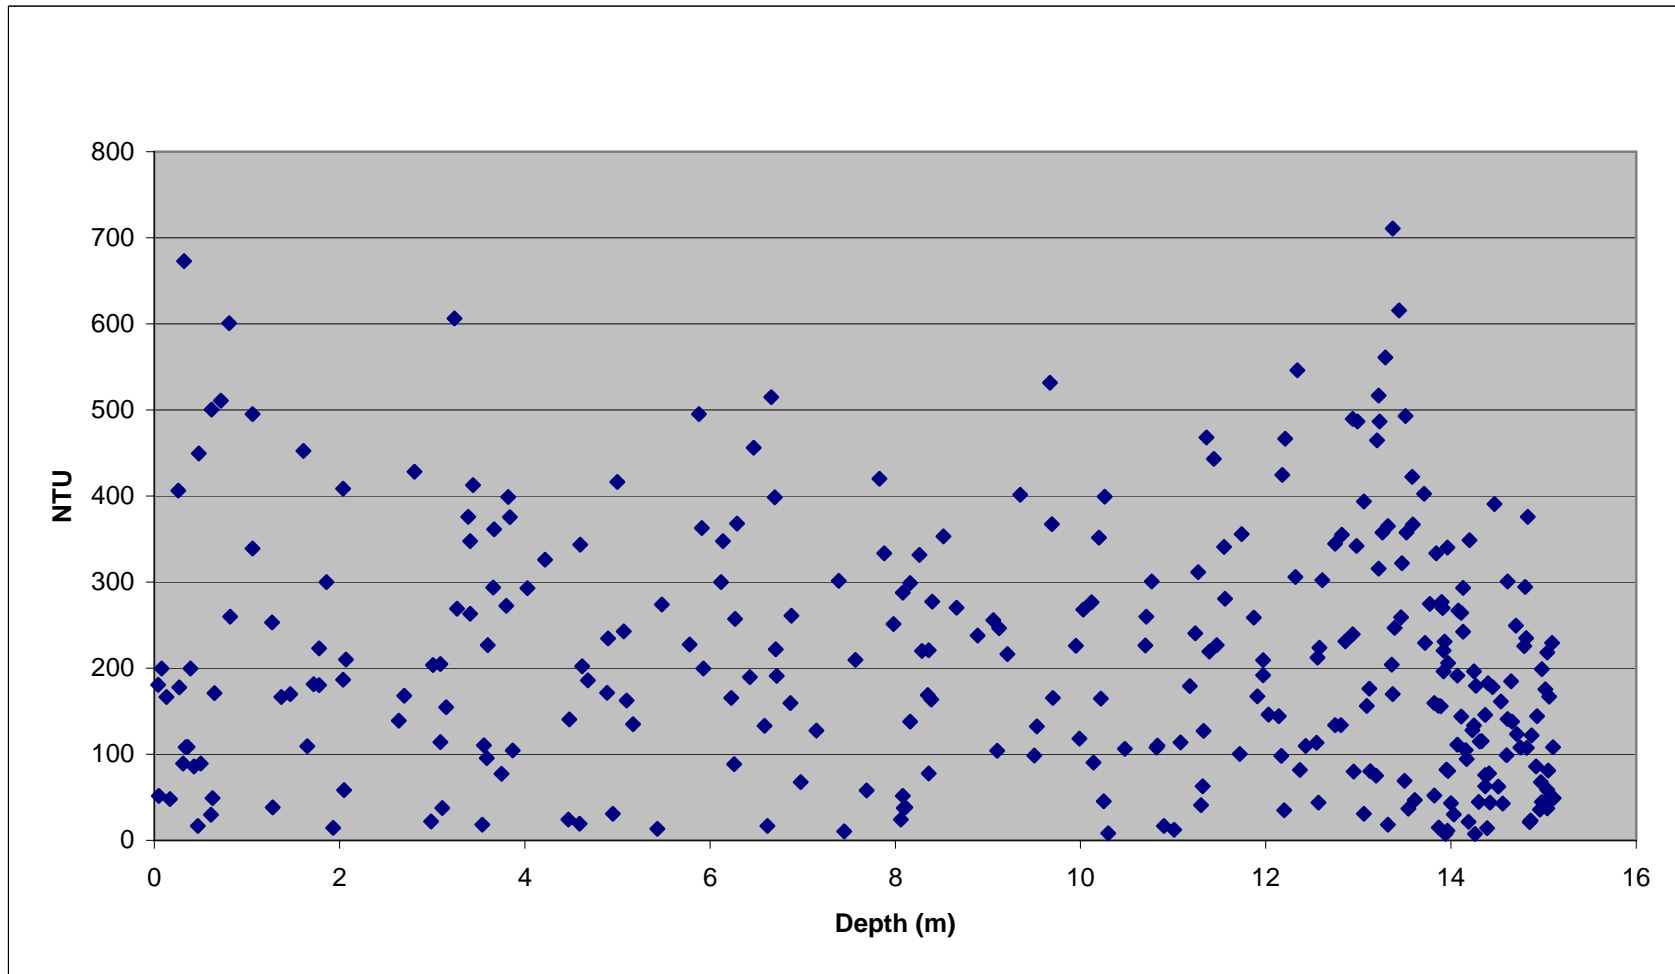
Figure 22. Turbidity measurements plotted versus depth and obtained from the bucket mounted OBS Unit during the first short-term duration dredging test (flood tide) on January 29, 2008.

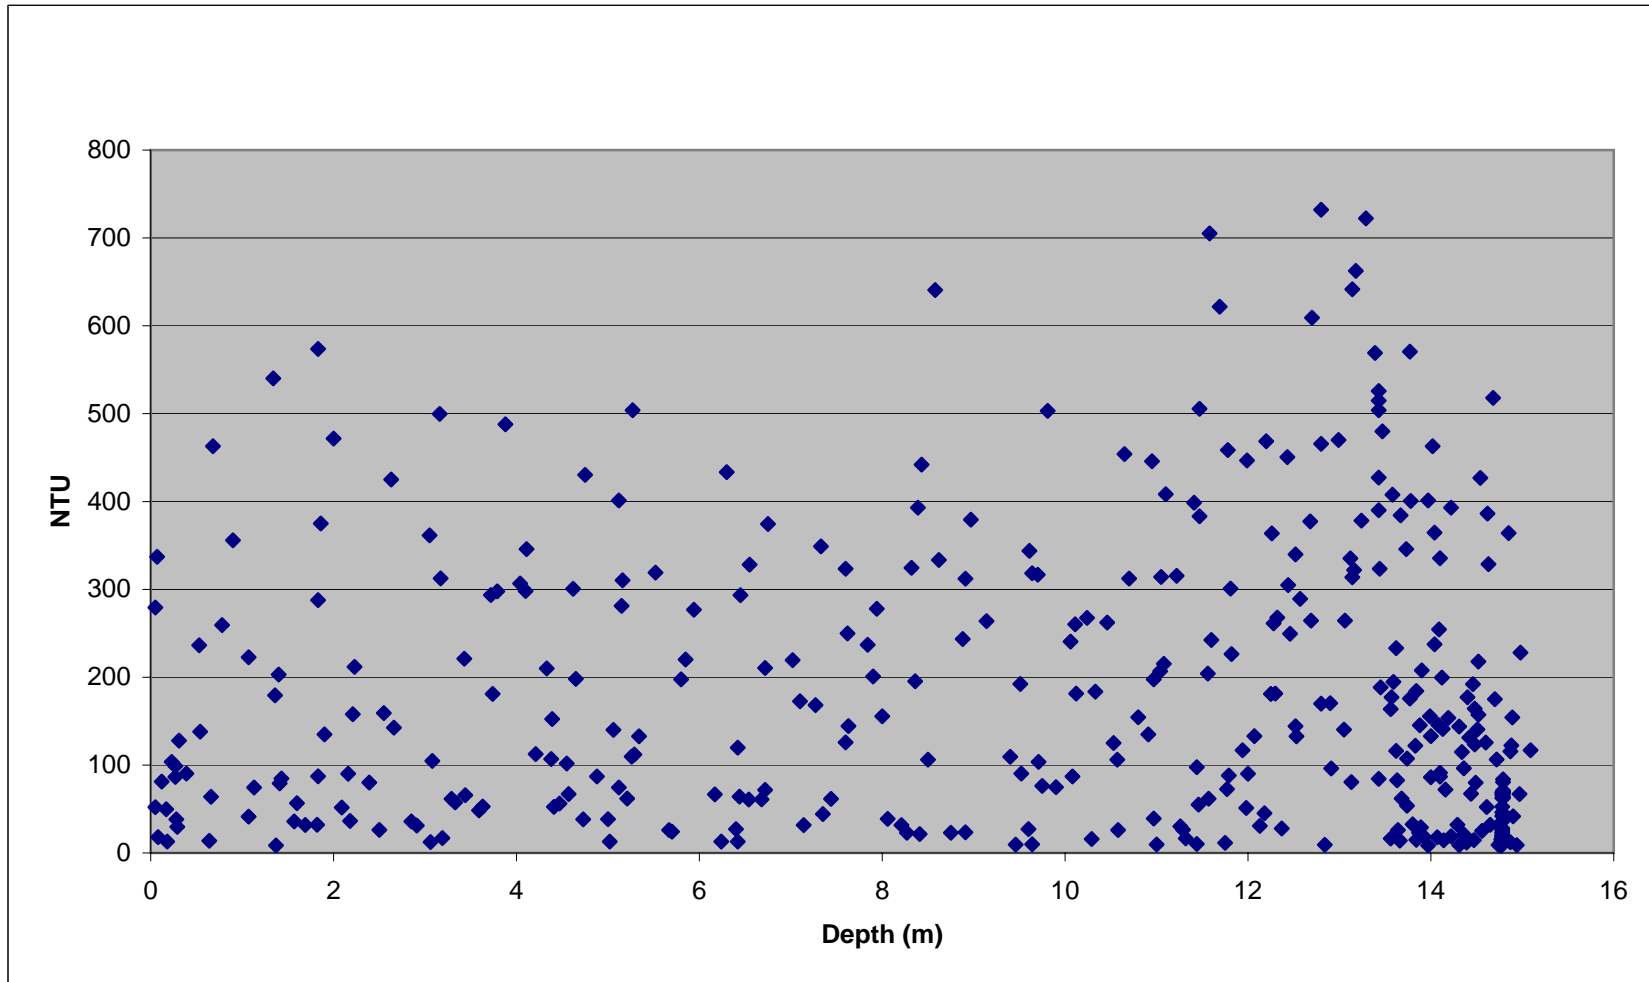
Figure 23. Turbidity measurements plotted versus depth and obtained from the bucket mounted OBS Unit during the second short-term duration dredging test (high slack tide) on January 29, 2008.

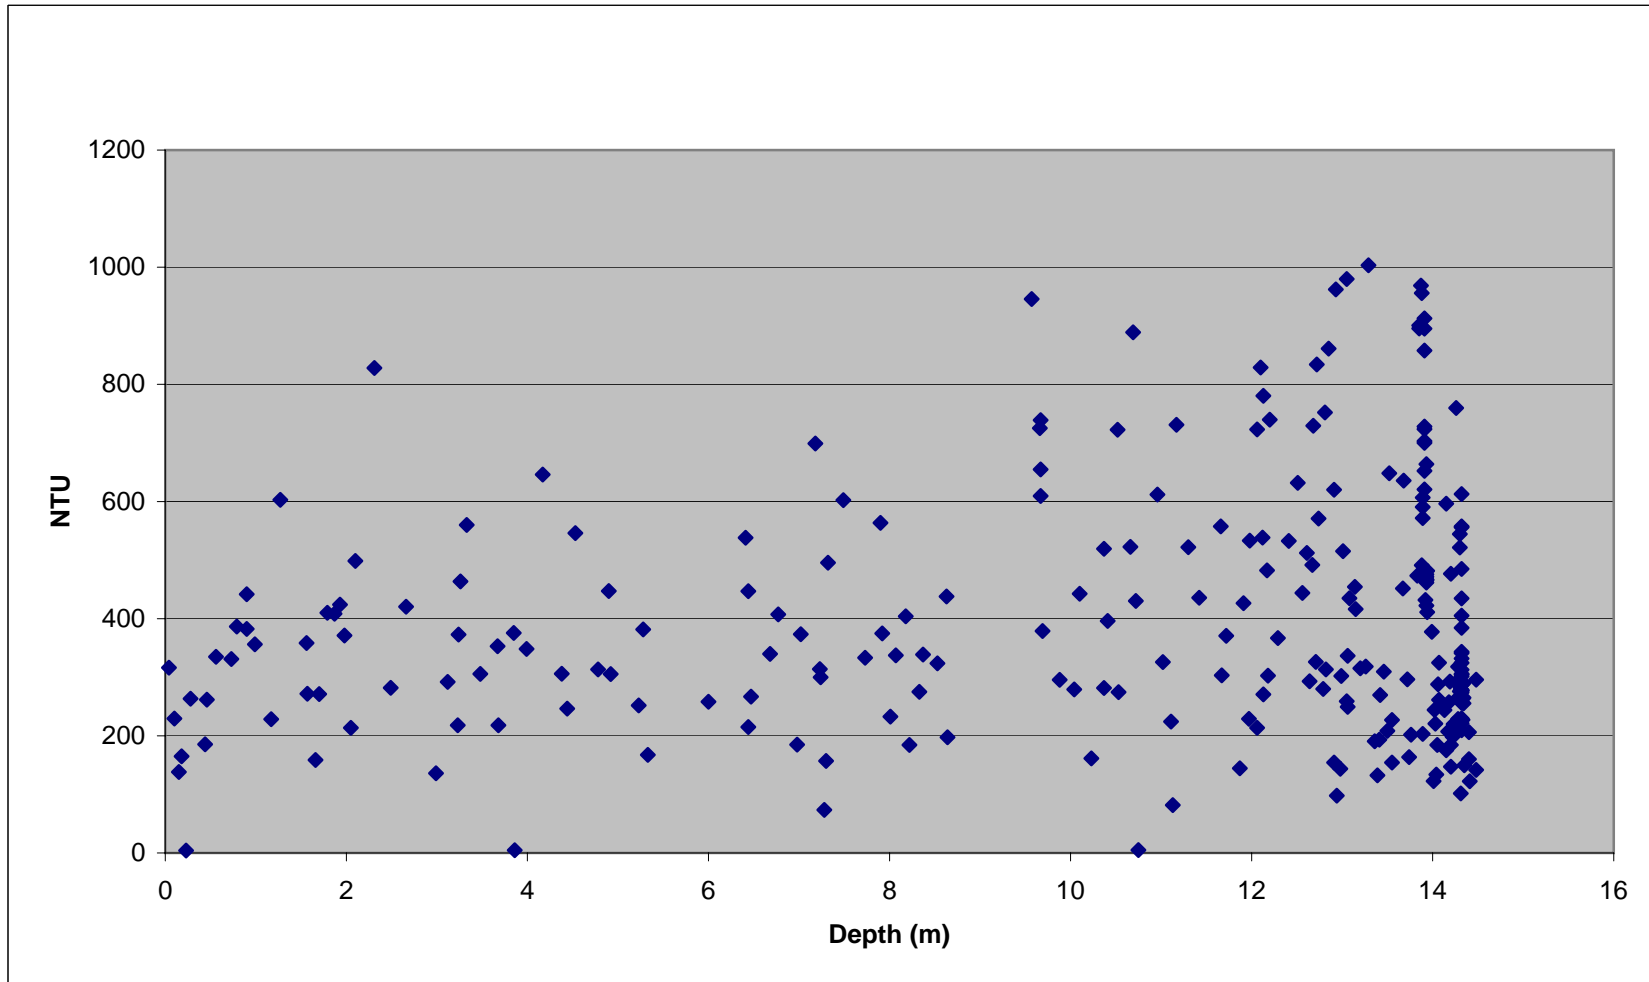
Figure 24. Turbidity measurements plotted versus depth and obtained from the bucket mounted OBS Unit during the third short-term duration dredging test (ebb tide) on January 29, 2008.

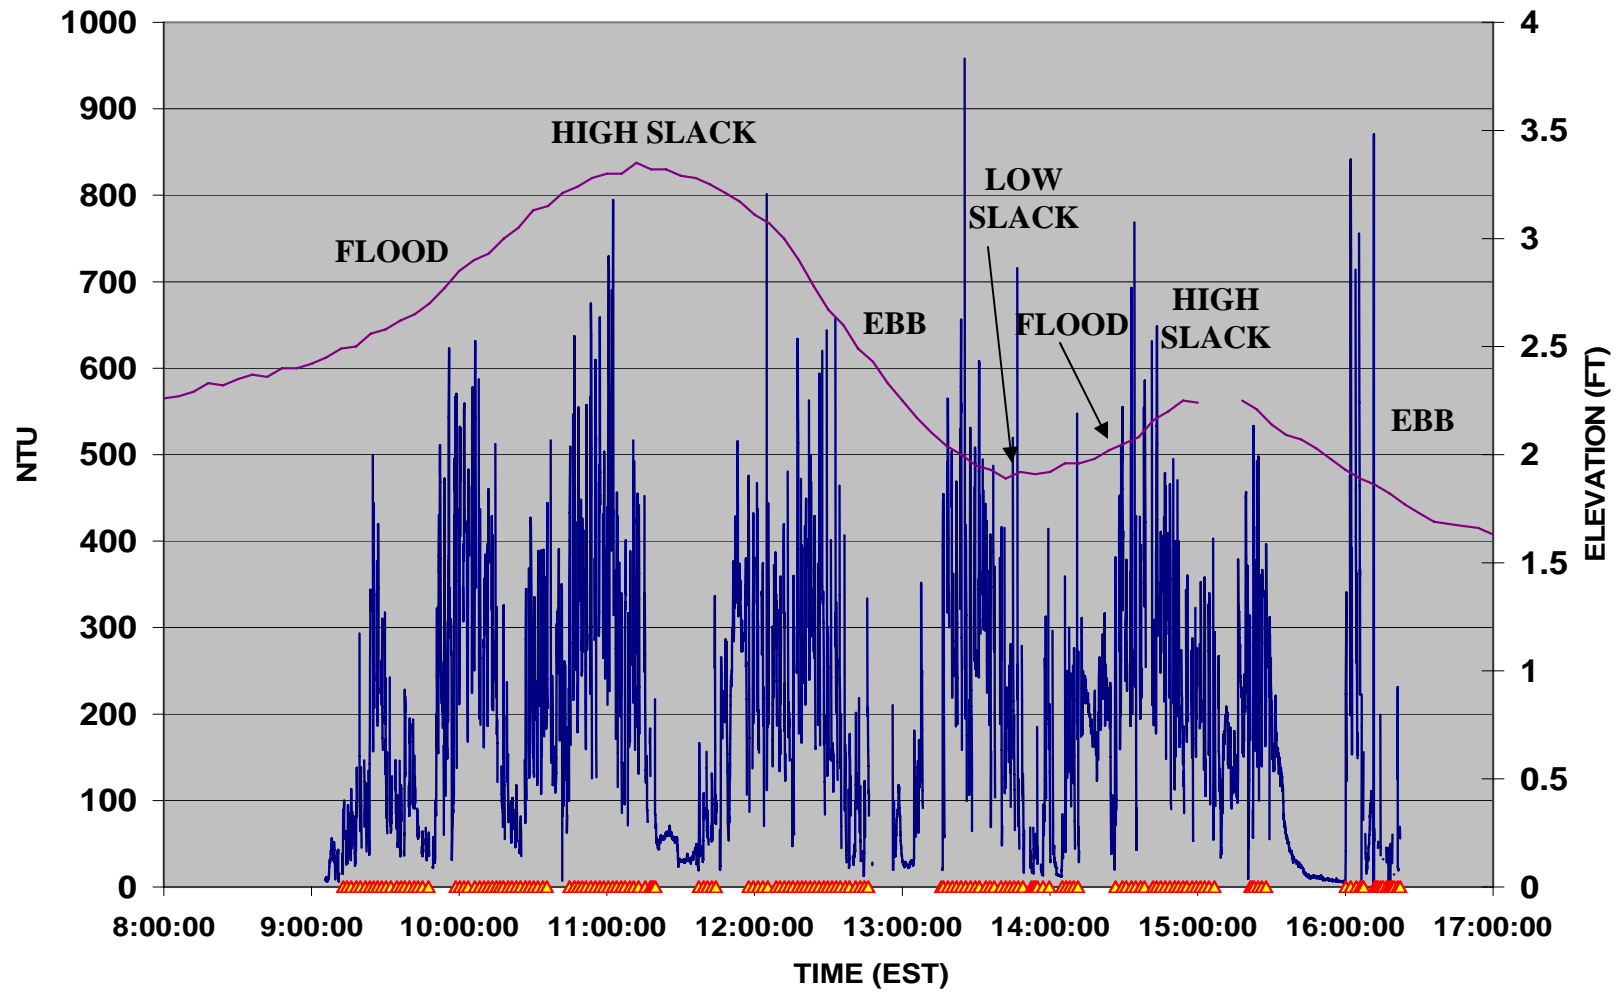
Figure 25. Turbidity measurements obtained by a bucket-mounted sensor during the first long-term dredging test on January 30, 2008.

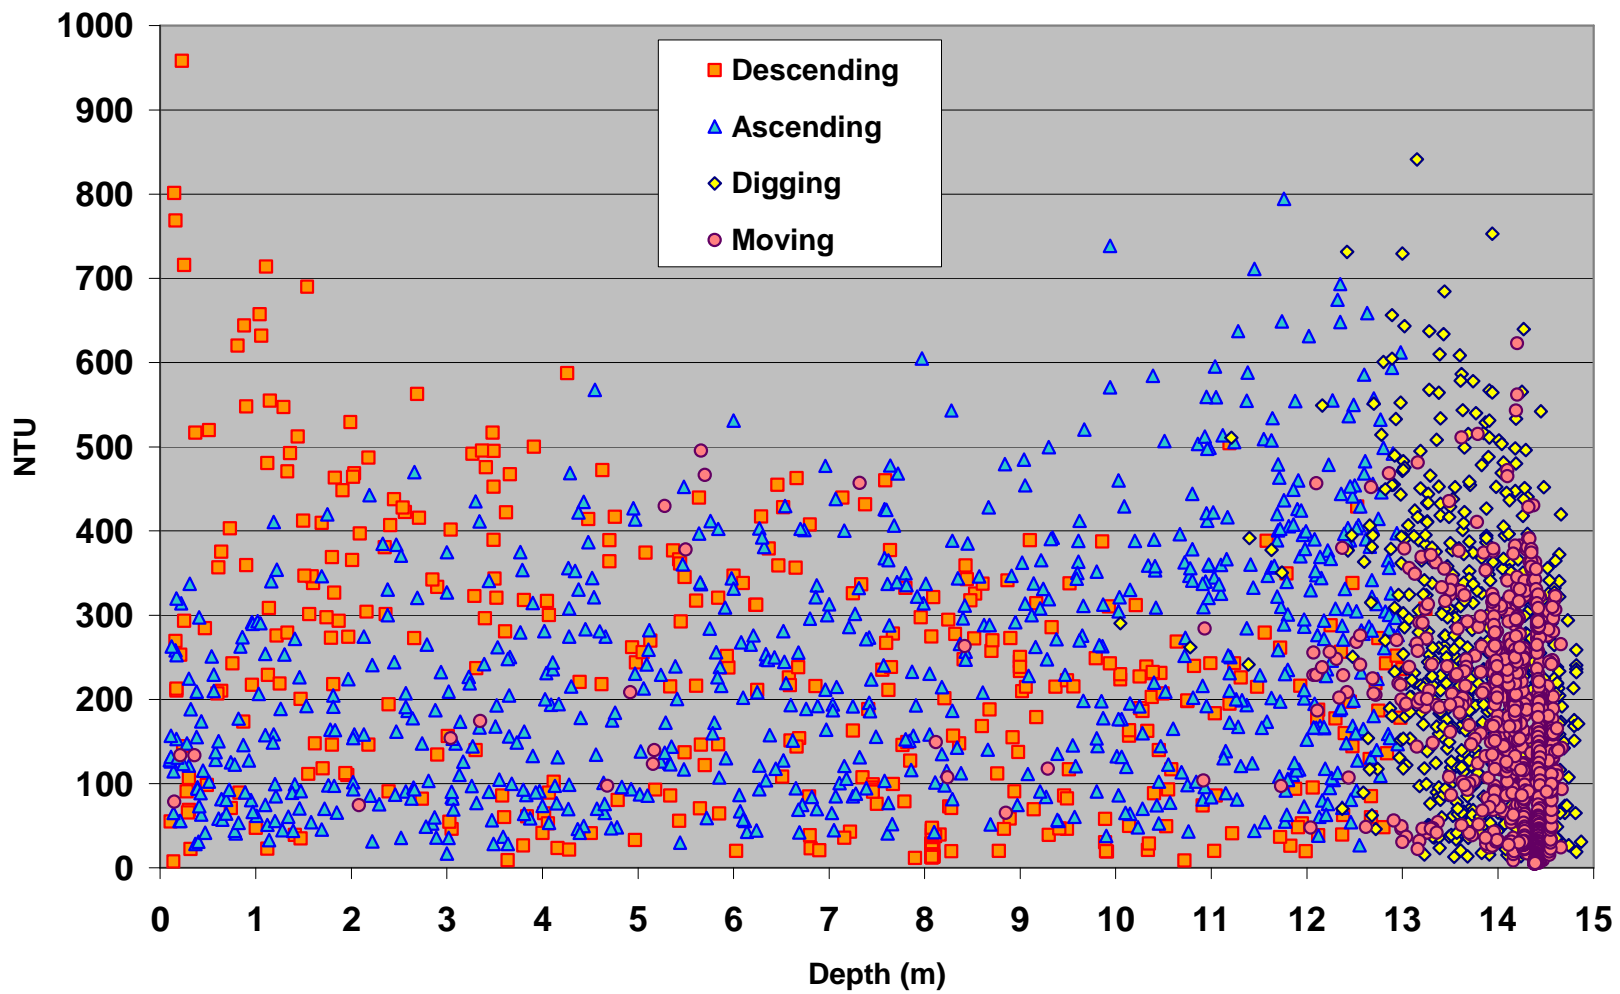
Figure 26. All turbidity measurements obtained by a bucket-mounted sensor during the first long-term dredging test on January 30, 2008.

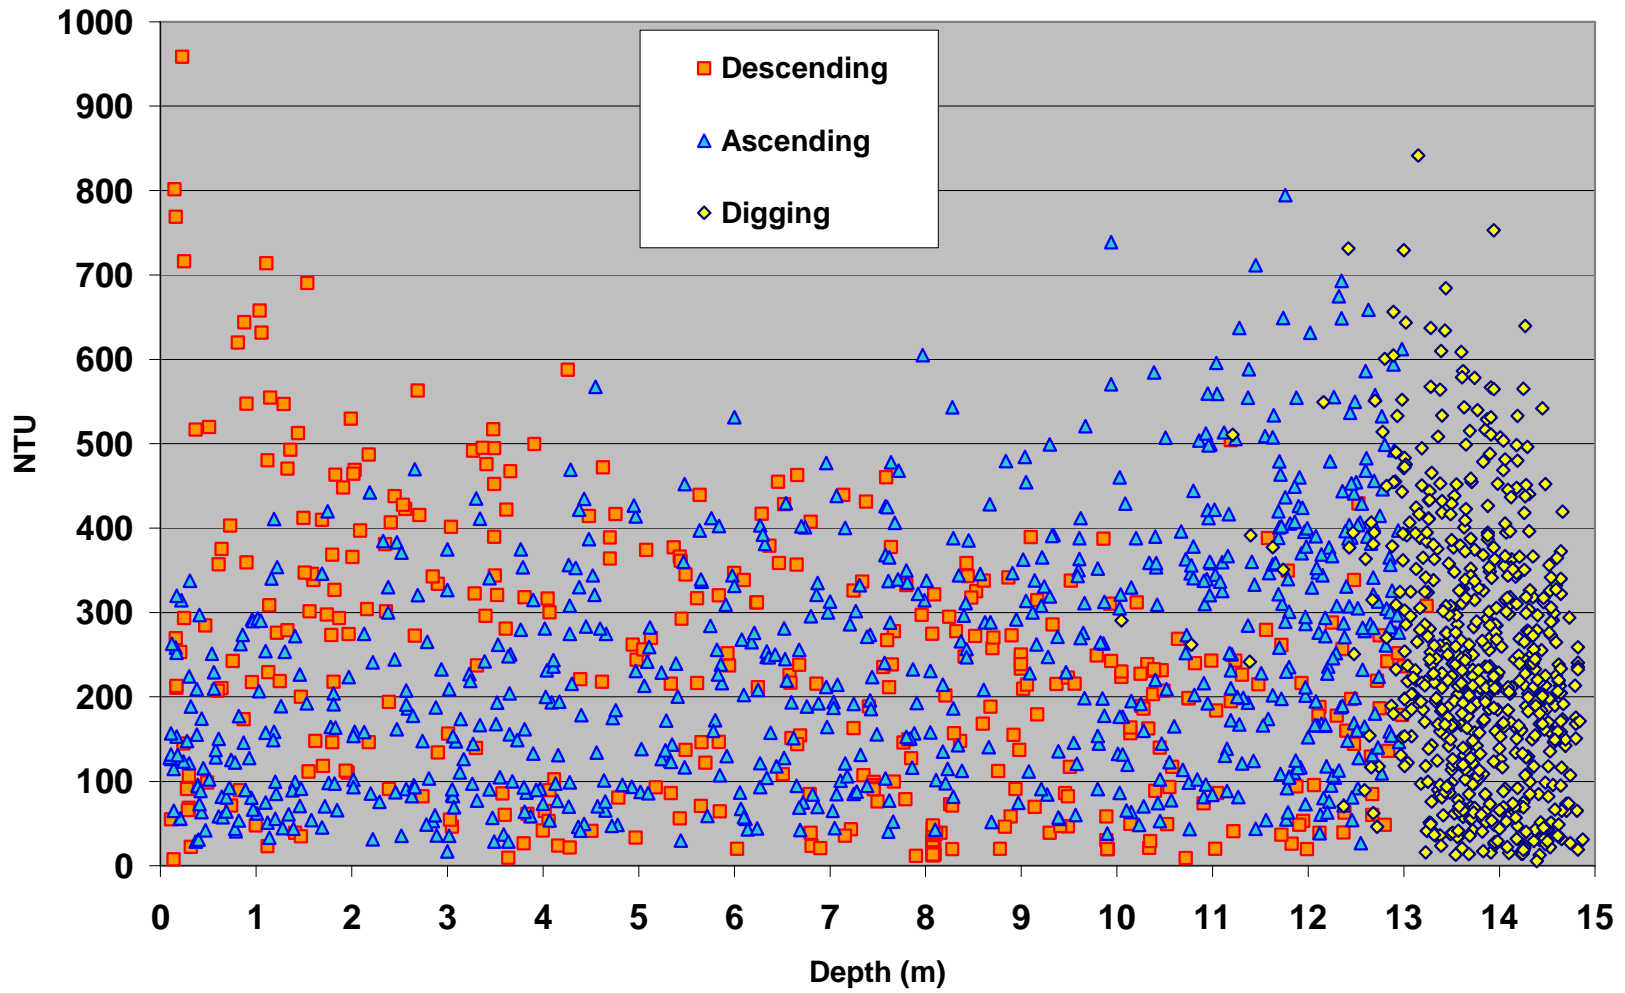
Figure 27. Bucket-mounted turbidities during the first long-term dredging test on January 30, 2008; descent, ascent and dredging data only.

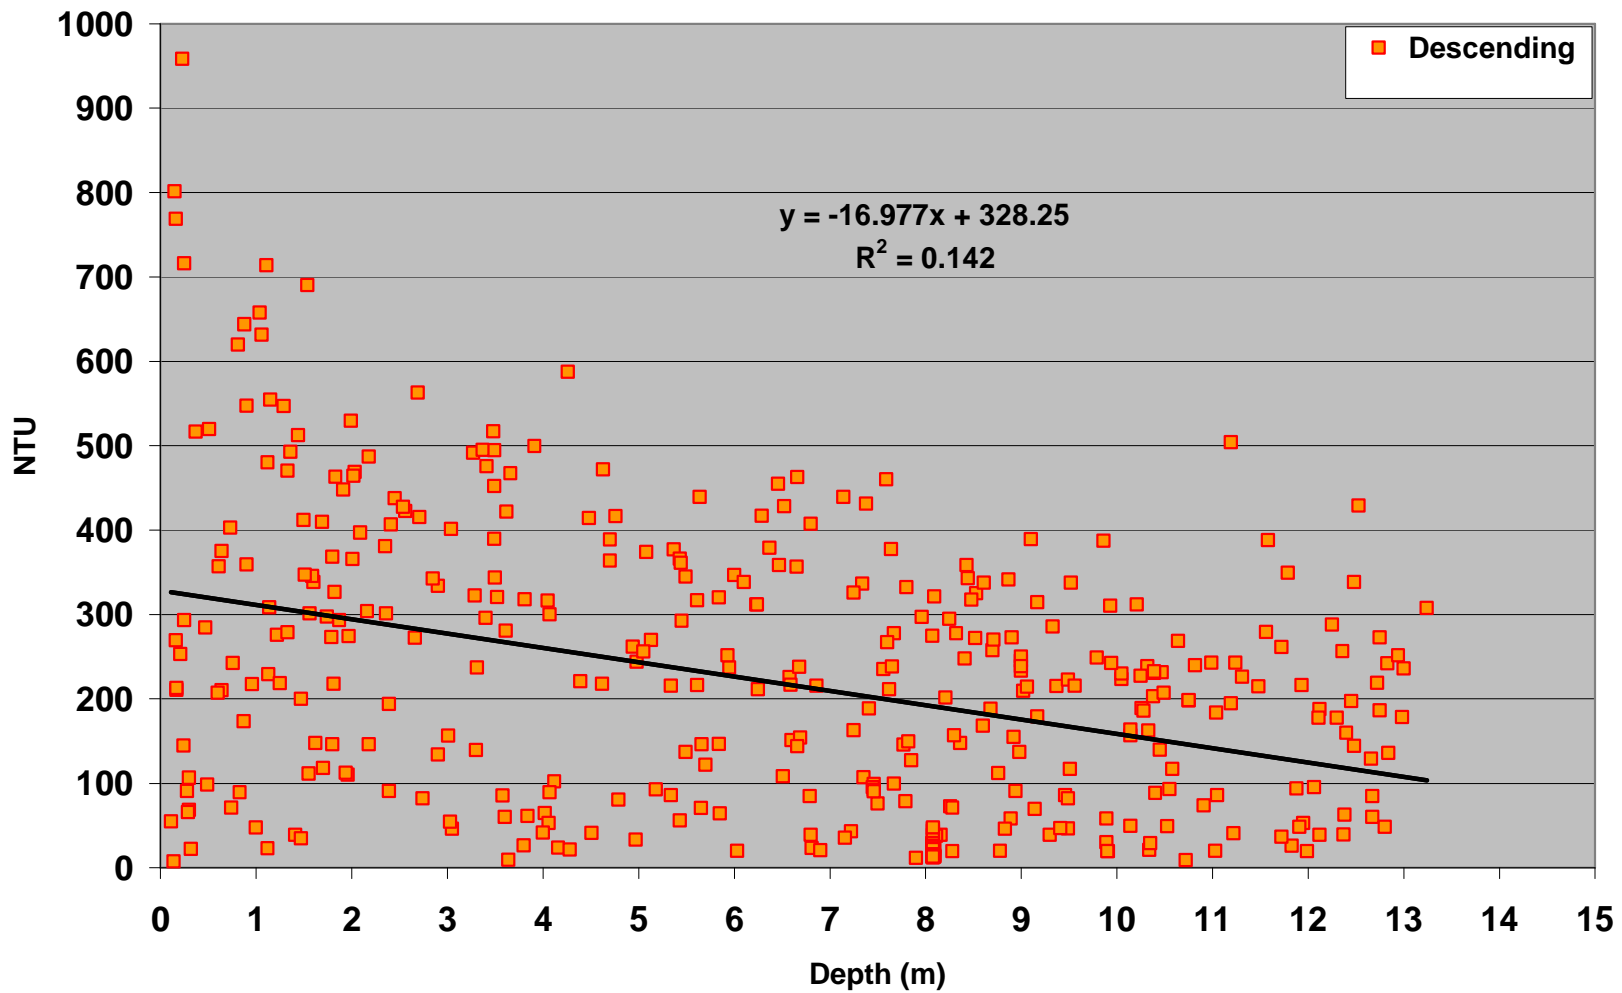
Figure 28. All turbidity measurements obtained by a bucket-mounted sensor during the descent component of the bucket cycle during the first long-term dredging test on January 30, 2008.

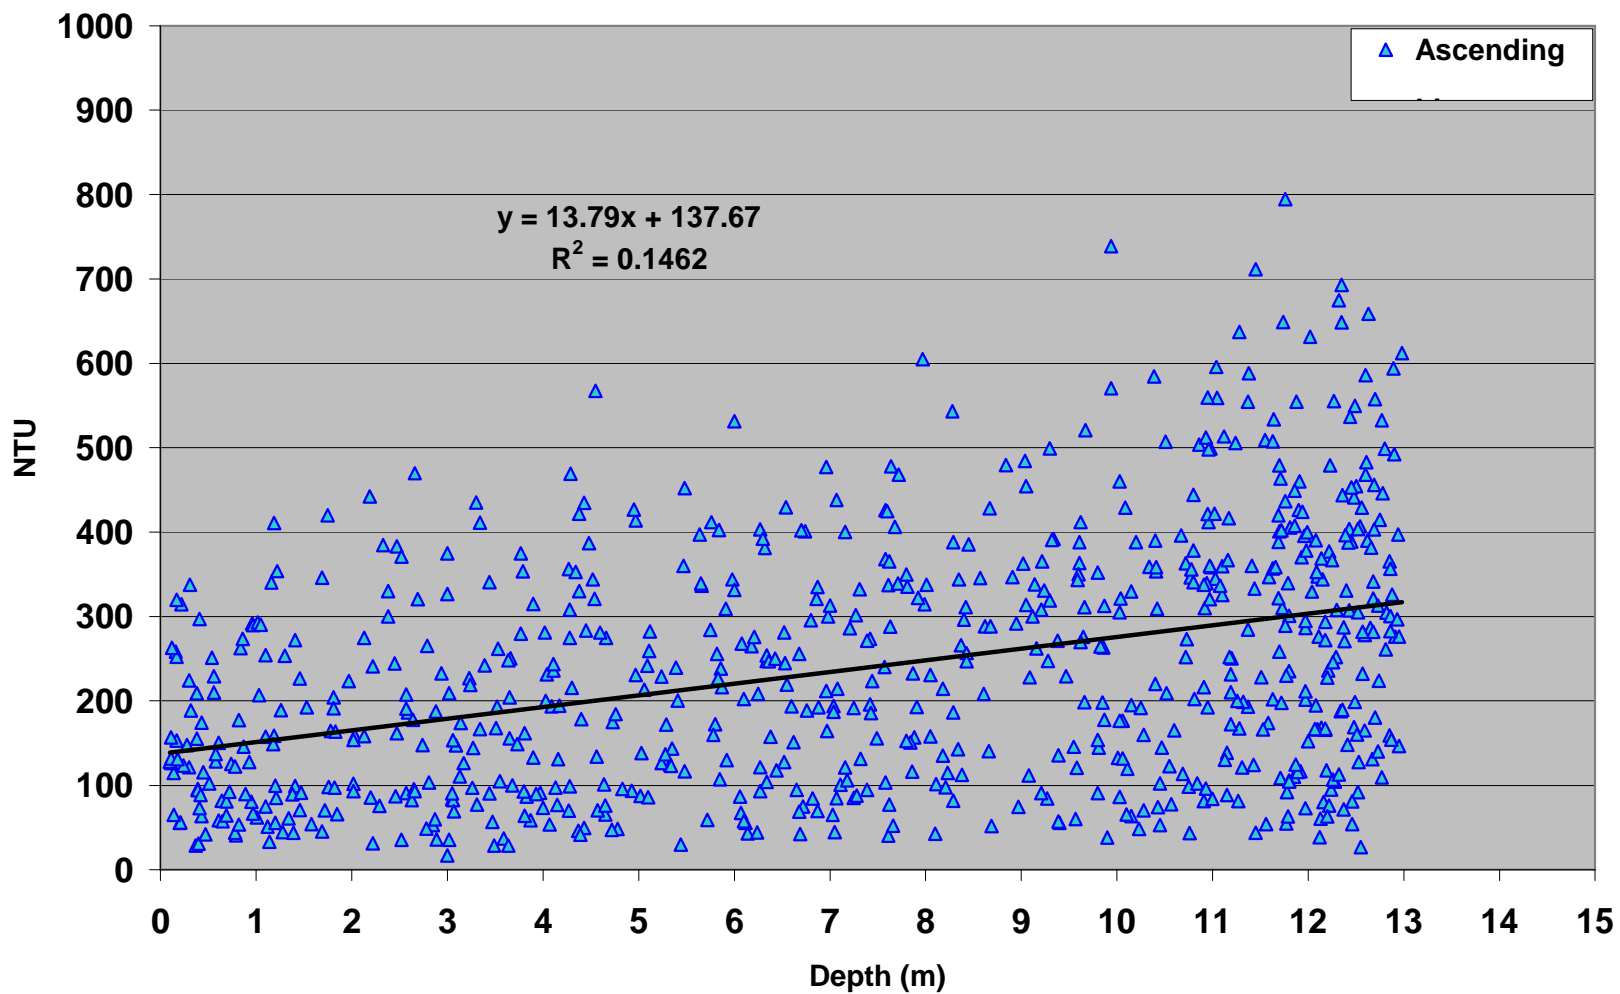
Figure 29. All turbidity measurements obtained by a bucket-mounted sensor during the ascent component of the bucket cycle during the first long-term dredging test on January 30, 2008.

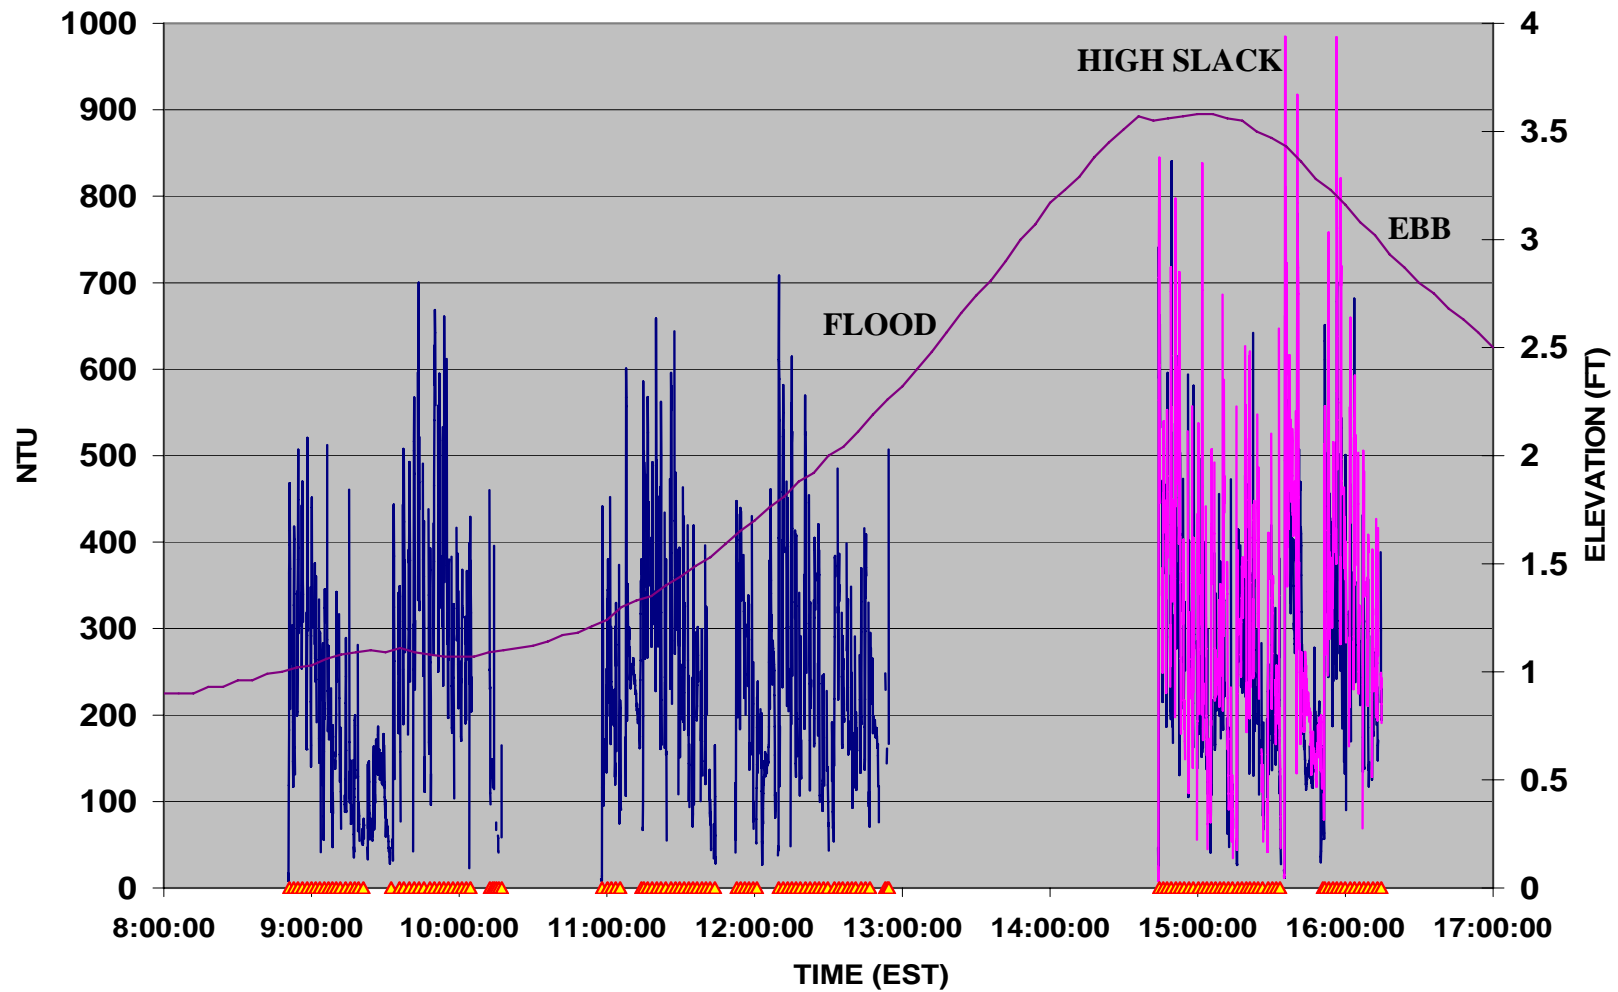
Figure 30. Turbidity measurements obtained by a bucket-mounted sensor during the second long-term dredging test on January 31, 2008. Note two sensors were mounted on opposite sides of bucket: inboard sensor (blue) & outboard sensor (purple).

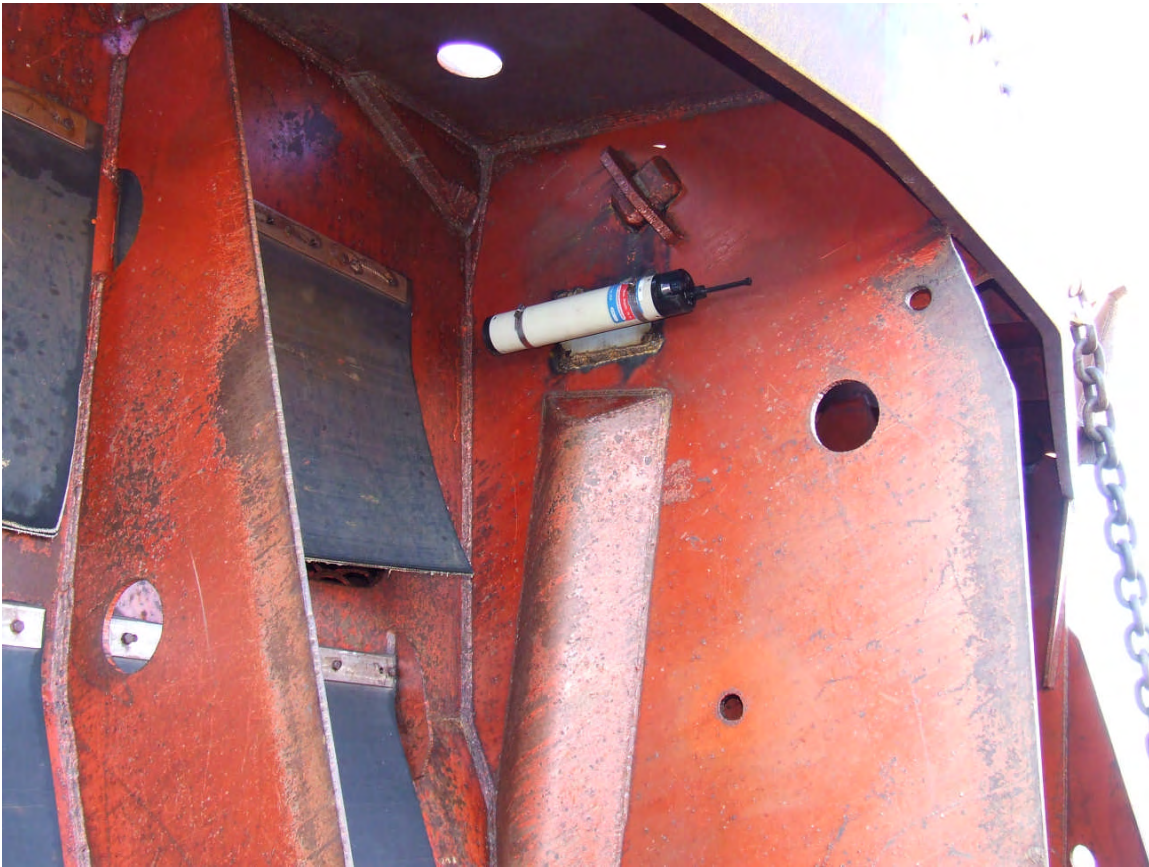
Figure 31. Location of OBS instrument on the outboard side of the bucket.

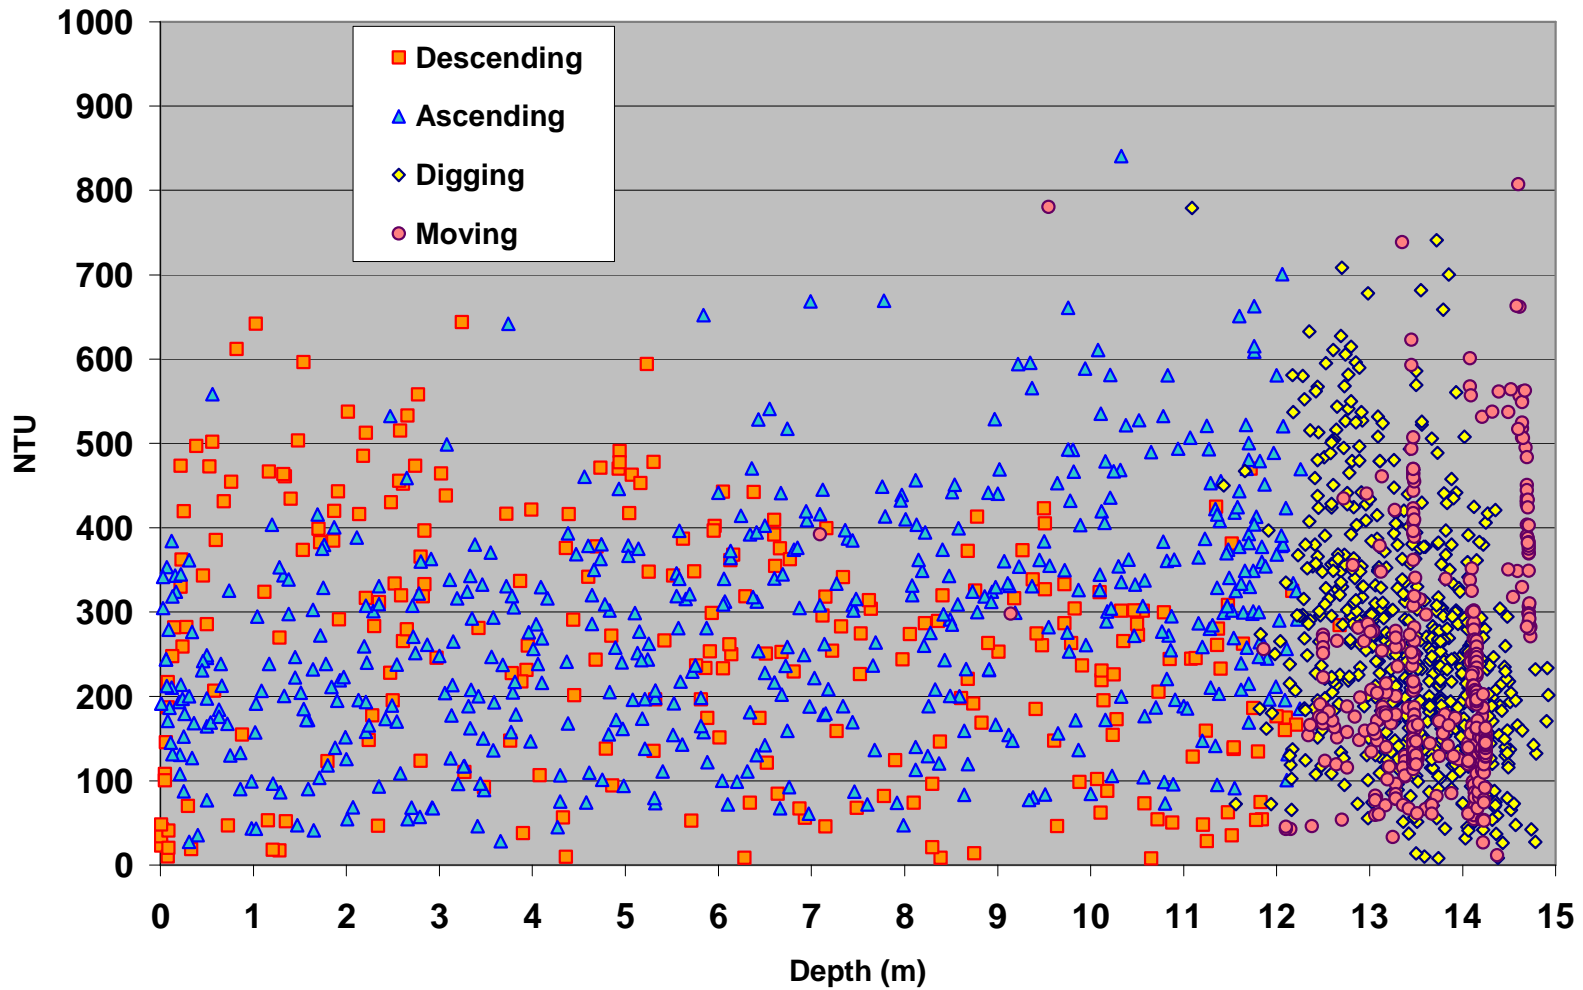
Figure 32. All turbidity measurements obtained by a bucket-mounted sensor (inboard side) during the second long-term dredging test on January 31, 2008.

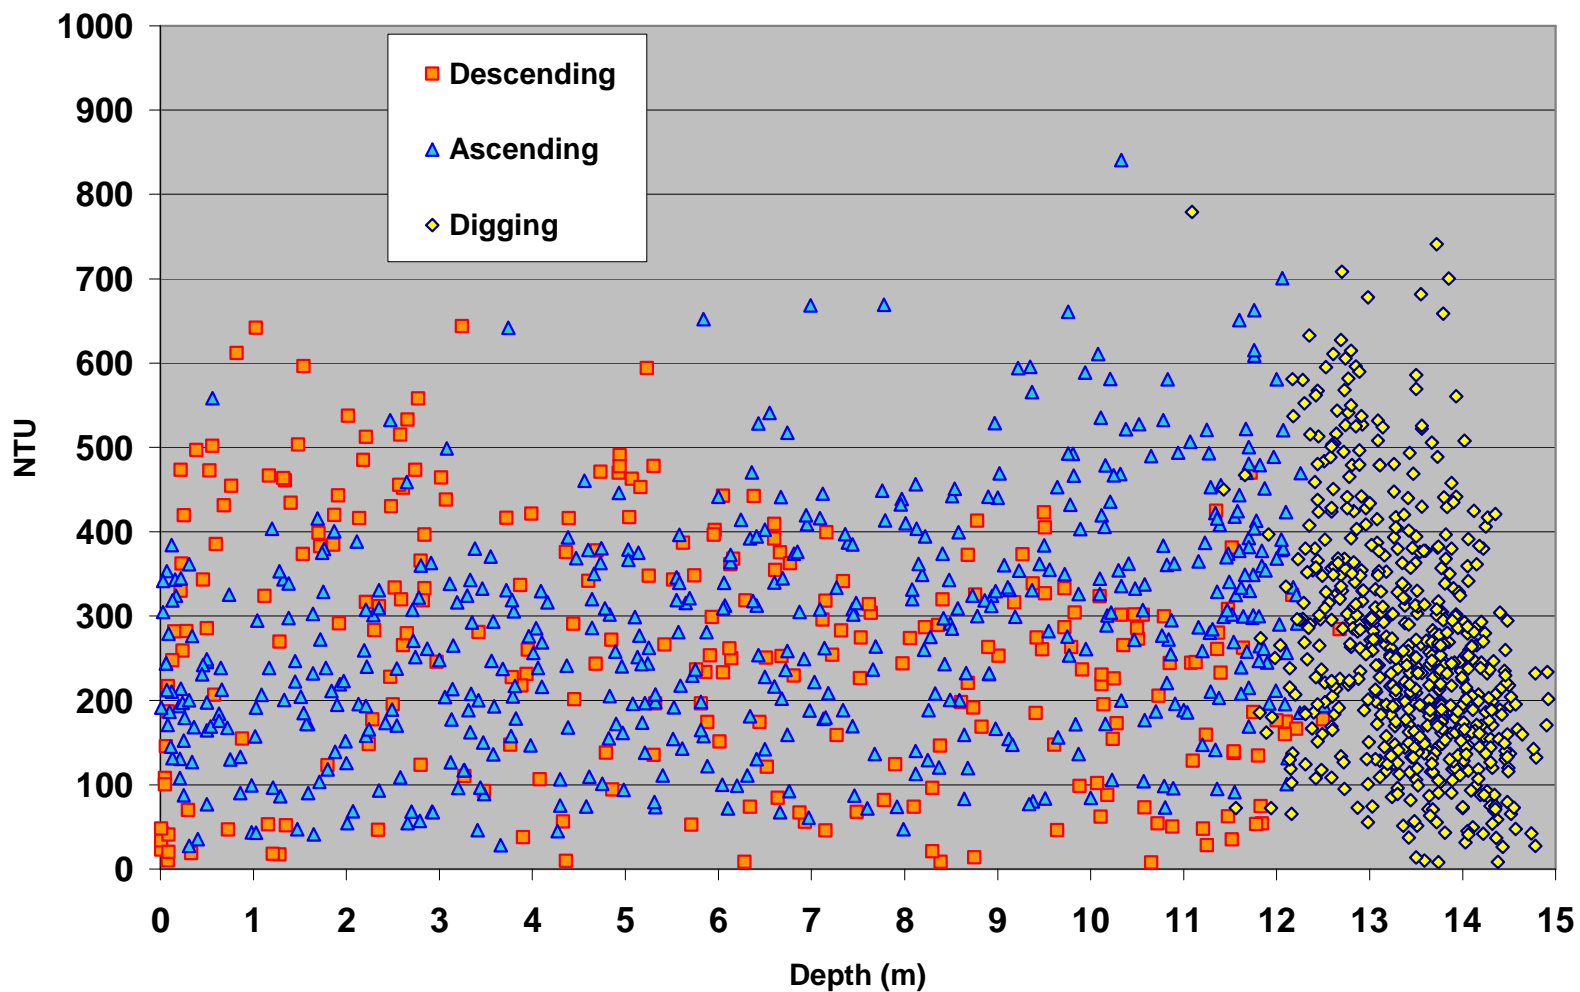
Figure 33. All turbidity measurements obtained by a bucket-mounted sensor (inboard side) during the second long-term dredging test after removal of all data for dredge advances on January 31, 2008.
