Table 1. Sequence of bubble and dredging tests with prevailing tide stage and number of bucket cycles recorded for each test.

Figure 1. a) Option areas of the S-NB-1 Contract area of the NY/NJ Harbor Deepening Project and b) bathymetry of S-NB-1 dredge contract area during the Pilot Study.

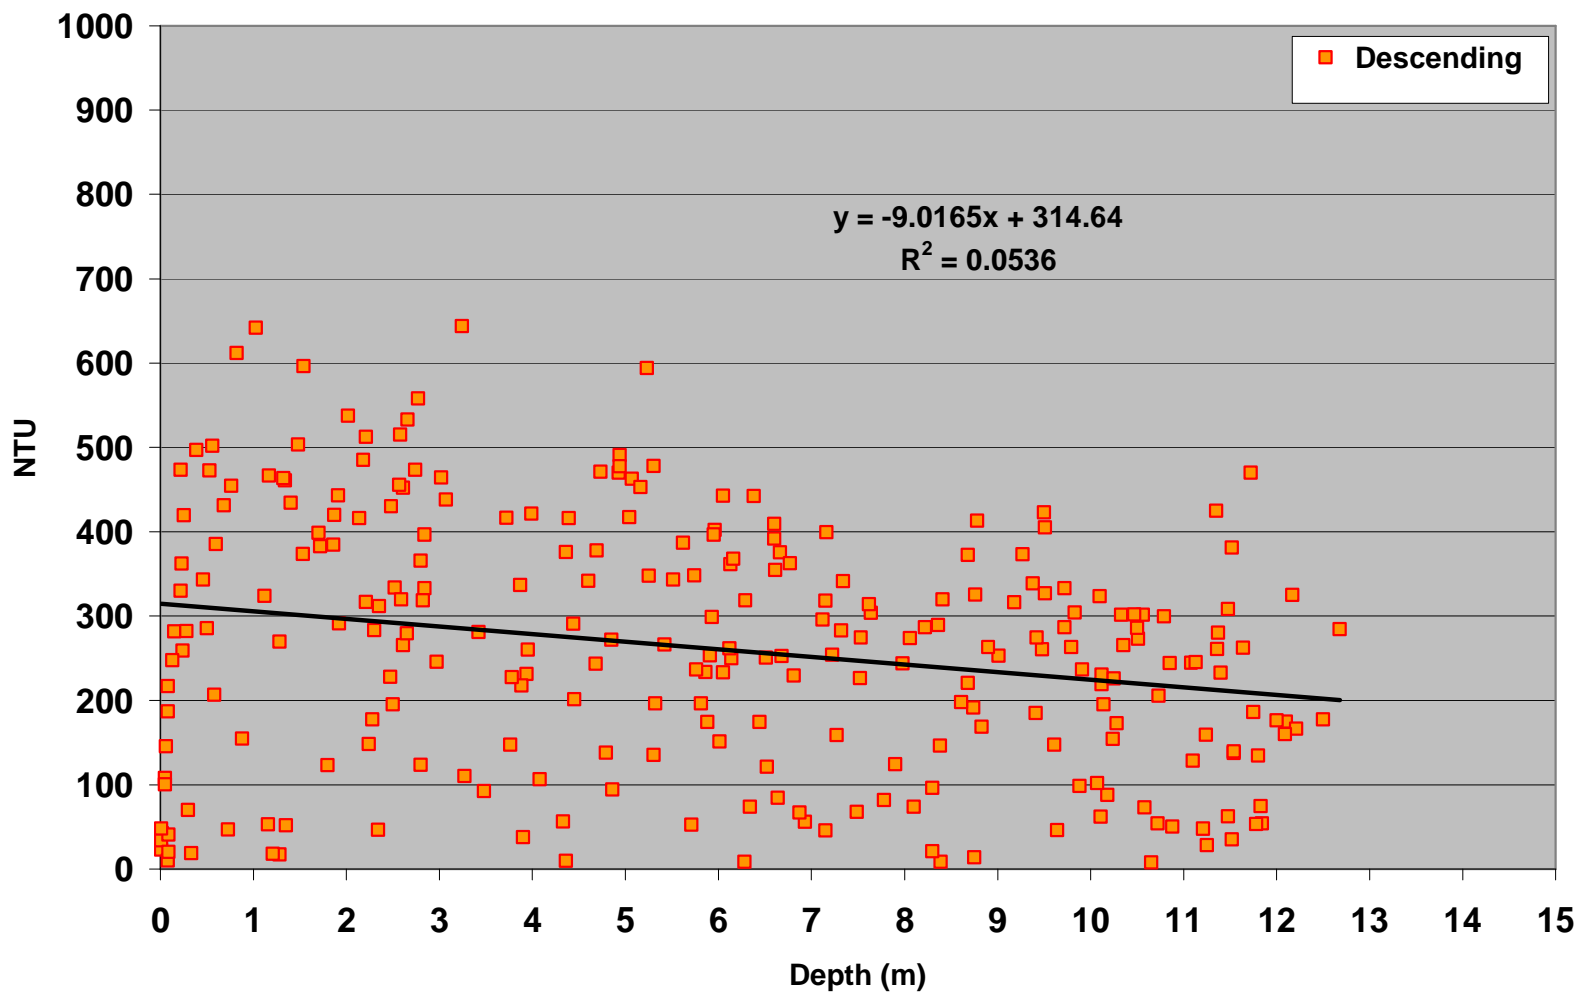
Figure 34. All turbidity measurements obtained by a bucket-mounted sensor (inboard side) during the descent component of the bucket cycle during the second long-term dredging test on January 31, 2008.

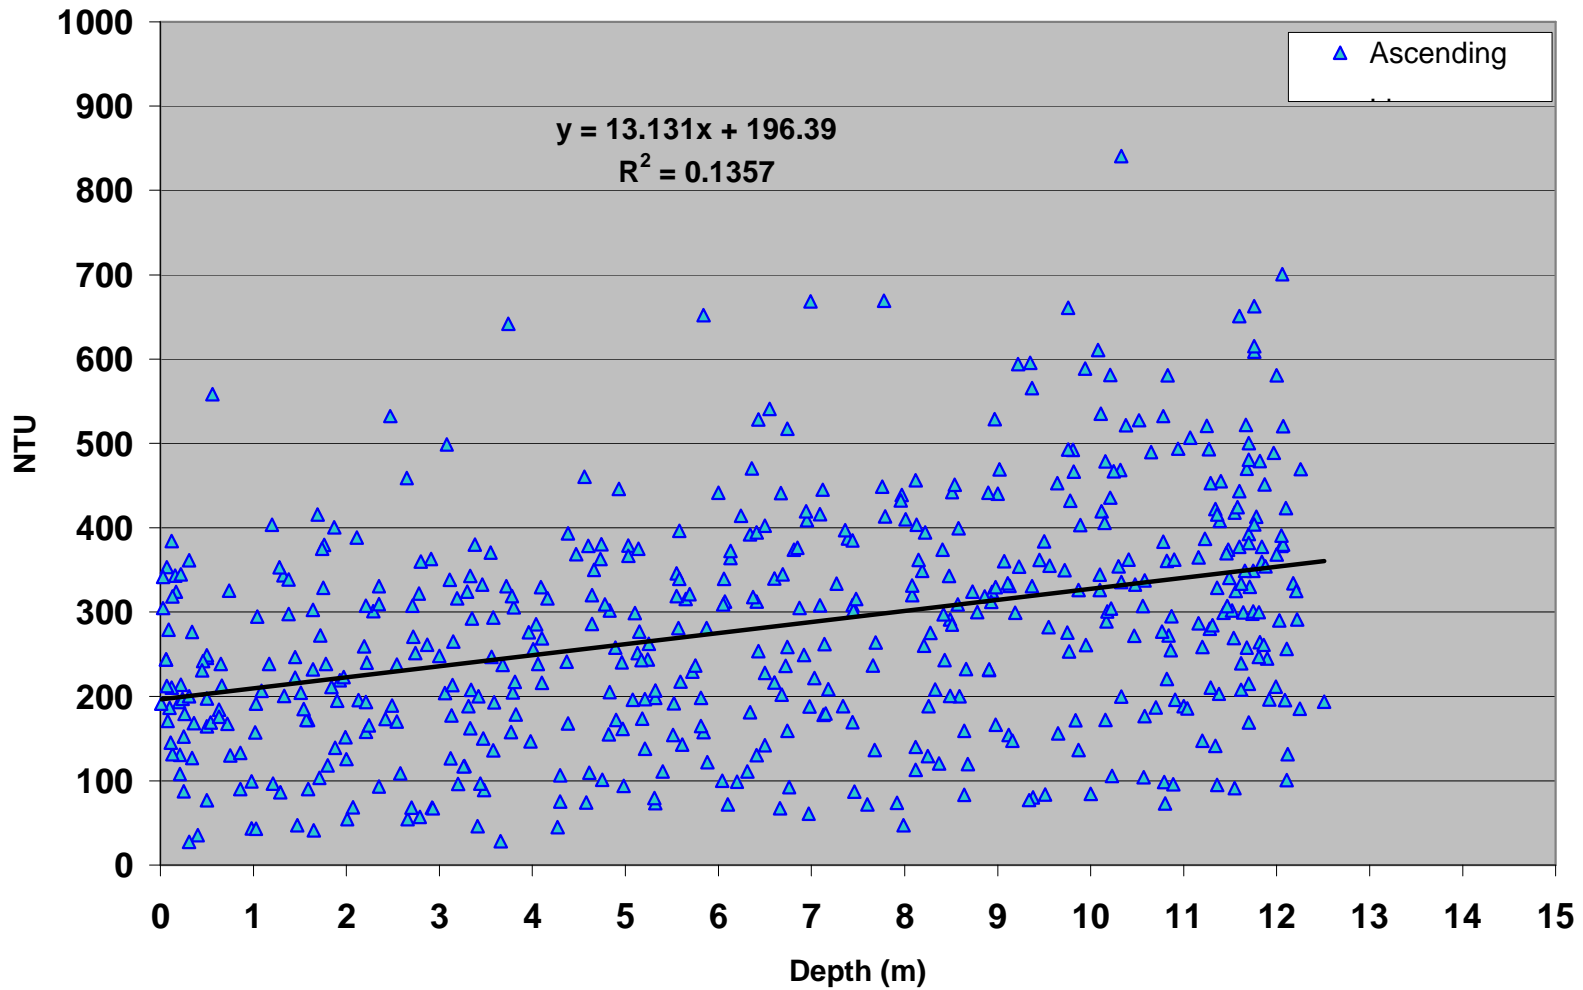
Figure 35. All turbidity measurements obtained by a bucket-mounted sensor (inboard side) during the ascent component of the bucket cycle during the second long-term dredging test on January 31, 2008.

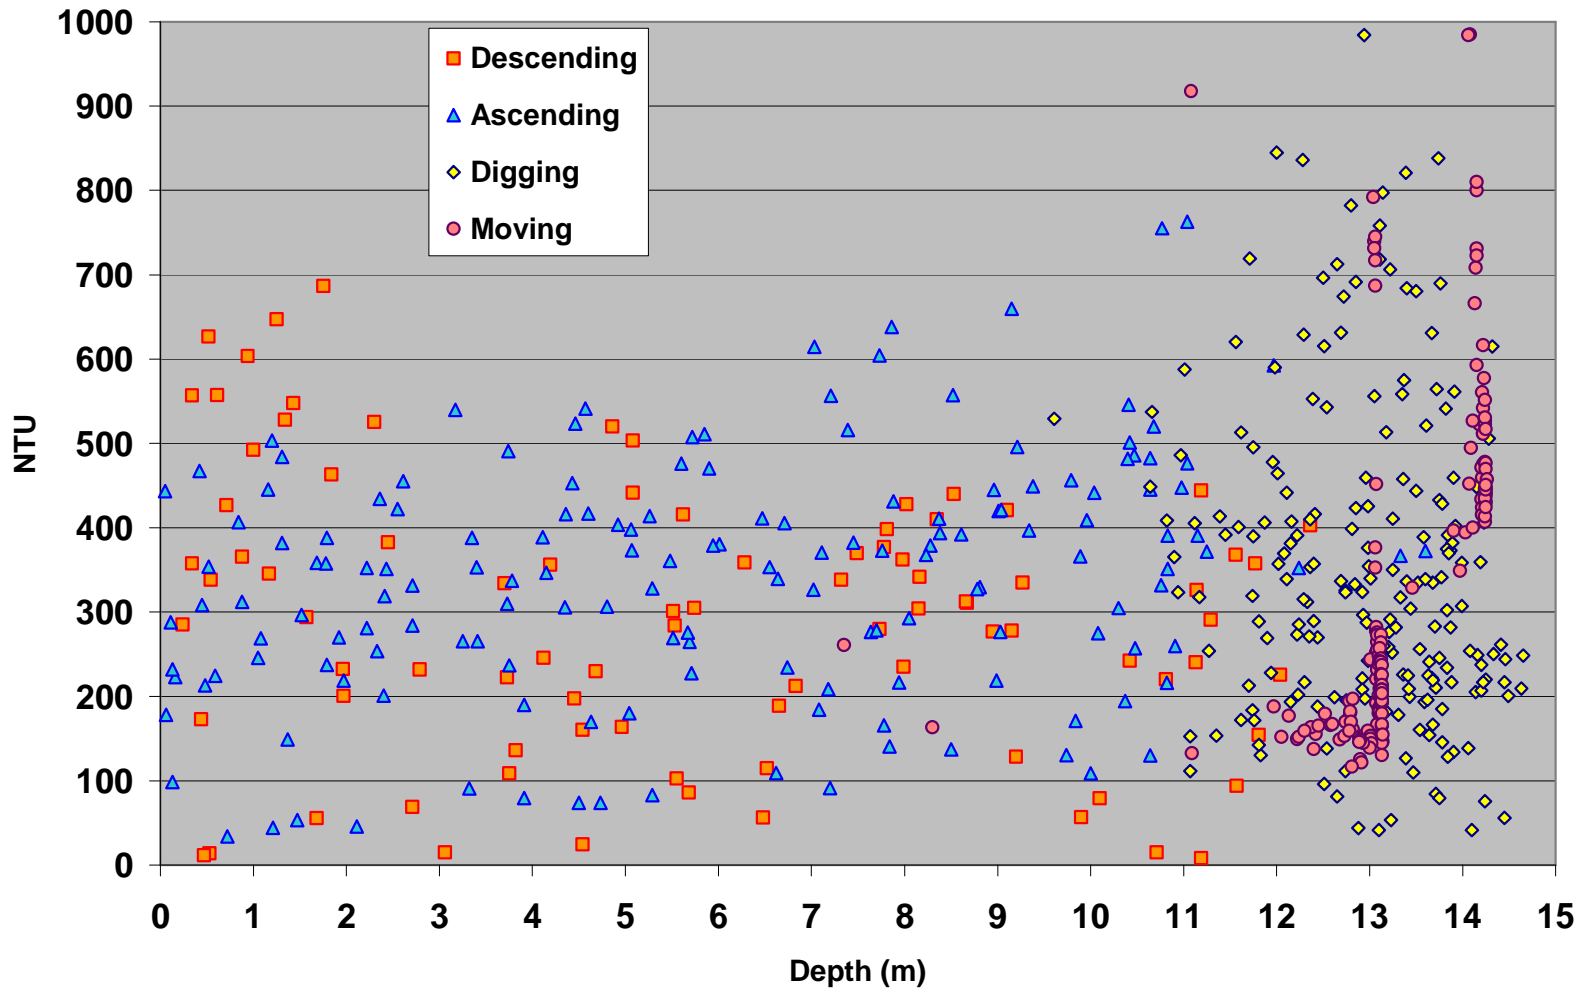
Figure 36. All turbidity measurements obtained by a bucket-mounted sensor (outboard side) during the second long-term dredging test on January 31, 2008.

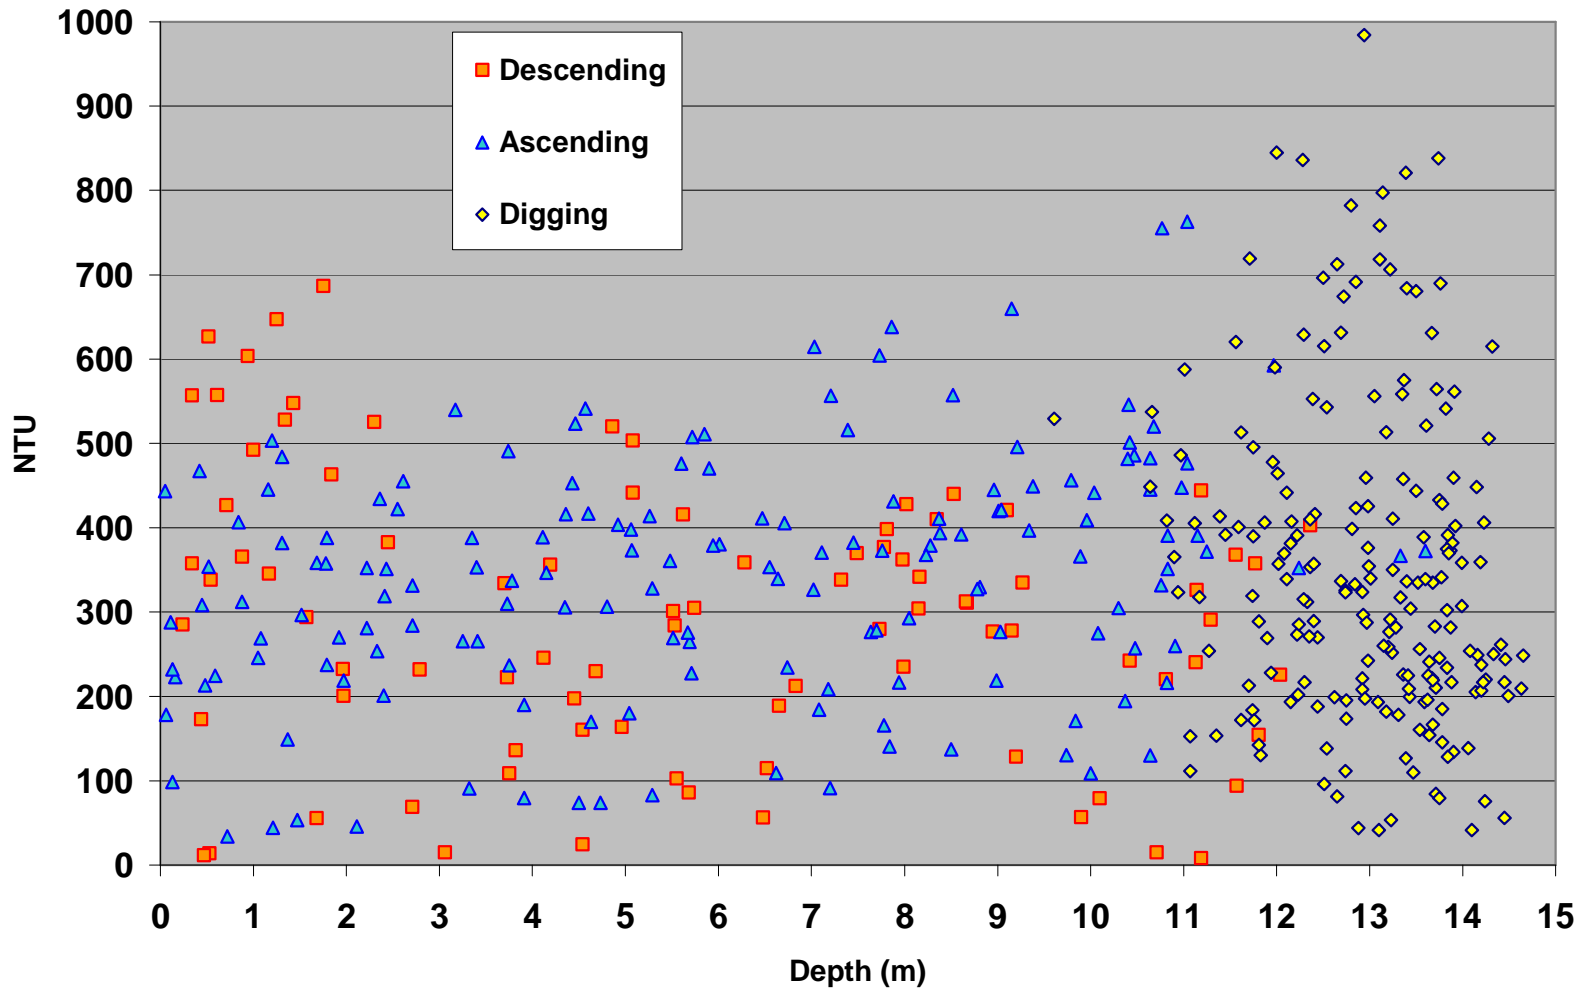
Figure 37. All turbidity measurements obtained by a bucket-mounted sensor (outboard side) during the second long-term dredging test after removal of all data for dredge advances on January 31, 2008.

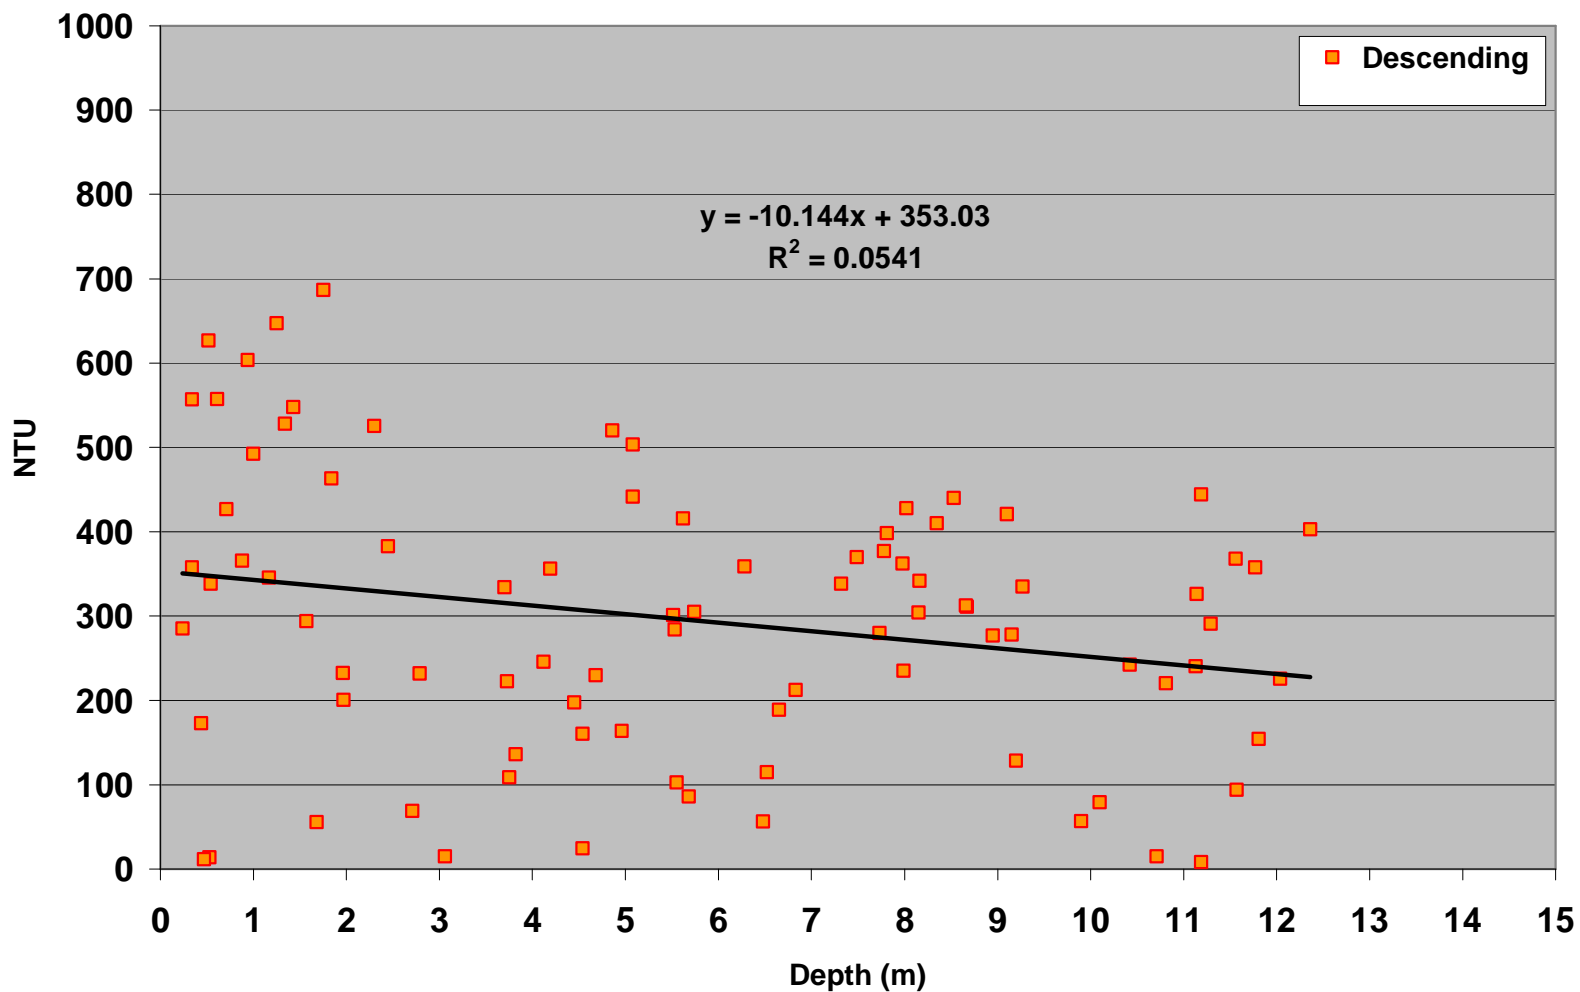
Figure 38. All turbidity measurements obtained by a bucket-mounted sensor (outboard side) during the descent component of the bucket cycle during the second long-term dredging test on January 31, 2008.

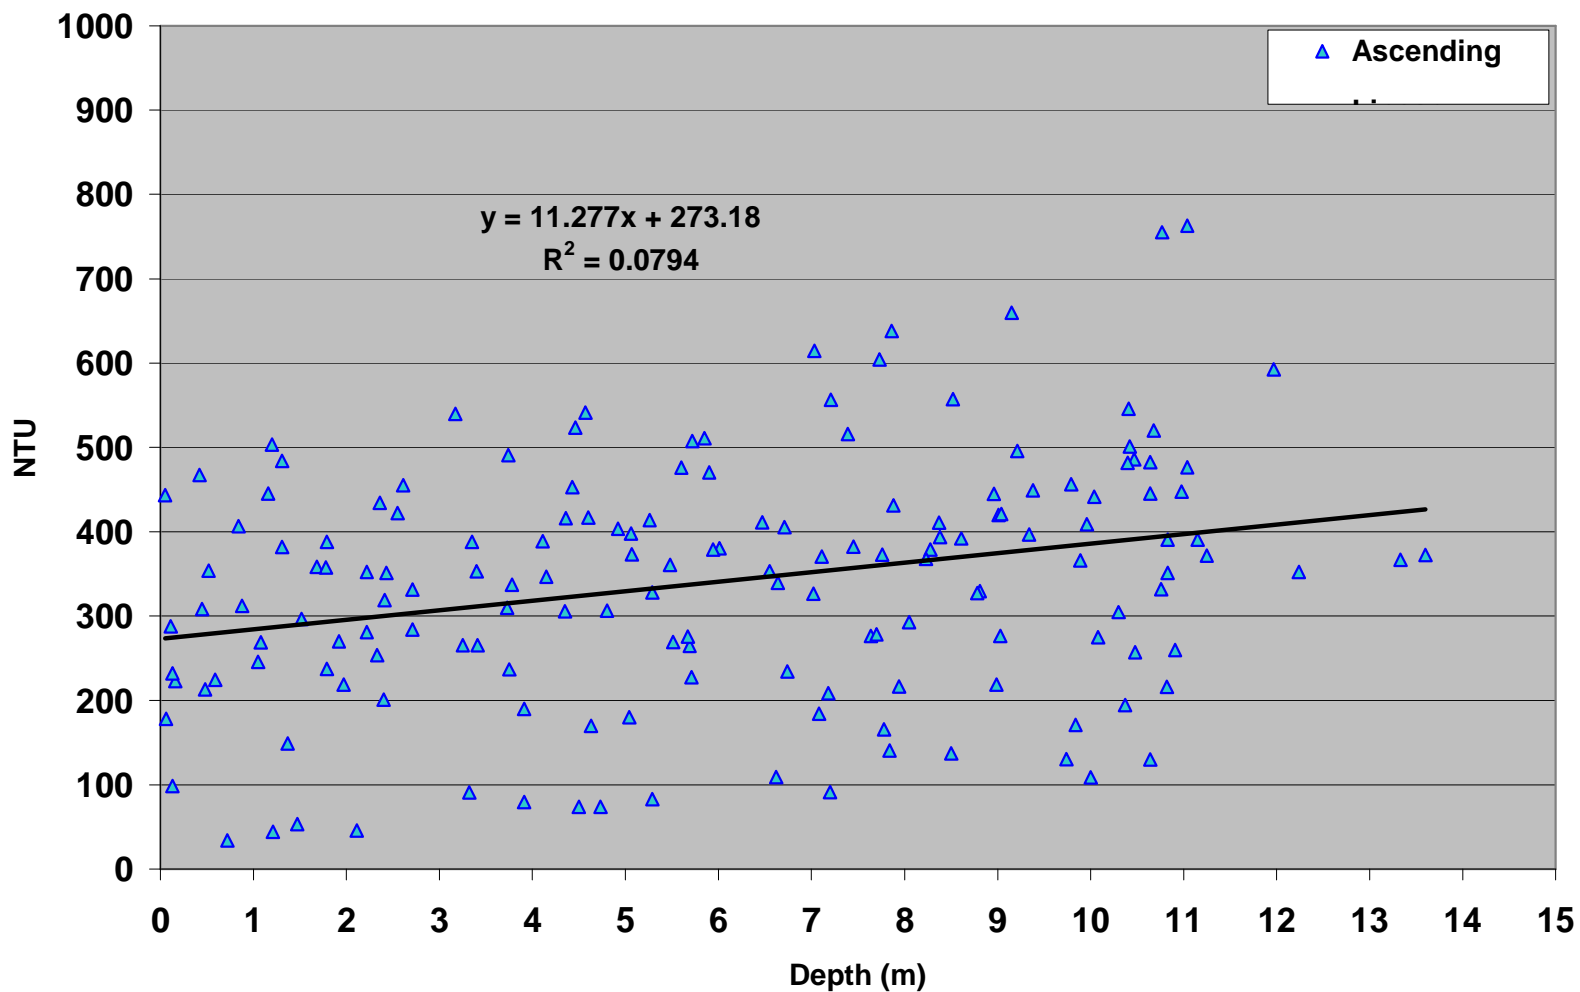
Figure 39. All turbidity measurements obtained by a bucket-mounted sensor (outboard side) during the ascent component of the bucket cycle during the second long-term dredging test on January 31, 2008.

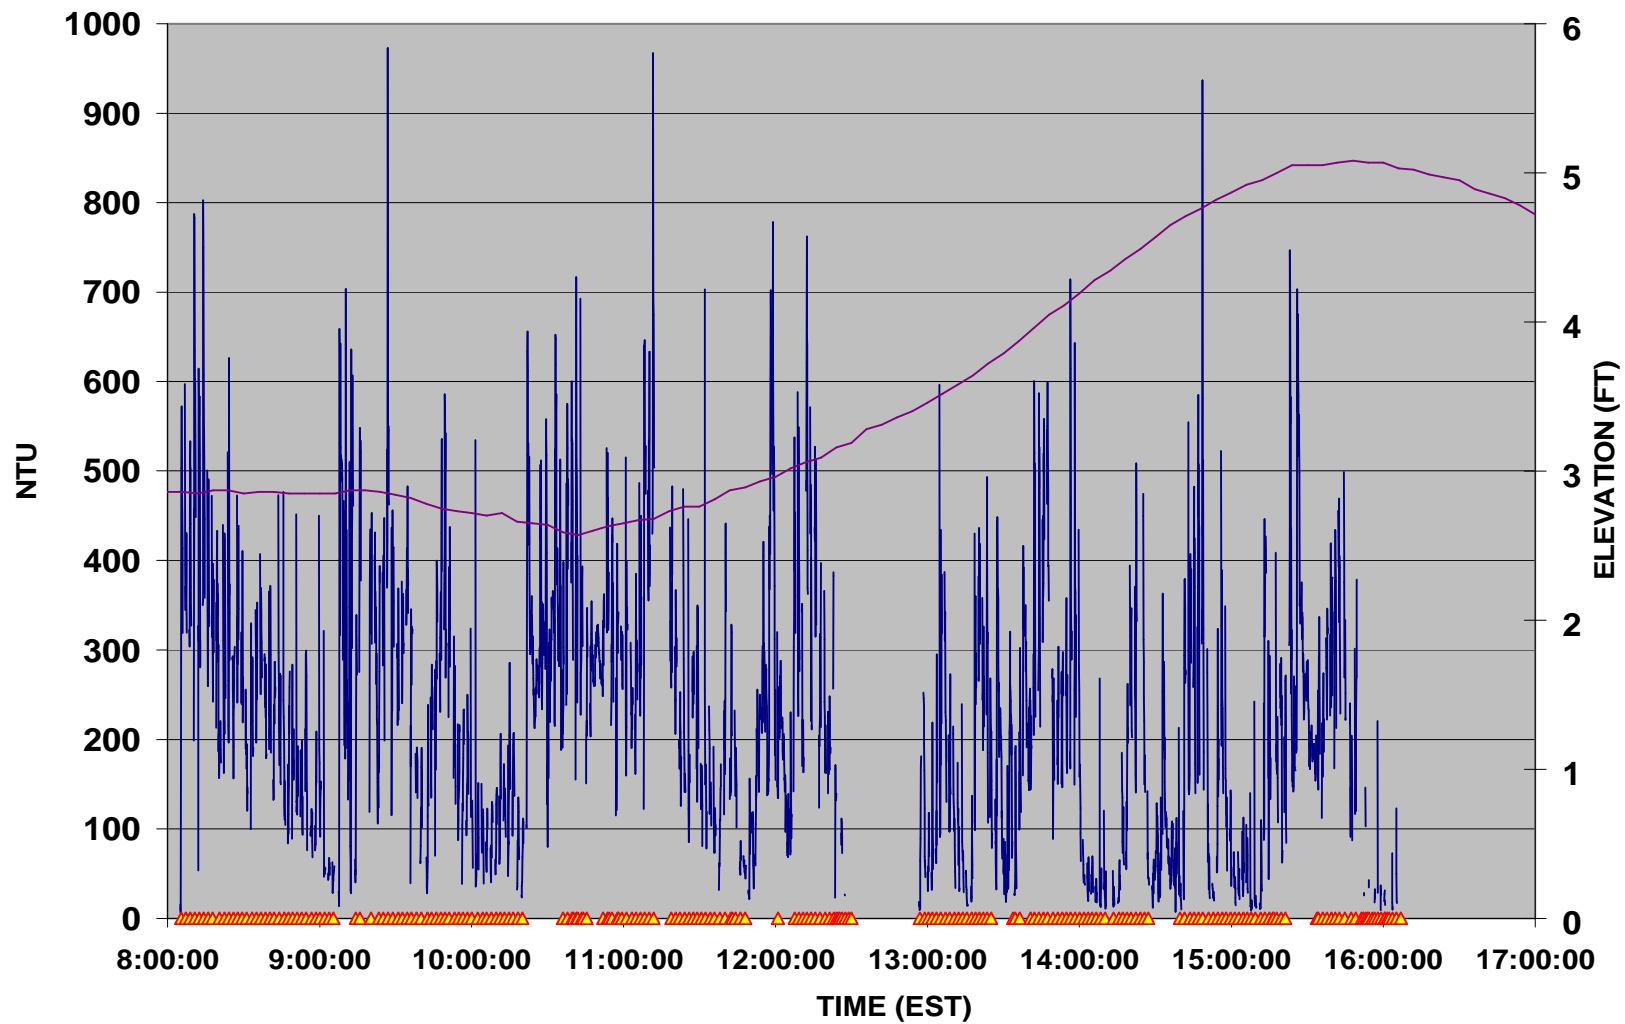
Figure 40. Turbidity measurements obtained by a bucket-mounted sensor during the third long-term dredging test on February 1, 2008.

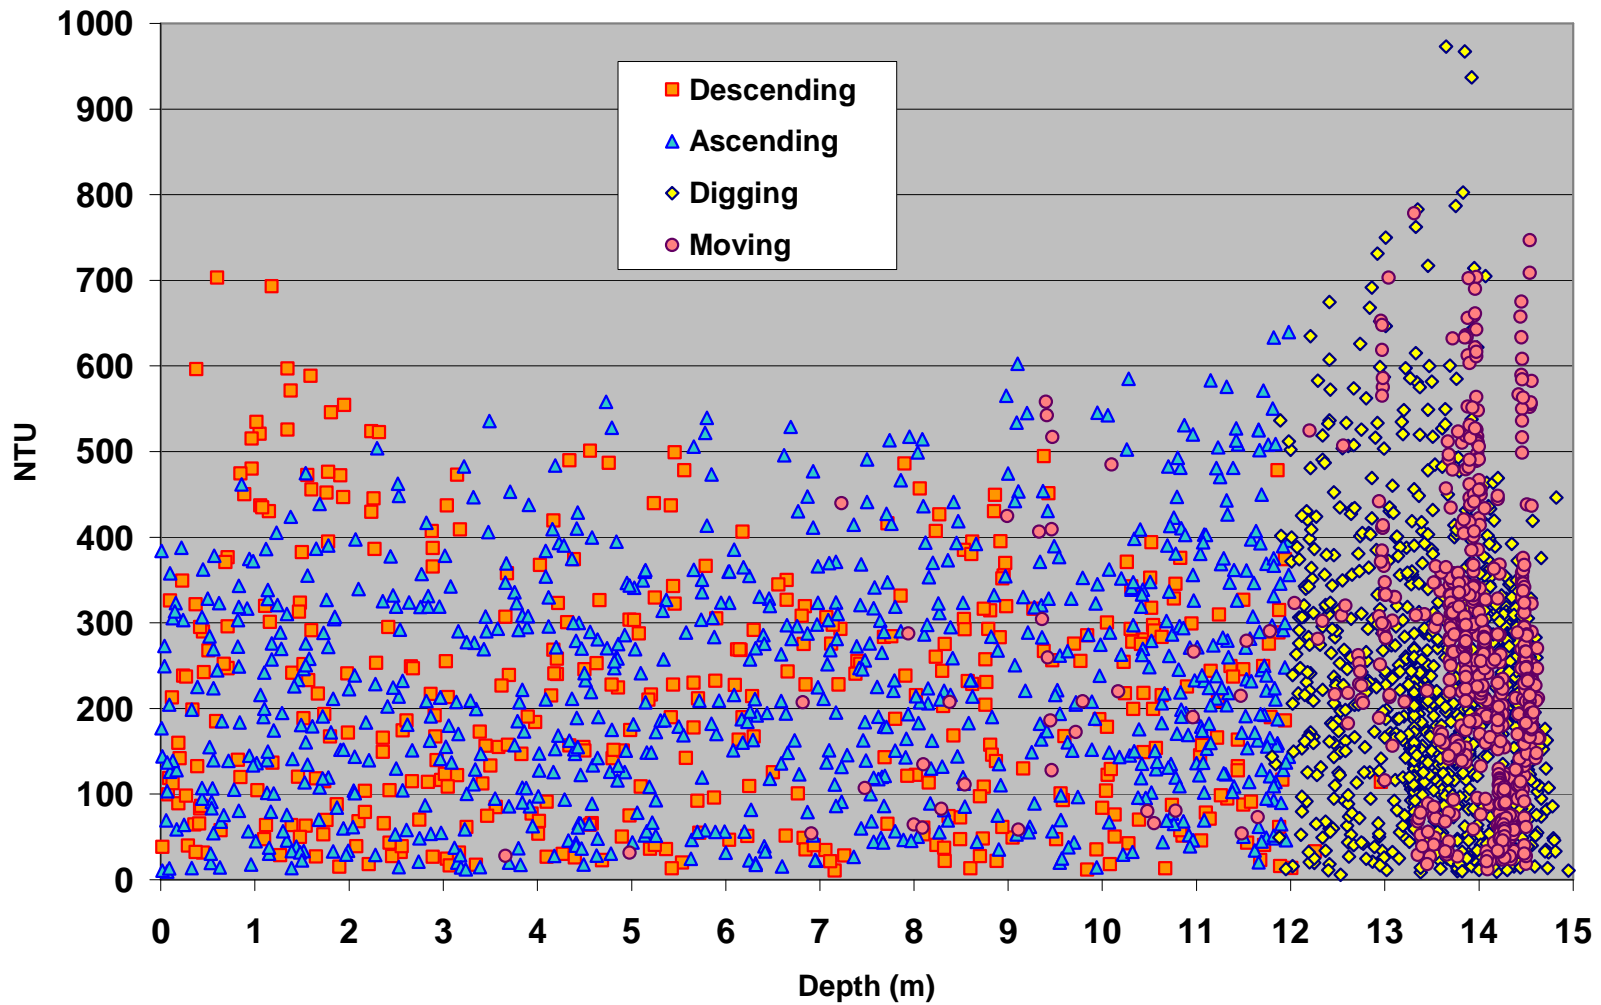
Figure 41. All turbidity measurements obtained by a bucket-mounted sensor (outboard side) during the third long-term dredging test on February 1, 2008.
