HUDSON-RARITAN ESTUARY COMPREHENSIVE RESTORATION PLAN
POTENTIAL RESTORATION OPPORTUNITIES
PROJECT SUMMARY SHEETS
NEWARK BAY, PASSAIC & HACKENSACK

Hackensack

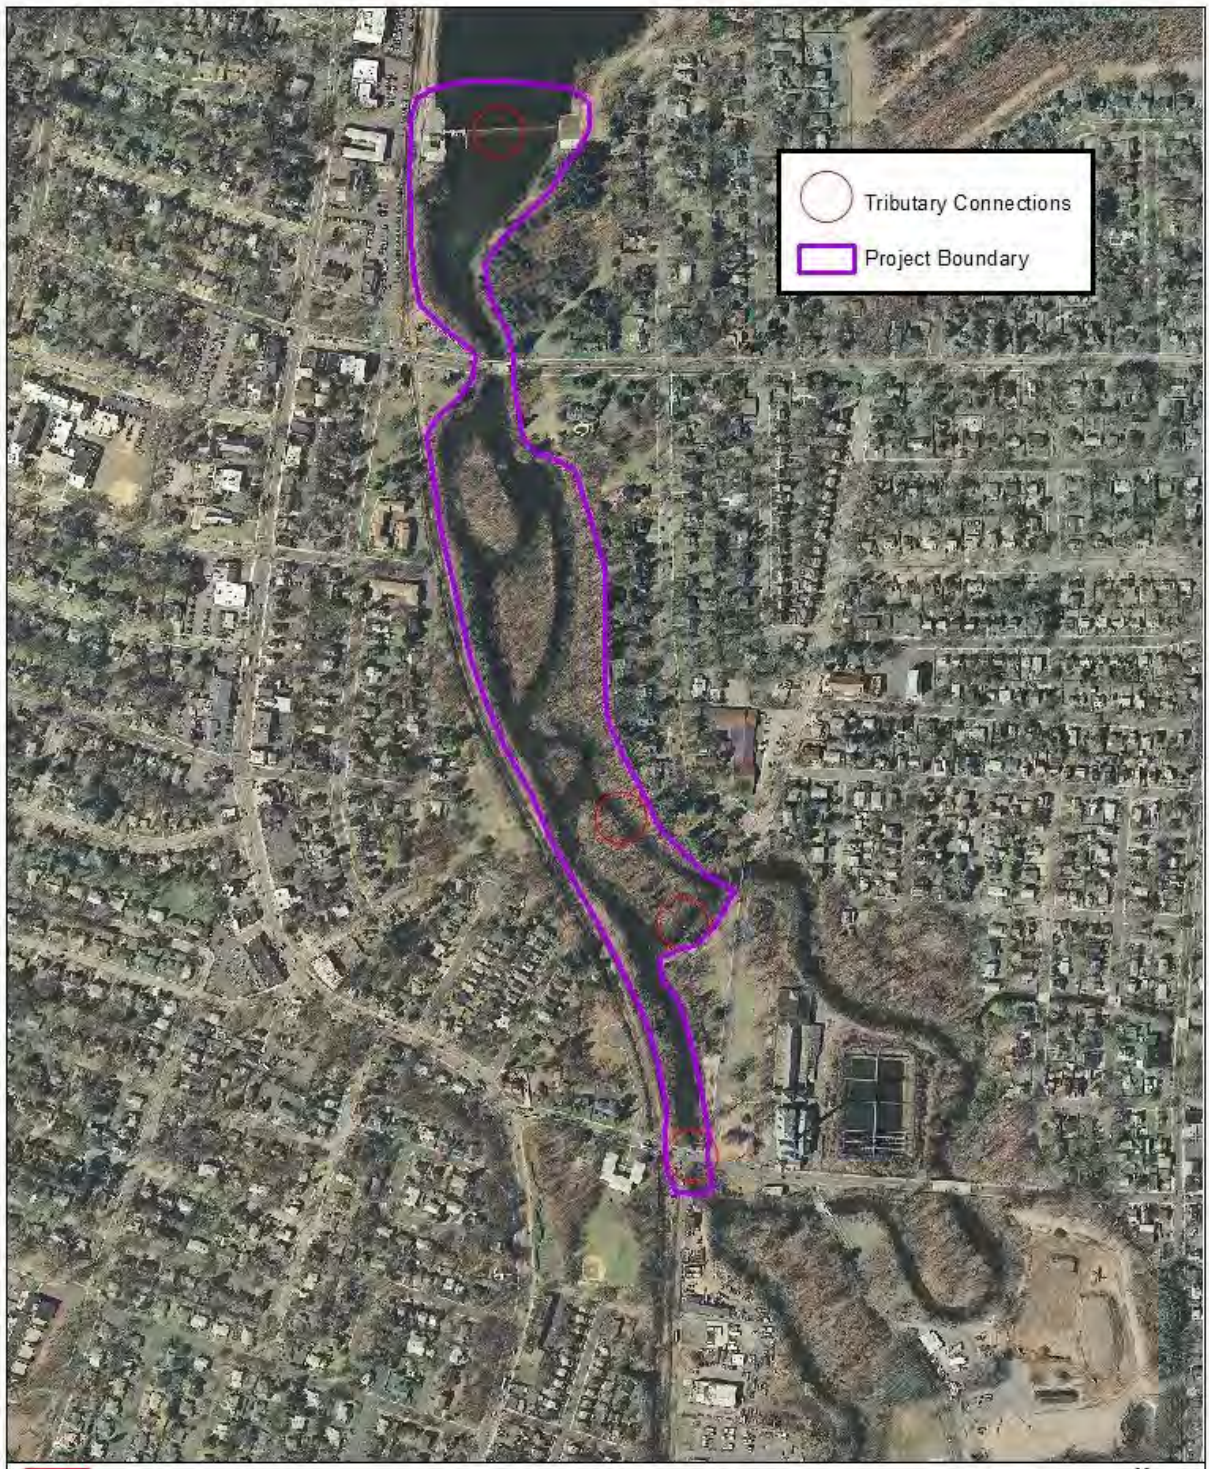
TRC Omni Environmental Corp. Oradell Dam Fish Ladder Feasibility Study. June 2006

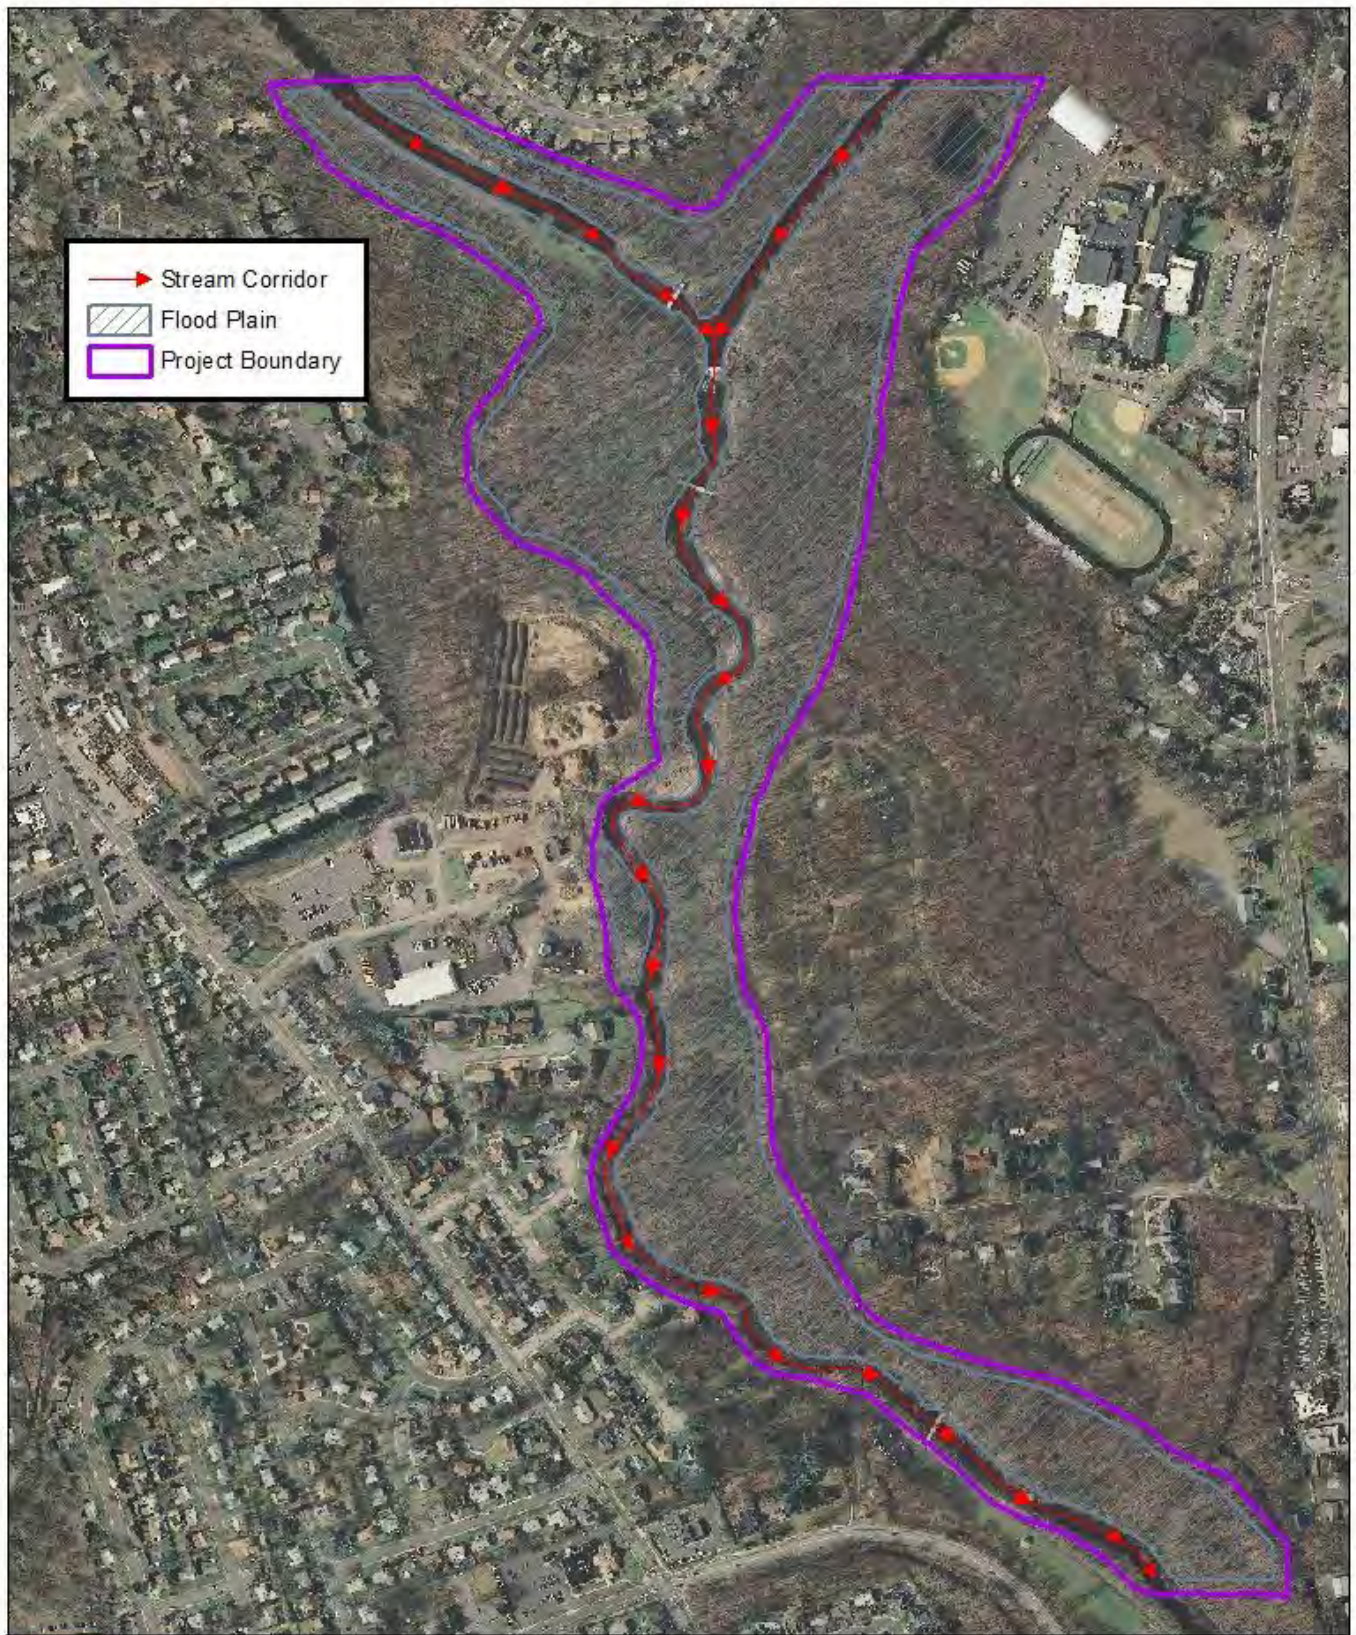
—→ Stream Corridor
▨ Flood Plain
▭ Project Boundary

Storm Water Management – The current stormwater systems in place at the park bypass the hydrologic cycle cutting off vegetation and overall water quality and quantity. Management should control for cleaning of silted in storm drains, stormwater ponding in grass and wooded areas and erosion due to non-functioning stormwater systems along ~ 8 acres. Mitigation could include the use of retention basins and planting of wetland vegetation. Gravity settling in basins removes suspended solids and associated pollutants while aquatic plants and microorganisms provide uptake of nutrients and degradation of organic contaminants.

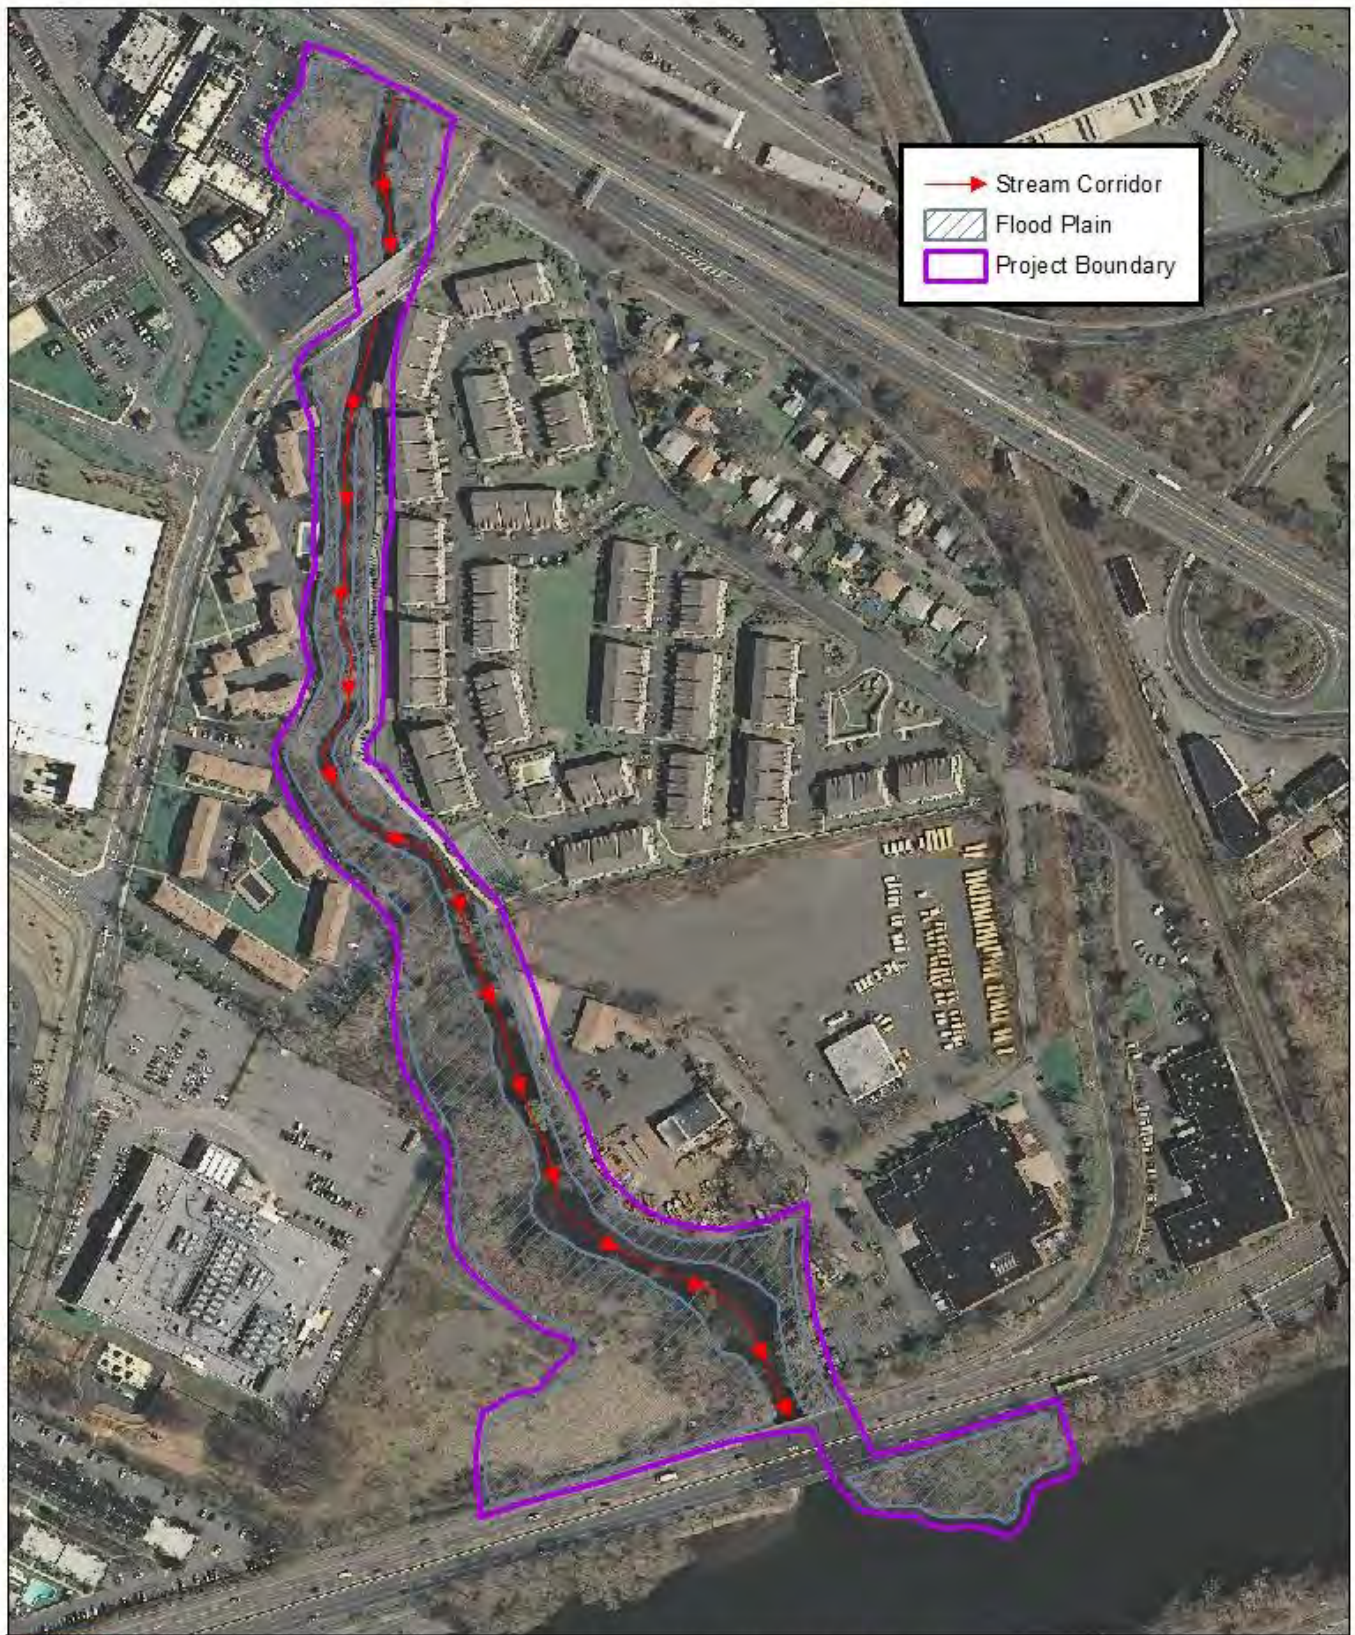
CRP 893 Third River (Mouth)

Tributary Connections – Restoration of \approx 6,383.54 linear feet of stream bed and banks and re-connection of \approx 14.21 acres of forested floodplain. Potentially, re-grade elevations to counter balance sedimentation. Preserve and restore riparian buffer, remove invasive species and re-plant with natives. Re-assess culvert capacity in channelized and underground portions.

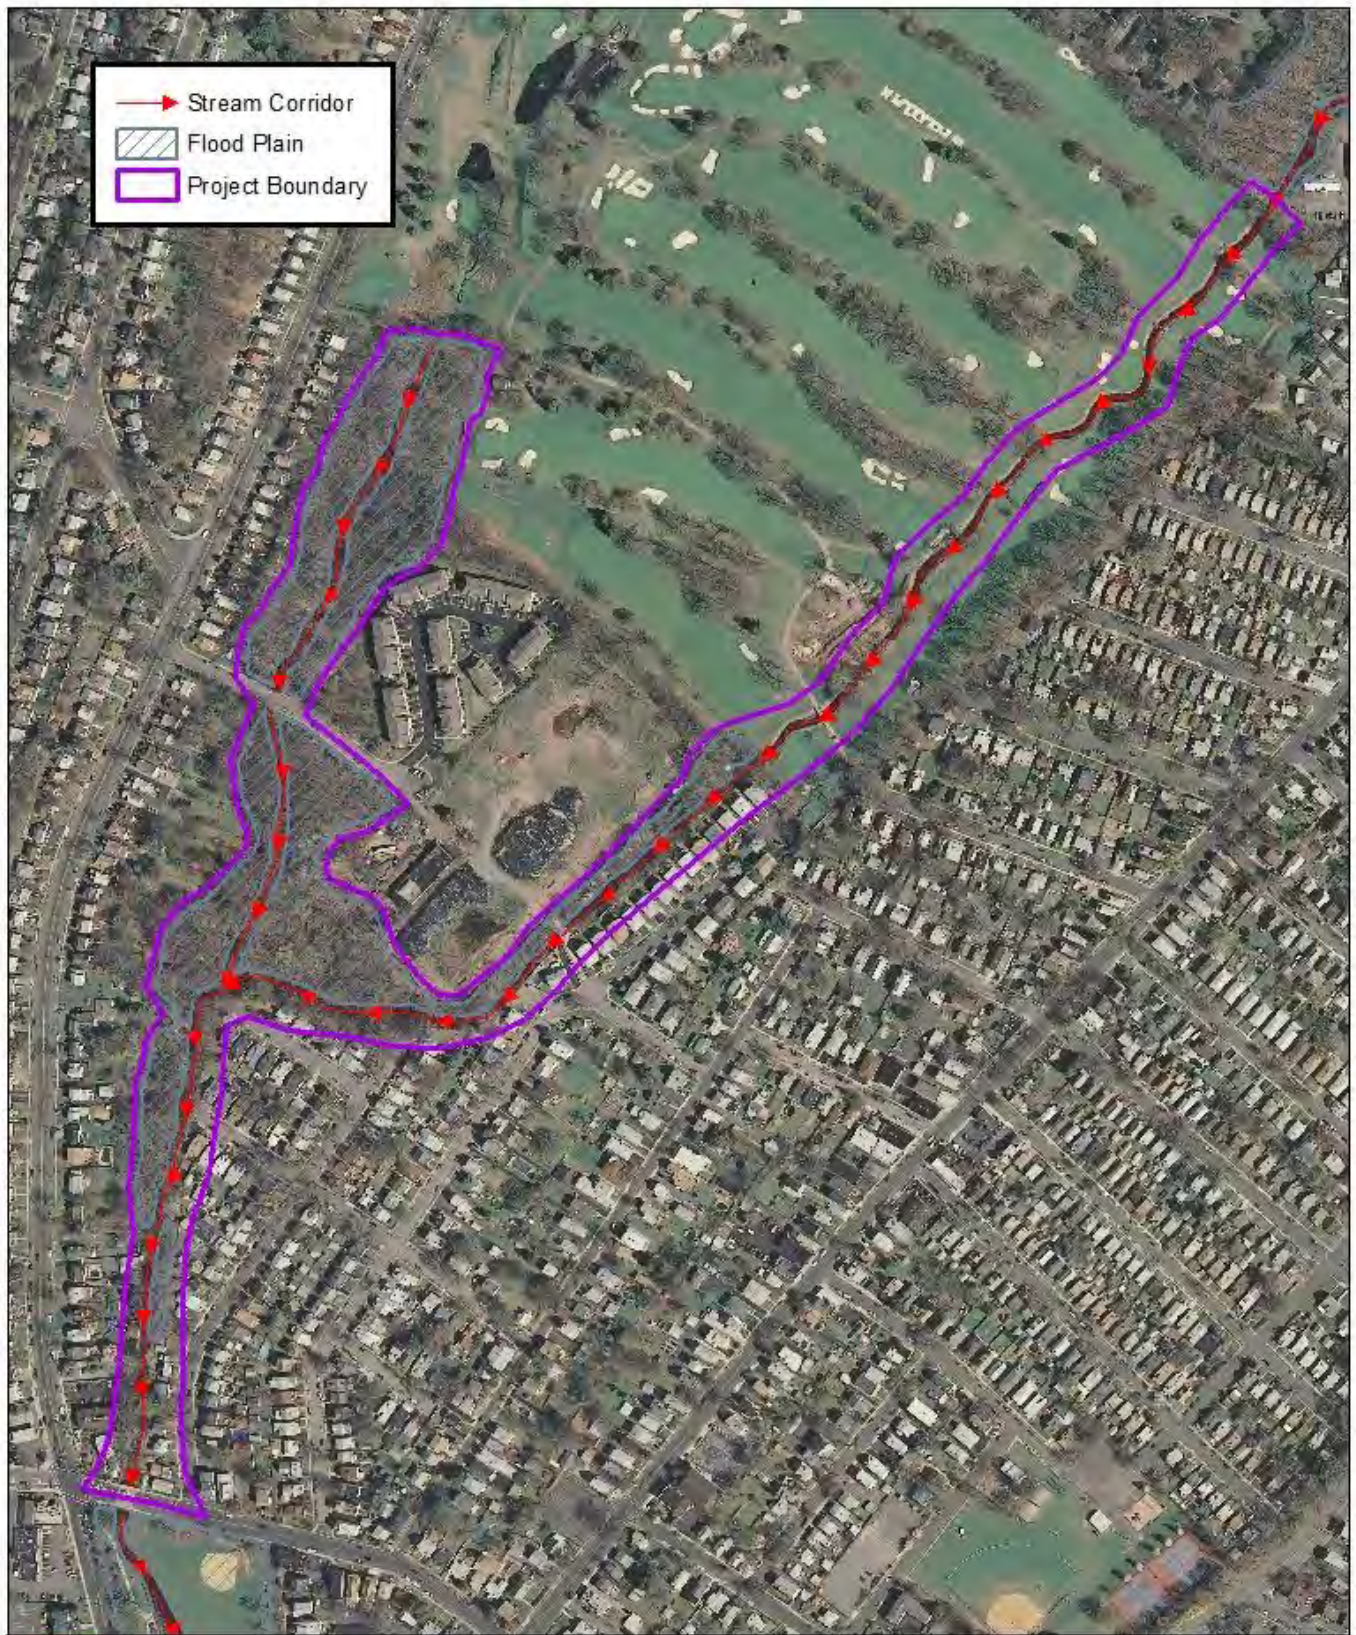
- Stream Corridor
- Flood Plain
- Project Boundary
