US Army Corps of Engineers New York District

Cumulative 5-year Sedimentation Due to Resuspension
Caused by the HDP and Other Dredging

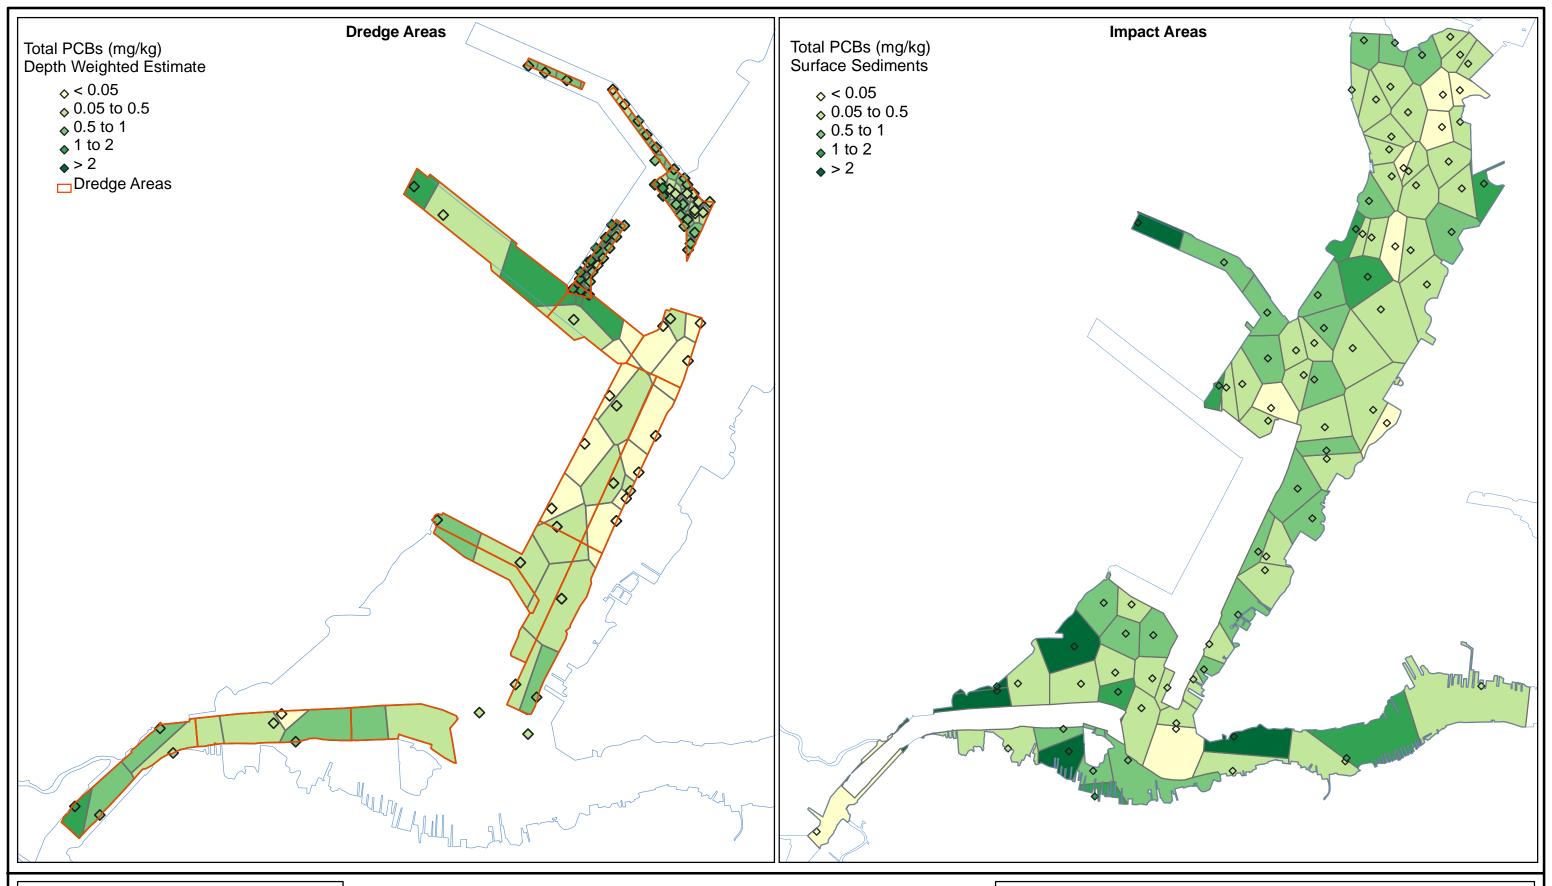
Figure 5-5

Total PCBs in the sediments of Newark Bay under current conditions: Thiessen polygons, cumulative assessment

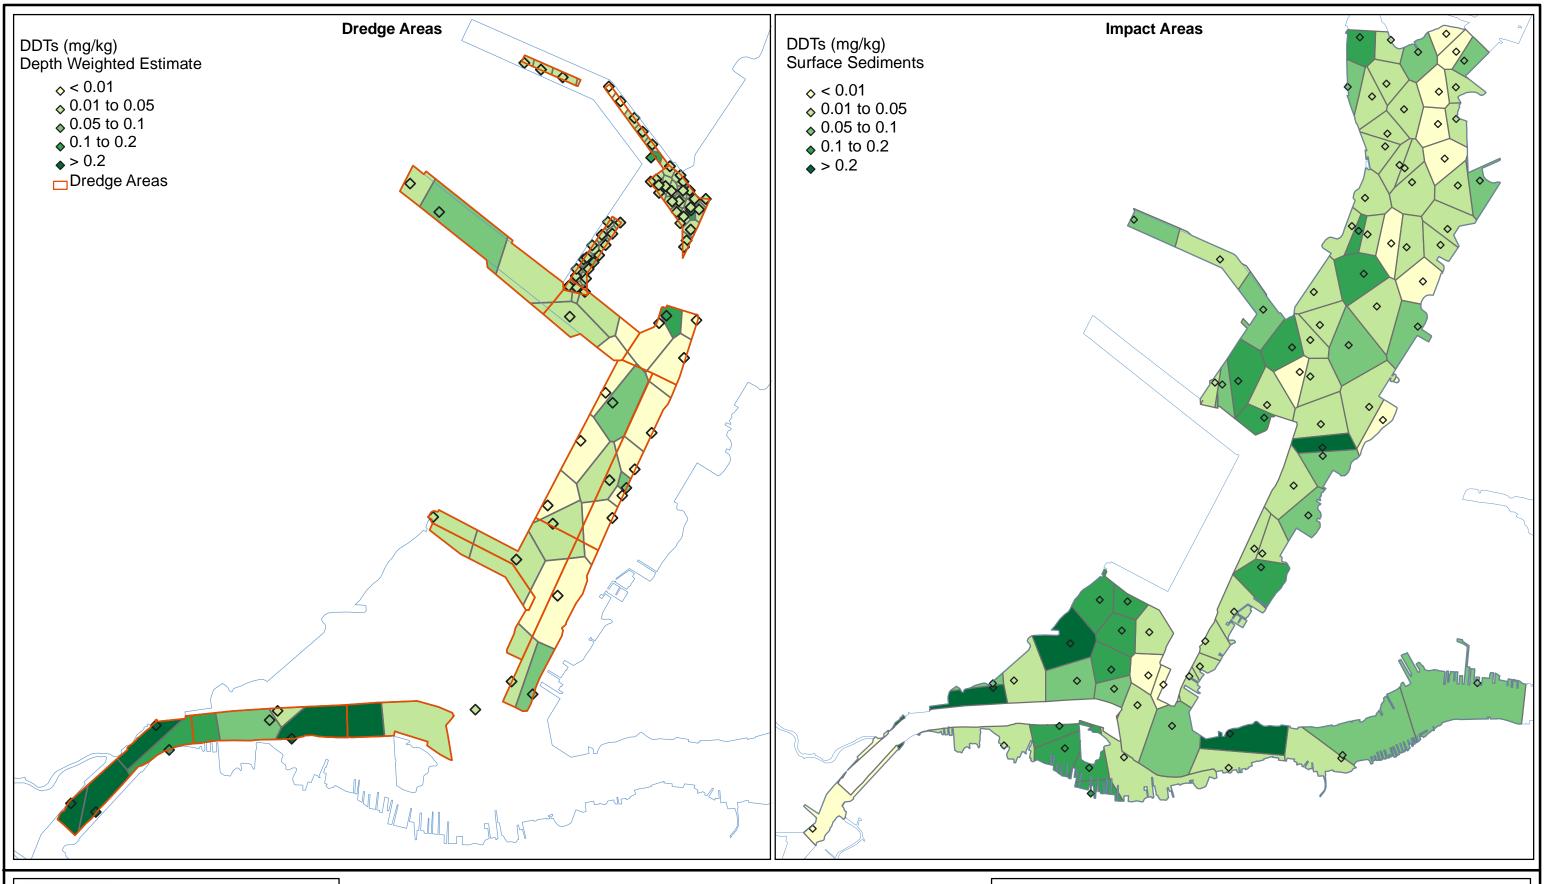
Figure 5-6

DDTs in the sediments of Newark Bay under current conditions: Thiessen polygons, cumulative assessment

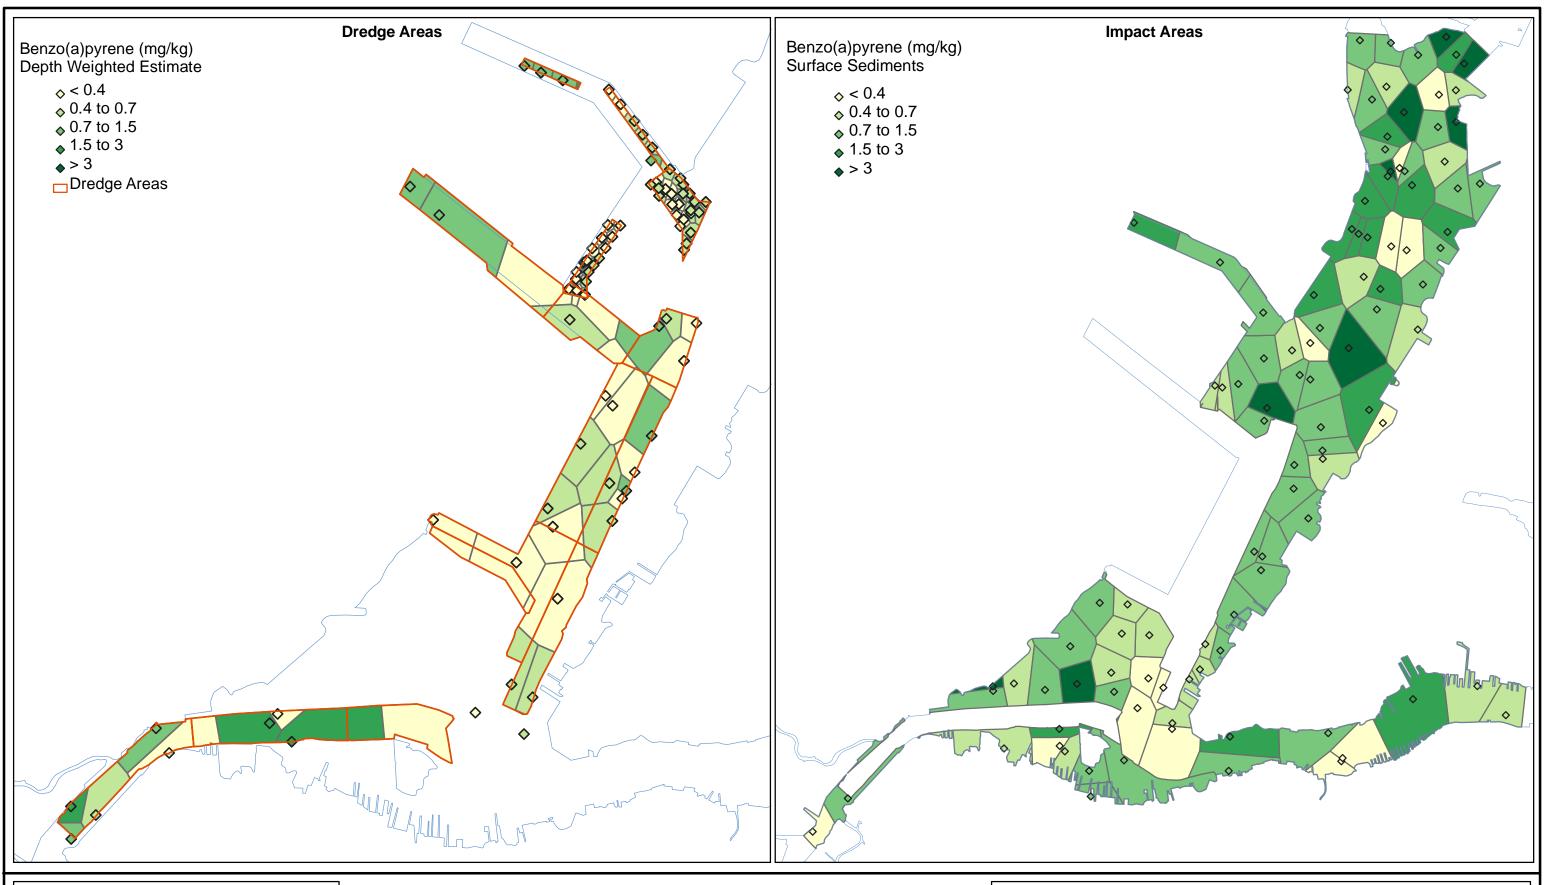
Figure 5-7
Benzo(a)pyrene in the sediments of Newark Bay under current conditions: Thiessen polygons, cumulative assessment

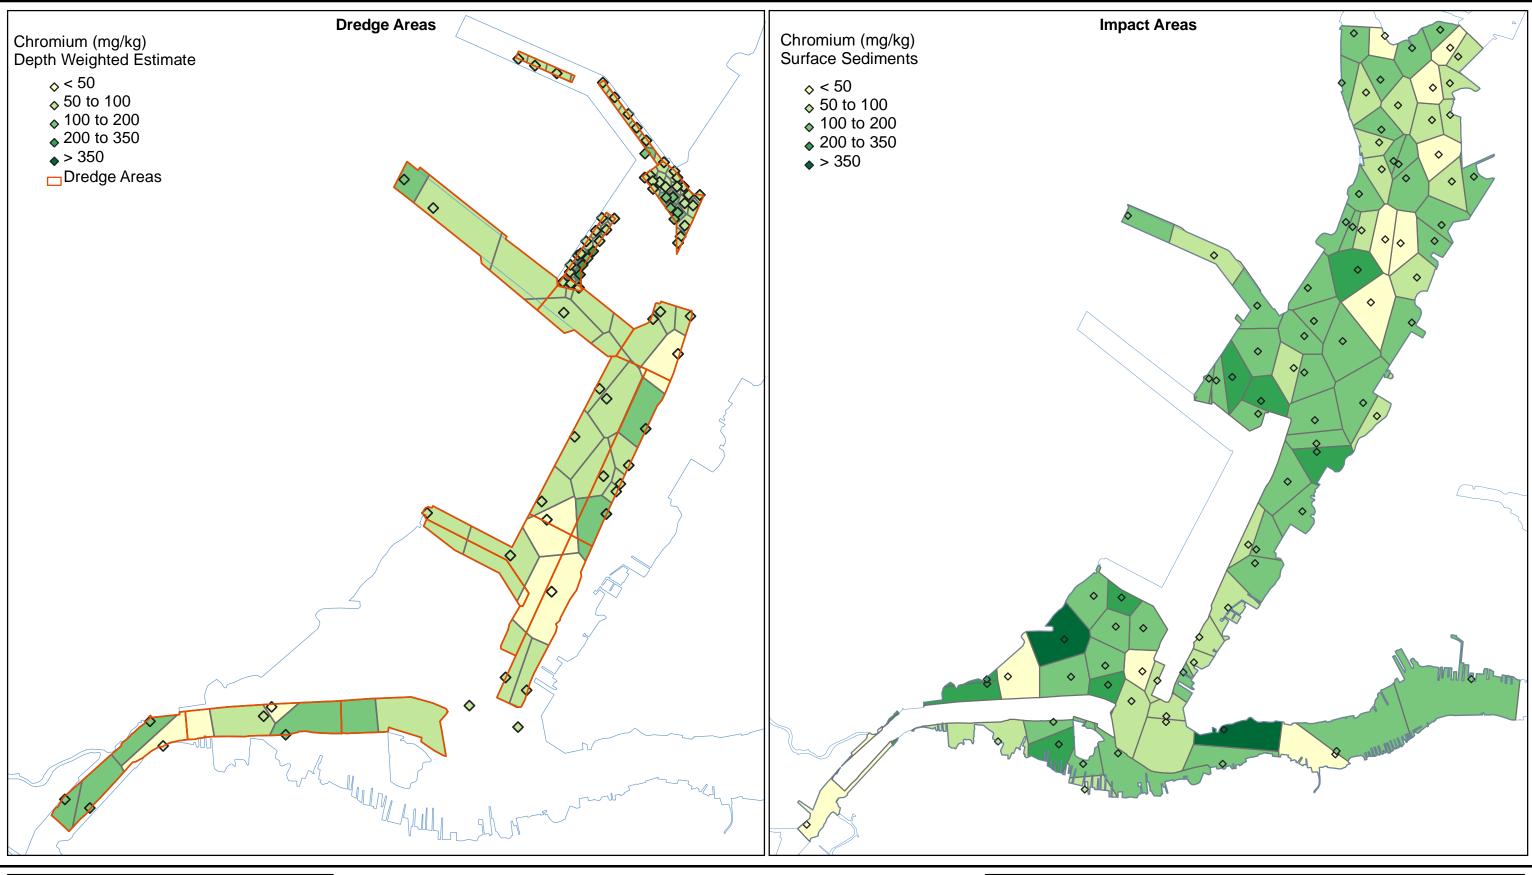
Figure 5-9
Chromium in the sediments of Newark Bay under current conditions: Thiessen polygons, cumulative assessment
