Corps restores Lady Liberty's image

Restoring Lady Liberty's seawall

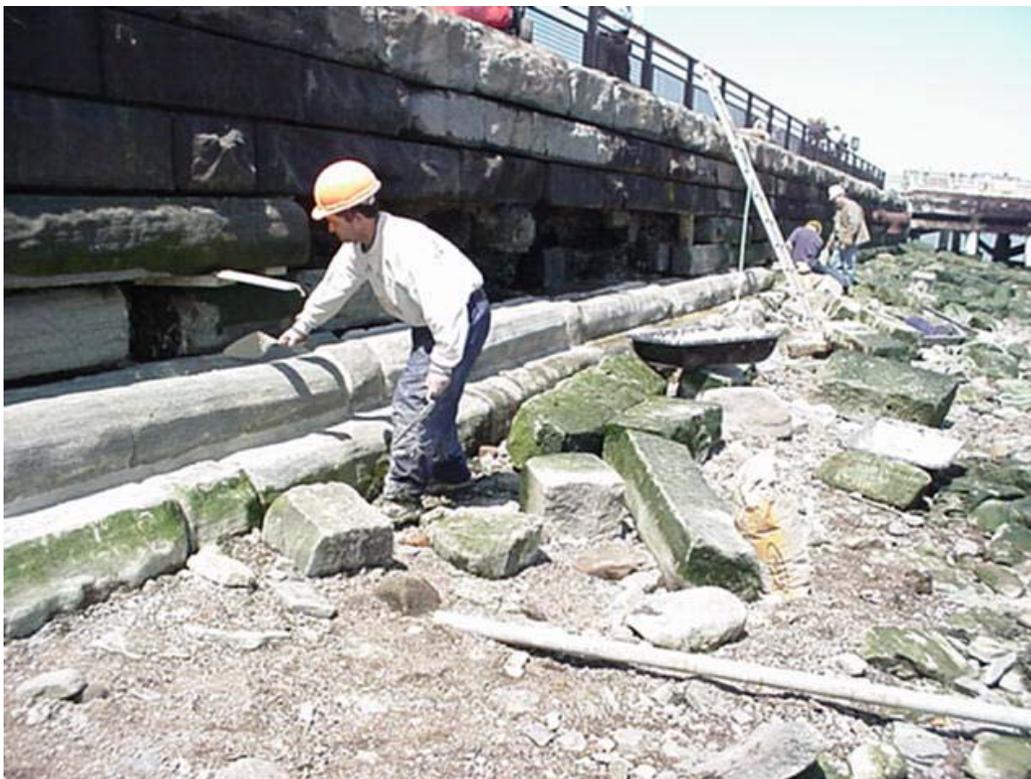
Photo: Brian Jackson, USACE [📖](#)

The National Park Service (NPS) is the present caretaker for the Statue of Liberty and her island. On June 12, 2003, the NPS signed an agreement with the Corps New York District to have them repair 340 linear feet of the 3,119 foot granite-faced vertical concrete Liberty Island seawall that was originally constructed in the early 19th century and surrounds most of the island. The repairs took place at locations where granite stones had fallen out of the seawall.

On September 29, 2003, the construction contract for the seawall repair was awarded to Perello Inc. of Lake Hapatcong, New Jersey. Construction began in April 2004 and ended in June 2004. "We repaired the seawall on the north and south side of the Liberty Island NPS shuttle dock located in the Southeast section of the island," said Ciorra. "We did this by first hydro blasting the exposed concrete on the seawall, in areas where seawall blocks have dislodged, in order to remove algae, moss and dirt, and then manually removed old grout and loose disintegrated concrete. We also replaced the disintegrated concrete with Sulphate-Resistant Air Entrained Concrete that is resistant to the marine environment. We took the 36 existing large granite blocks that dislodged, cleaned them, and grouted and reset them back into the wall with mortar."

“In addition, the entire 340 linear feet of seawall was cleaned and repointed beyond where the actual stones were dislodged and reset,” said Brian Jackson, Project Engineer, USACE, New York District. “The stones that were dislodged and reset were actually only a small portion of the entire length of the wall.”
