Overlook Wetlands Preserve LaGrange, NY

A site in the Hudson-Wappinger Service Area

Prepared by: The Wetland Trust
4729 State Route 414, Burdett, NY 14818

October 2018

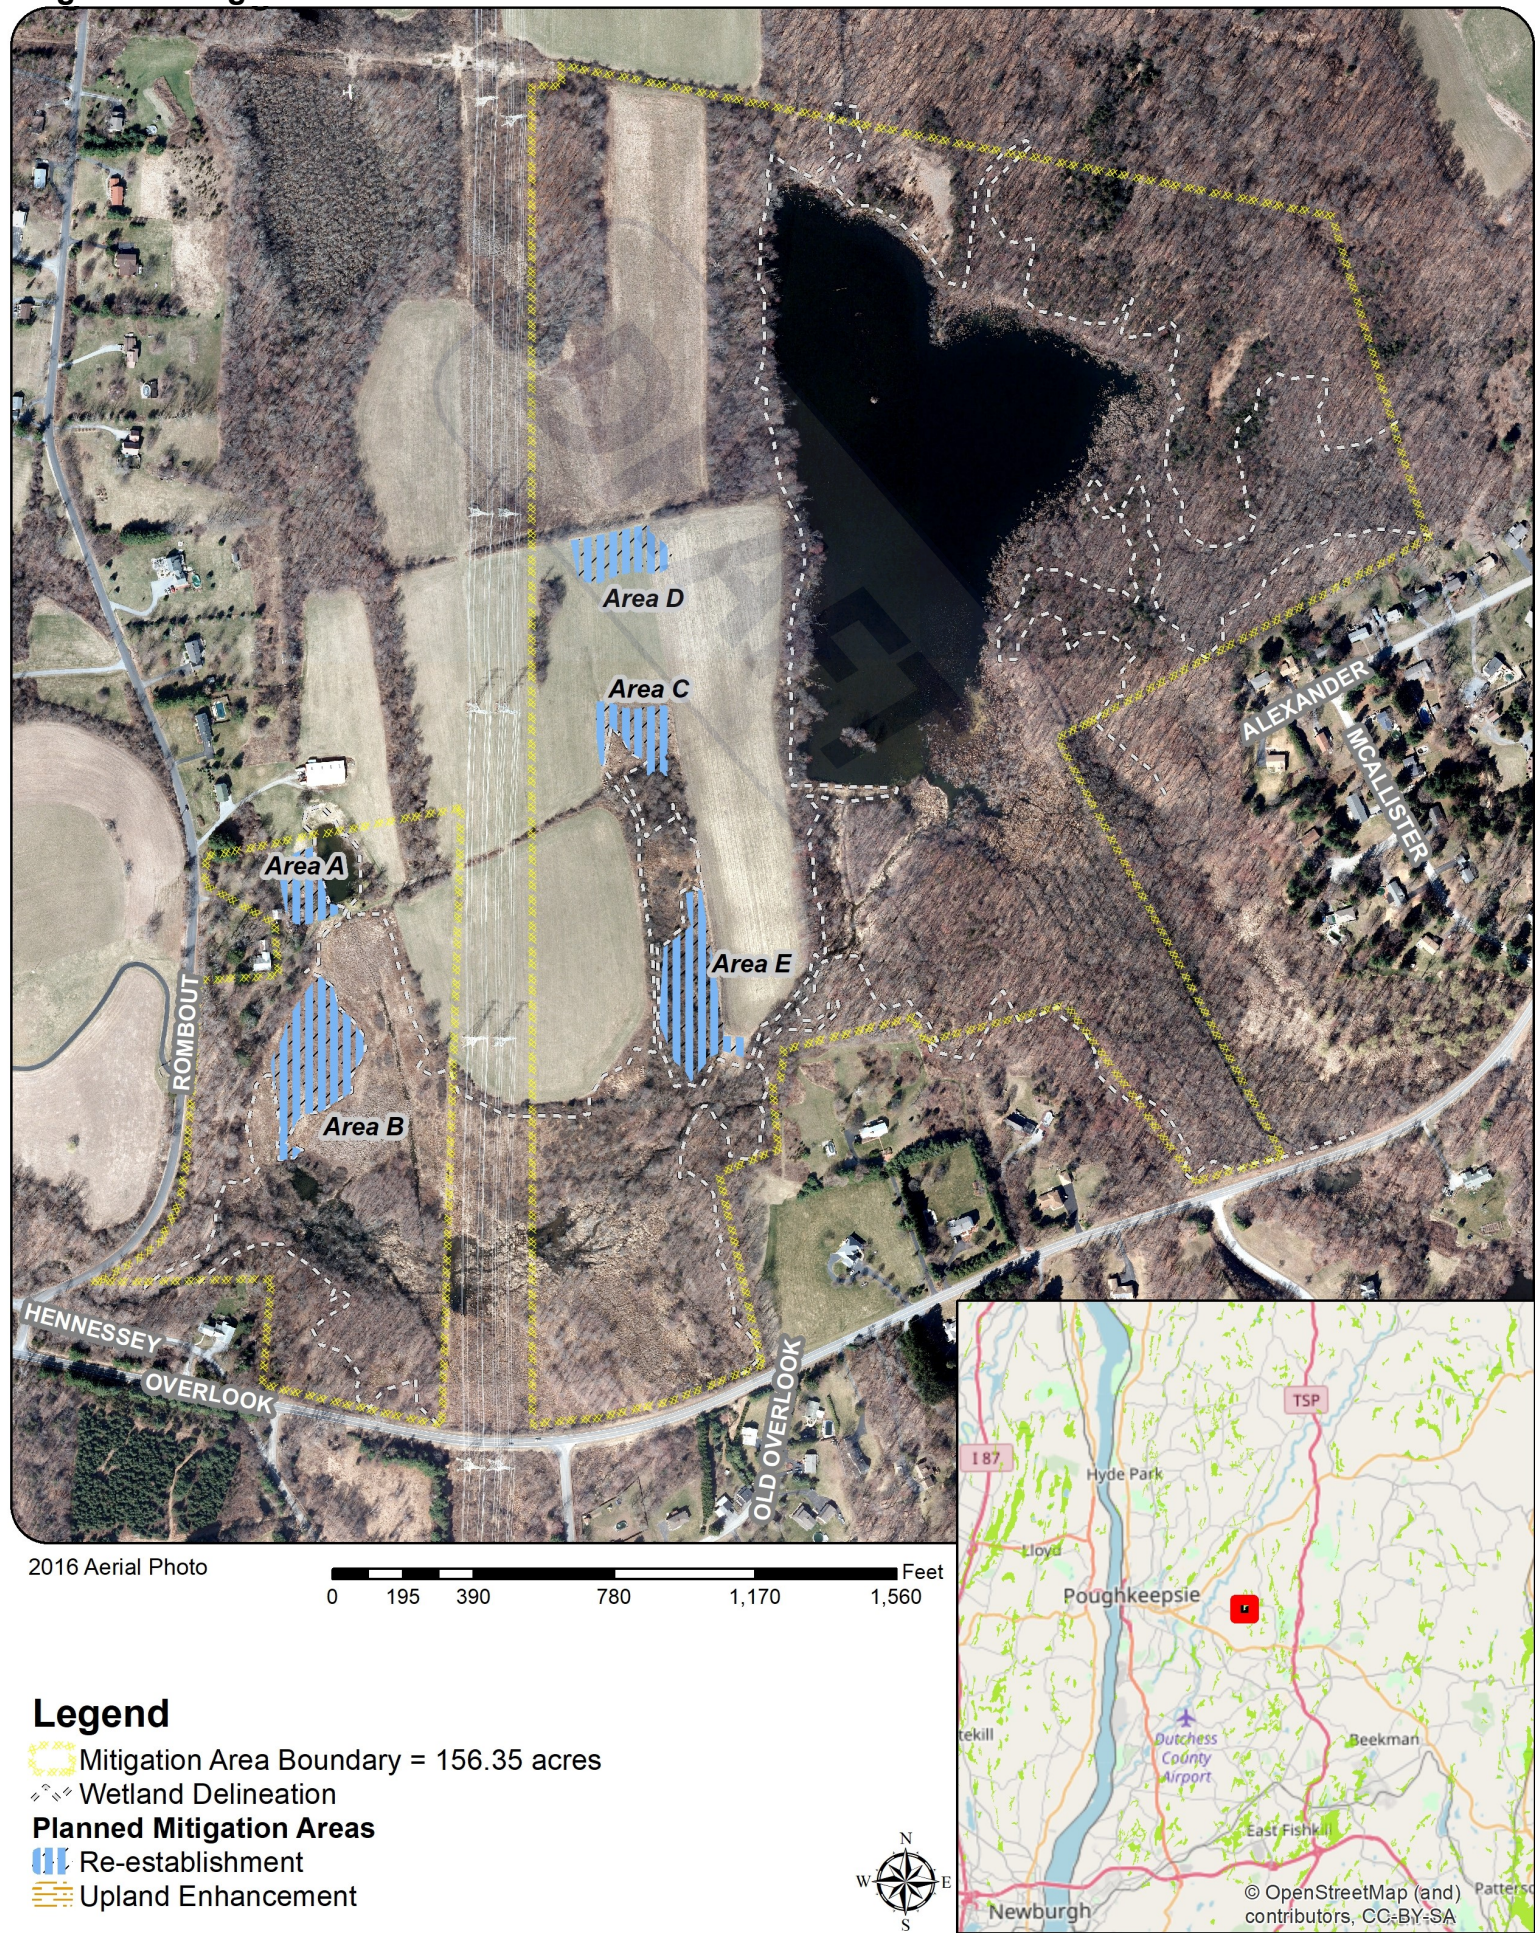
Figure 2: Mitigation Site Plan

Table 1 Credit Generation: based on wetland type and size featured in Figure 2

mitigation plan. TWT plans to describe and delineate most of this parcel as a Hudson River Bank Mitigation Site (Figure 2 and record in Dutchess County, NY a USACE approved third party conservation easement, naming the USACE and **The Wetland Conservancy, P.O. Box 220, Burdett, NY 14818-0220**, a 501(c)3 nonprofit as a third-party entity to be notified in the case of violations. TWT is the landowner and Bank Sponsor, which provides for an additional layer of protection, as any protection violation will also impact the viability of the Sponsor's Bank Mitigation Instrument.

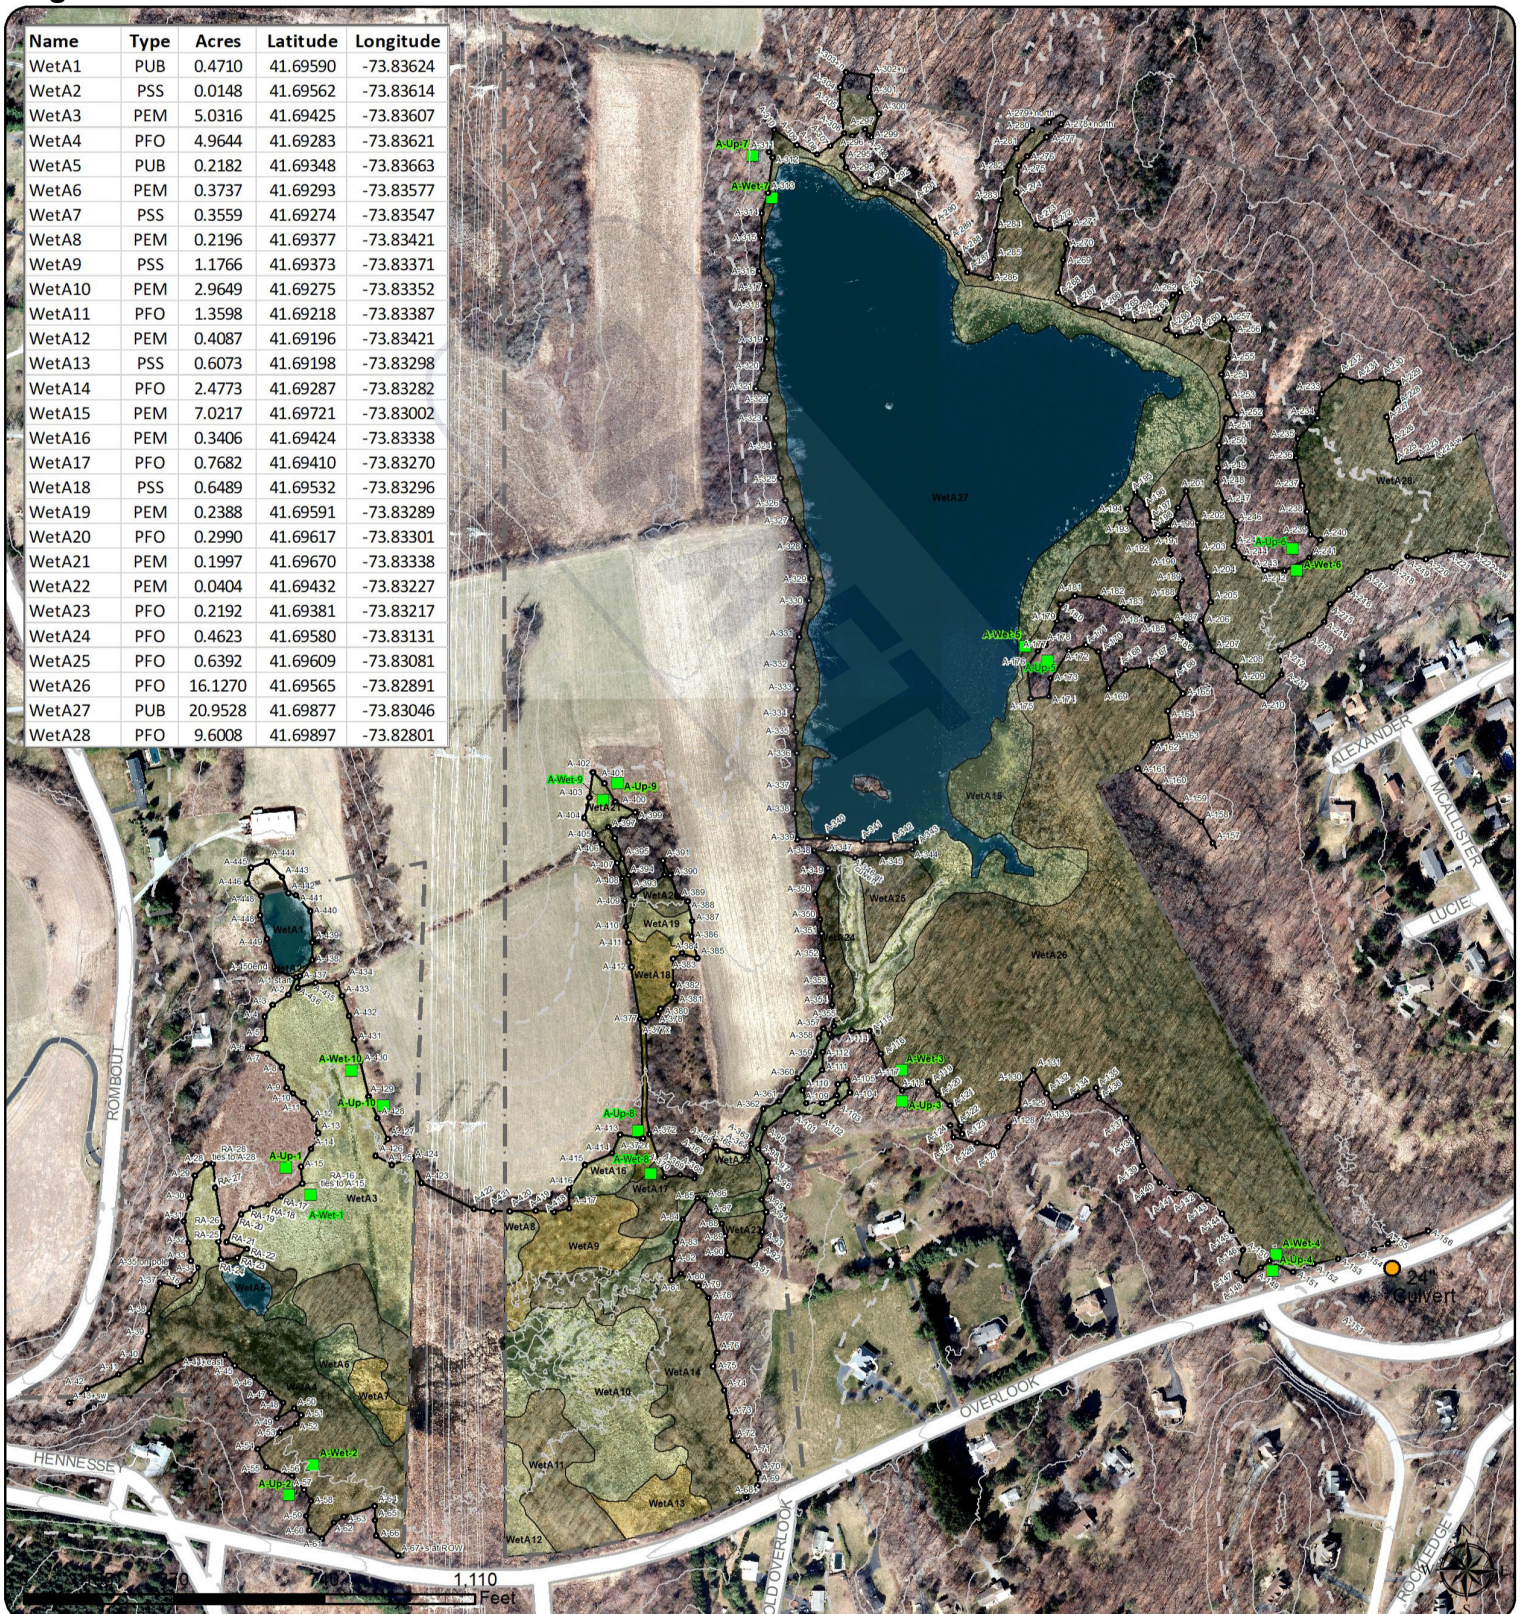
Figure 4: Overlook Wetland Delineation

The wetland points identified in this Figure were collected with a sub-meter accurate Trimble Geo7x Series Handheld GPS unit with floodlight/real-time correction enabled. At each wetland/flag location, data was recorded and averaged for a minimum of 10-15 seconds to ensure accurate positioning. The GPS points were uploaded and imported into Trimble Pathfinder Office Software. The points were differentially collected using data imported from the nearest available base station. They were then exported to a comma delimited file and imported into Microsoft Excel for final data manipulation and presentation to The Wetland Trust by Diehlux LLC. The final delineation points, listed in Addendum A, Appendix IV were then imported into ArcGIS 10.3.1 and used to create the Delineation Points Pointfile and Delineation Boundary Linefile included in Figure 3 and supplemental project maps.

- Delineation Points
- ▬ Property Boundary
- Data Points
- PEM = 16.84 acres
- PFO = 36.92 acres
- PSS = 2.80 acres
- PUB = 21.64 acres
- ~ Delineation Boundary
- ~ 10' LiDAR-Derived Contours
