Arthur Kill Wetland Mitigation Bank Prospectus

Date: December 2024

Site Development Concept Plan -Baseline Conditions Report, Ecological Suitability, and Conceptual Design Report

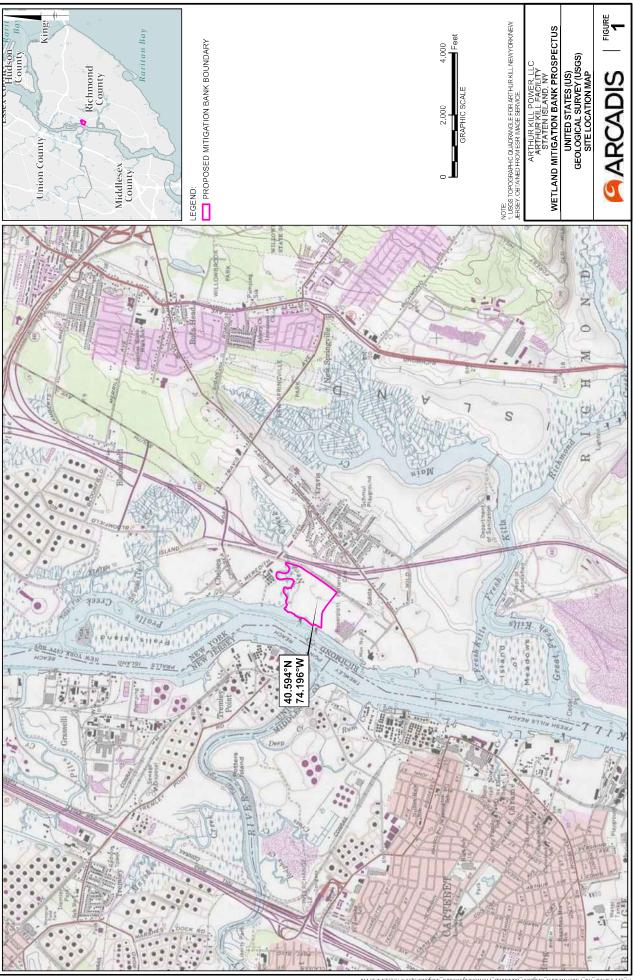
Figure 1. USGS Site Location Map

This Prospectus is submitted by Arthur Kill Power, LLC¹ (Arthur Kill Power) to the United States Army Corps of Engineers (USACE) – New York (NY) District, the Chair of the Interagency Review Team (IRT) to support development of the proposed Arthur Kill Wetland Mitigation Bank (Bank). This Prospectus has been prepared in accordance with the Final Rule for Compensatory Mitigation for Losses of Aquatic Resources (Federal Register Vol. 73, No. 70, April 10, 2008), and is intended to formally initiate the planning and agency review process for the proposed Bank. The proposed Bank is located on Staten Island, in Richmond County, NY. A Site Location Map as shown on the United States Geologic Survey (USGS) 7.5-minute series topographic map is included as Figure 1.

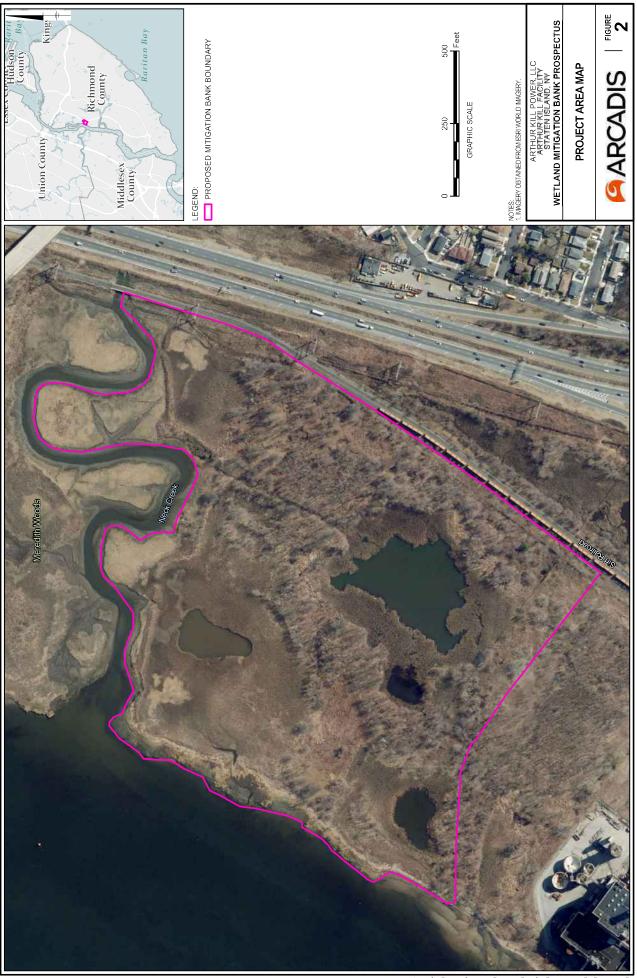
Figure 2. Project Area Map

This Site Development Concept Plan - Baseline Conditions, Ecological Suitability, and Conceptual Design Report (Conceptual Report) has been developed in support of the Prospectus for the proposed Arthur Kill Wetland Mitigation Bank (Bank) in accordance with the Final Rule for Compensatory Mitigation for Losses of Aquatic Resources (Federal Register Vol. 73, No. 70, April 10, 2008). The proposed Bank is located on Staten Island, in Richmond County, New York (NY). A Site Location Map as shown on the United States (US) Geologic Survey (USGS) 7.5-minute series topographic map included as Figure 1 as part of the Prospectus. The approximate center of the Bank is located at 40.5943, -74.19654 State Plane 83 NY Long Island North American Datum 1983 (NAD83). The Bank is proposed to occur on 47 acres (ac) of disturbed freshwater wetland and upland habitats to the north of the Arthur Kill Generating Station (AKGS) and shown on the Project Area Map, included as Figure 2 as part of the Prospectus.
