Saw Mill Creek Pilot Wetland Mitigation Bank
Staten Island, New York

EXHIBIT B
SOUTHWESTERN SECTION ADDITIONS

EXHIBIT C
BASELINE CONDITIONS REPORT
FOR SOUTHWESTERN SECTION

PLANS FOR
SOUTHWESTERN SECTION OF THE SAW MILL
CREEK WETLAND MITIGATION BANK
STATEN ISLAND, NEW YORK

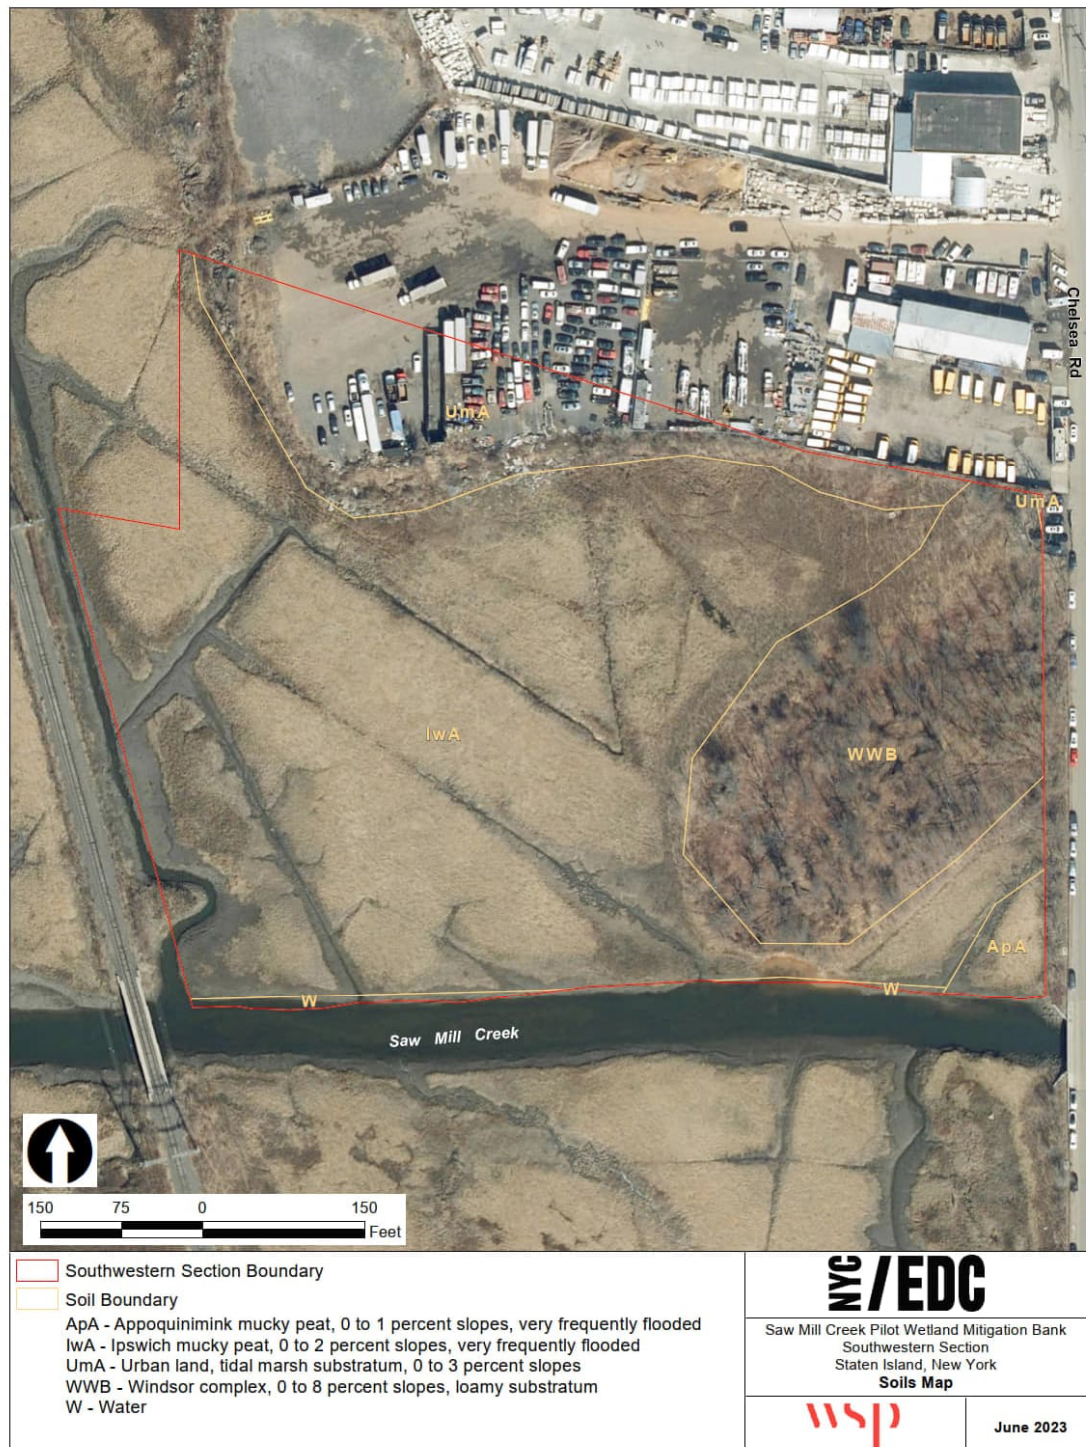
Figure C-2. Soils Map

Each mapping unit component includes soil series and miscellaneous areas. In general, soils in a series have the same parent material, drainage class, and sequence of major horizons.

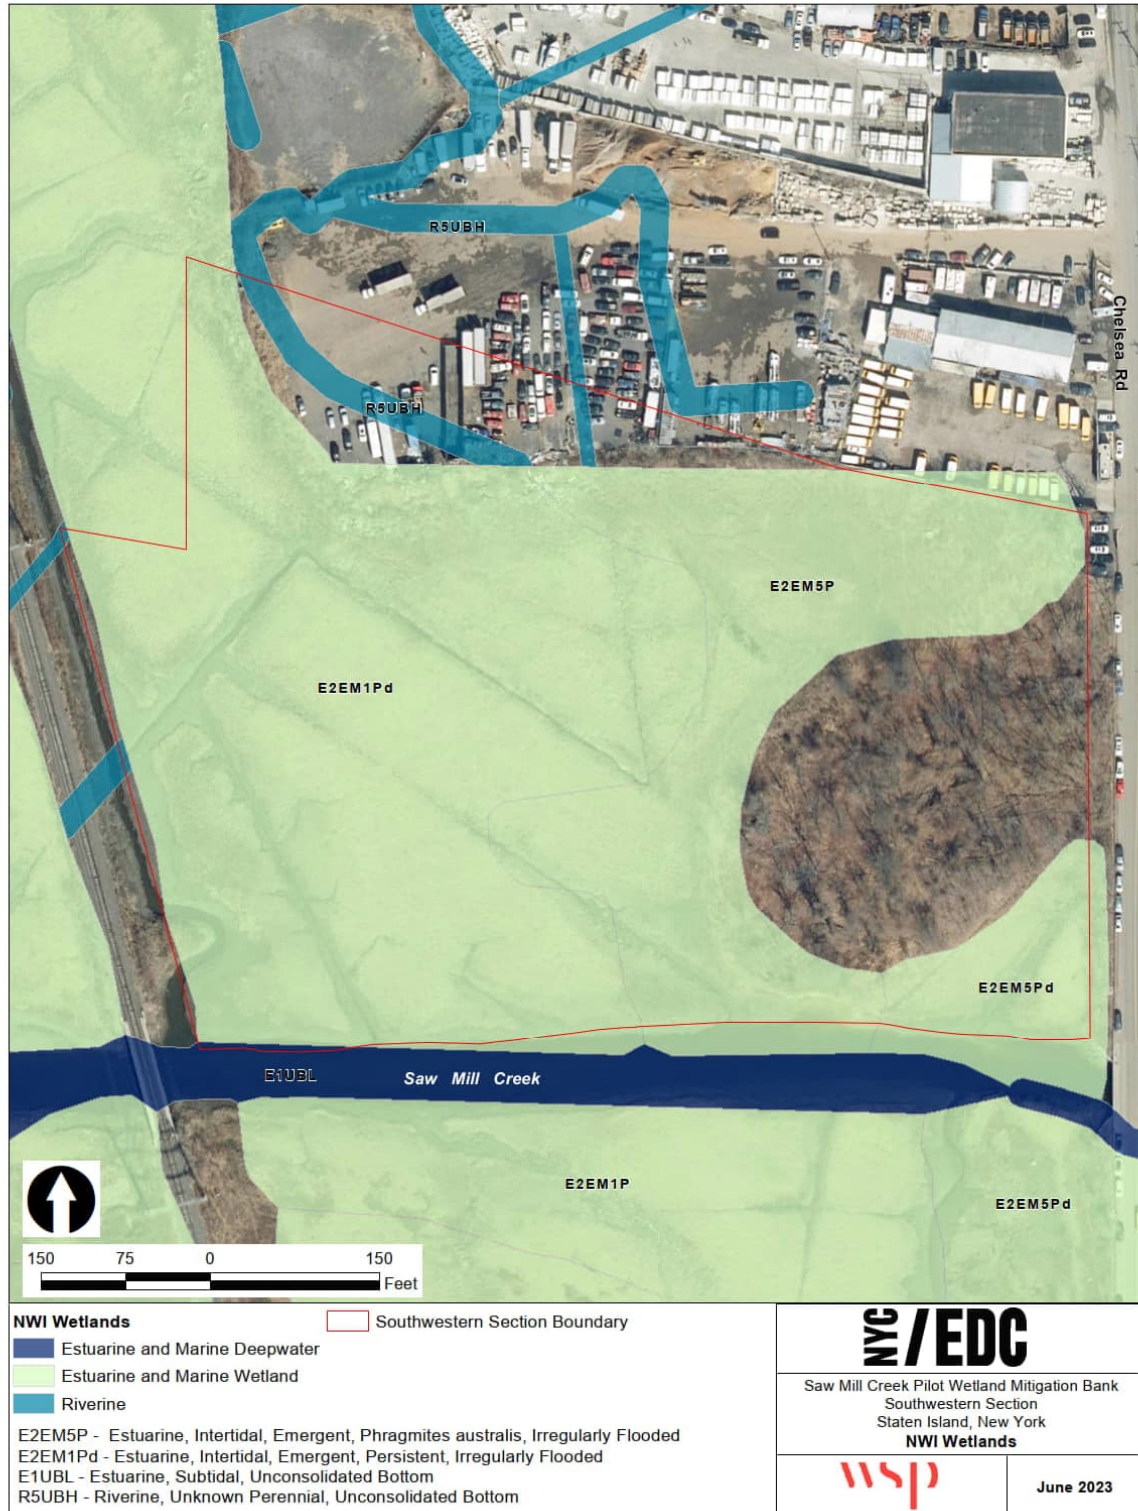
Figure C-4. National Wetlands Inventory Map

E1UBL	Estuarine, Subtidal, Unconsolidated Bottom, Subtidal
E2EM1Pd	Estuarine, Intertidal, Emergent, Persistent, Irregularly flooded, partially drained/ditched
E2EM5P	Estuarine, Intertidal, Emergent, Narrow-leaved Persistent
E2EM5Pd	Estuarine, Intertidal, Emergent, Narrow-leaved Persistent, Partially Drained/Ditched

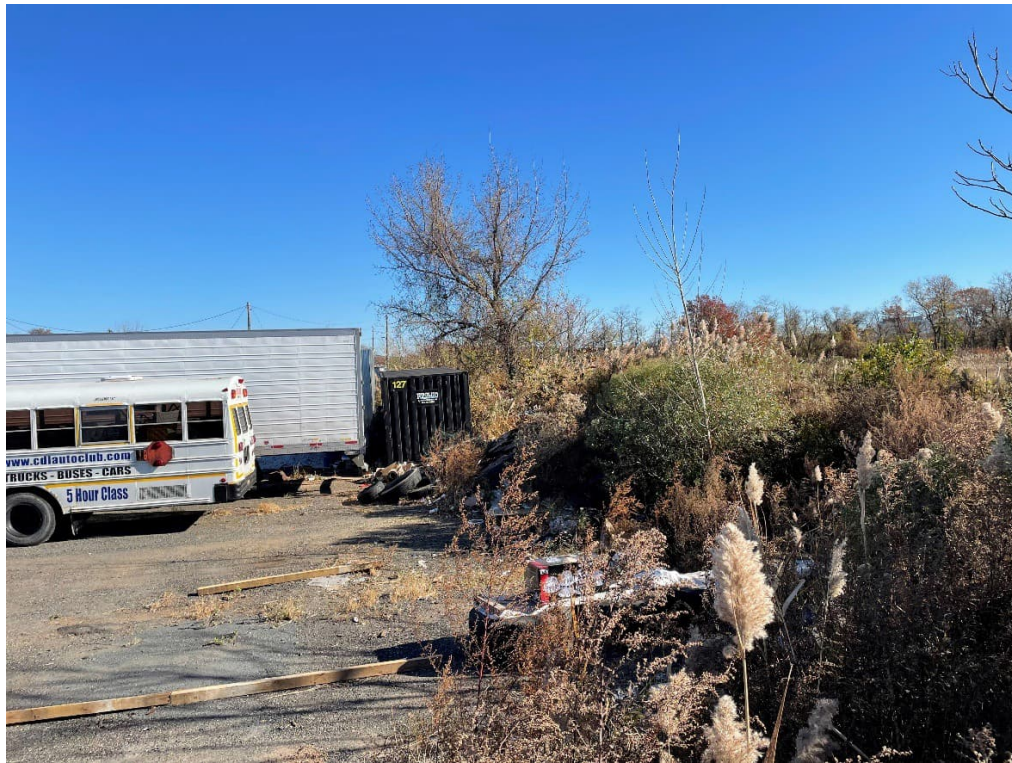
Photo 1: Paved Wetland Re-establishment Area, facing east, November 2021.

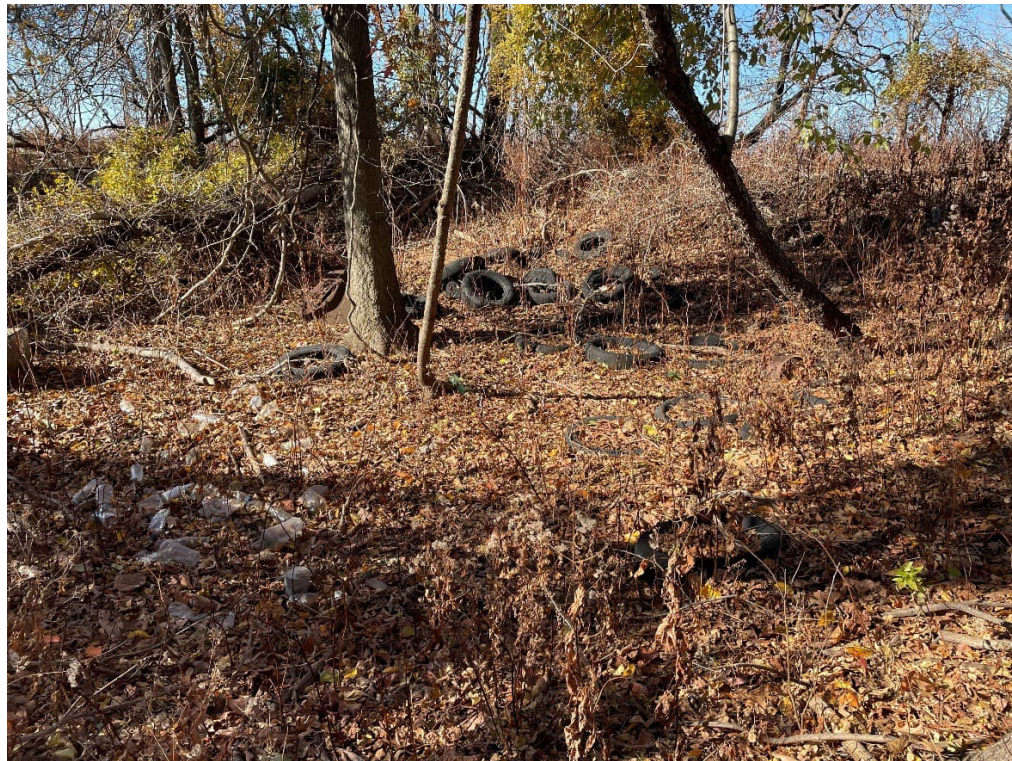
Photo 2: Debris piles located in the Upland Buffer Rehabilitation Area, facing west, November 2021.

All discarded and dumped items, and general project area-wide debris should be removed and properly disposed of at an off-site location in accordance with all applicable laws and regulations during marsh restoration activities. If, during removal, a release is encountered, additional investigation in accordance with the DER-10 may be warranted. Other RECs that were noted in are:

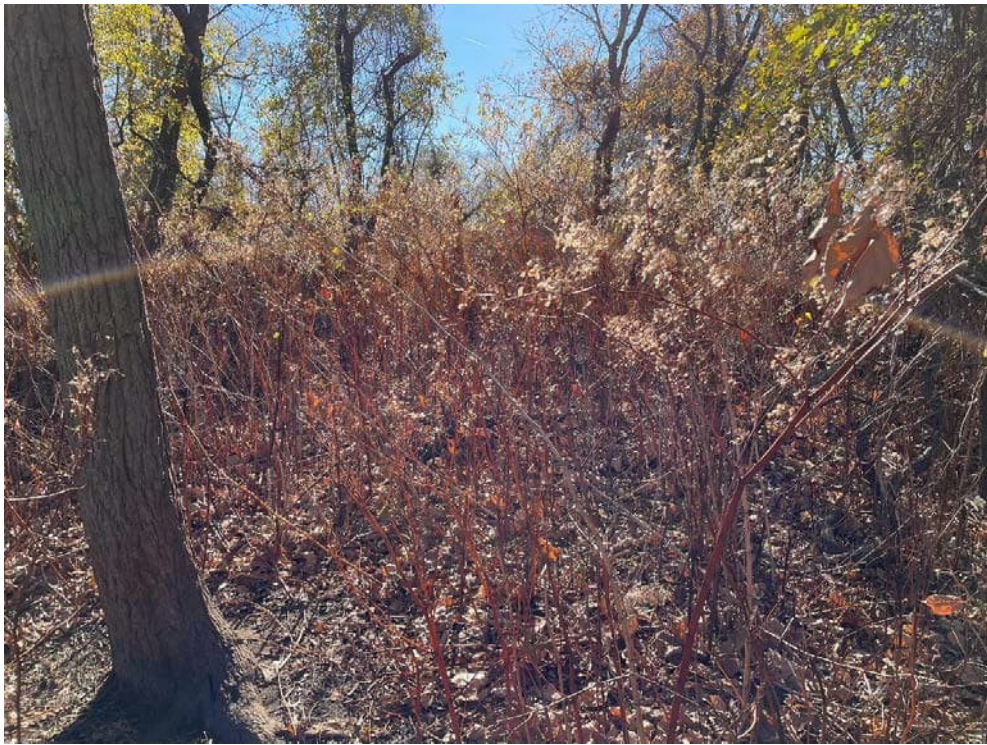
Photo 7: Understory of Japanese knotweed in Upland Buffer Rehabilitation Area ,facing south, November 2021.

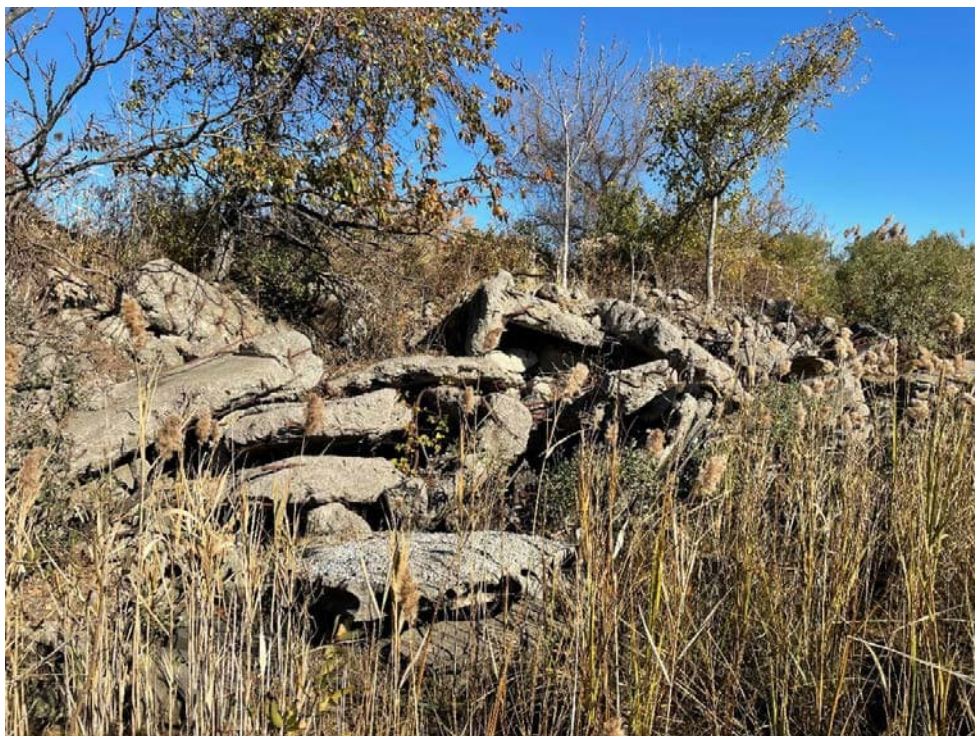
Photo 10: Fill material on edge of Wetland Re-establishment Area, facing northeast, November 2021.

Nonindigenous fill material should be removed and properly disposed of at an off-site location in accordance with all applicable laws and regulations during marsh restoration activities. It was recommended that prior to and/or during removal activities, an investigation of the fill material should be conducted to identify the extent, depth and physical characteristics of the fill in accordance with the NYSDEC DER-10-Technical Guidance for Site Investigation and Remediation (May 2010) (DER-10). Widespread dumping was observed, some of which consisted of:

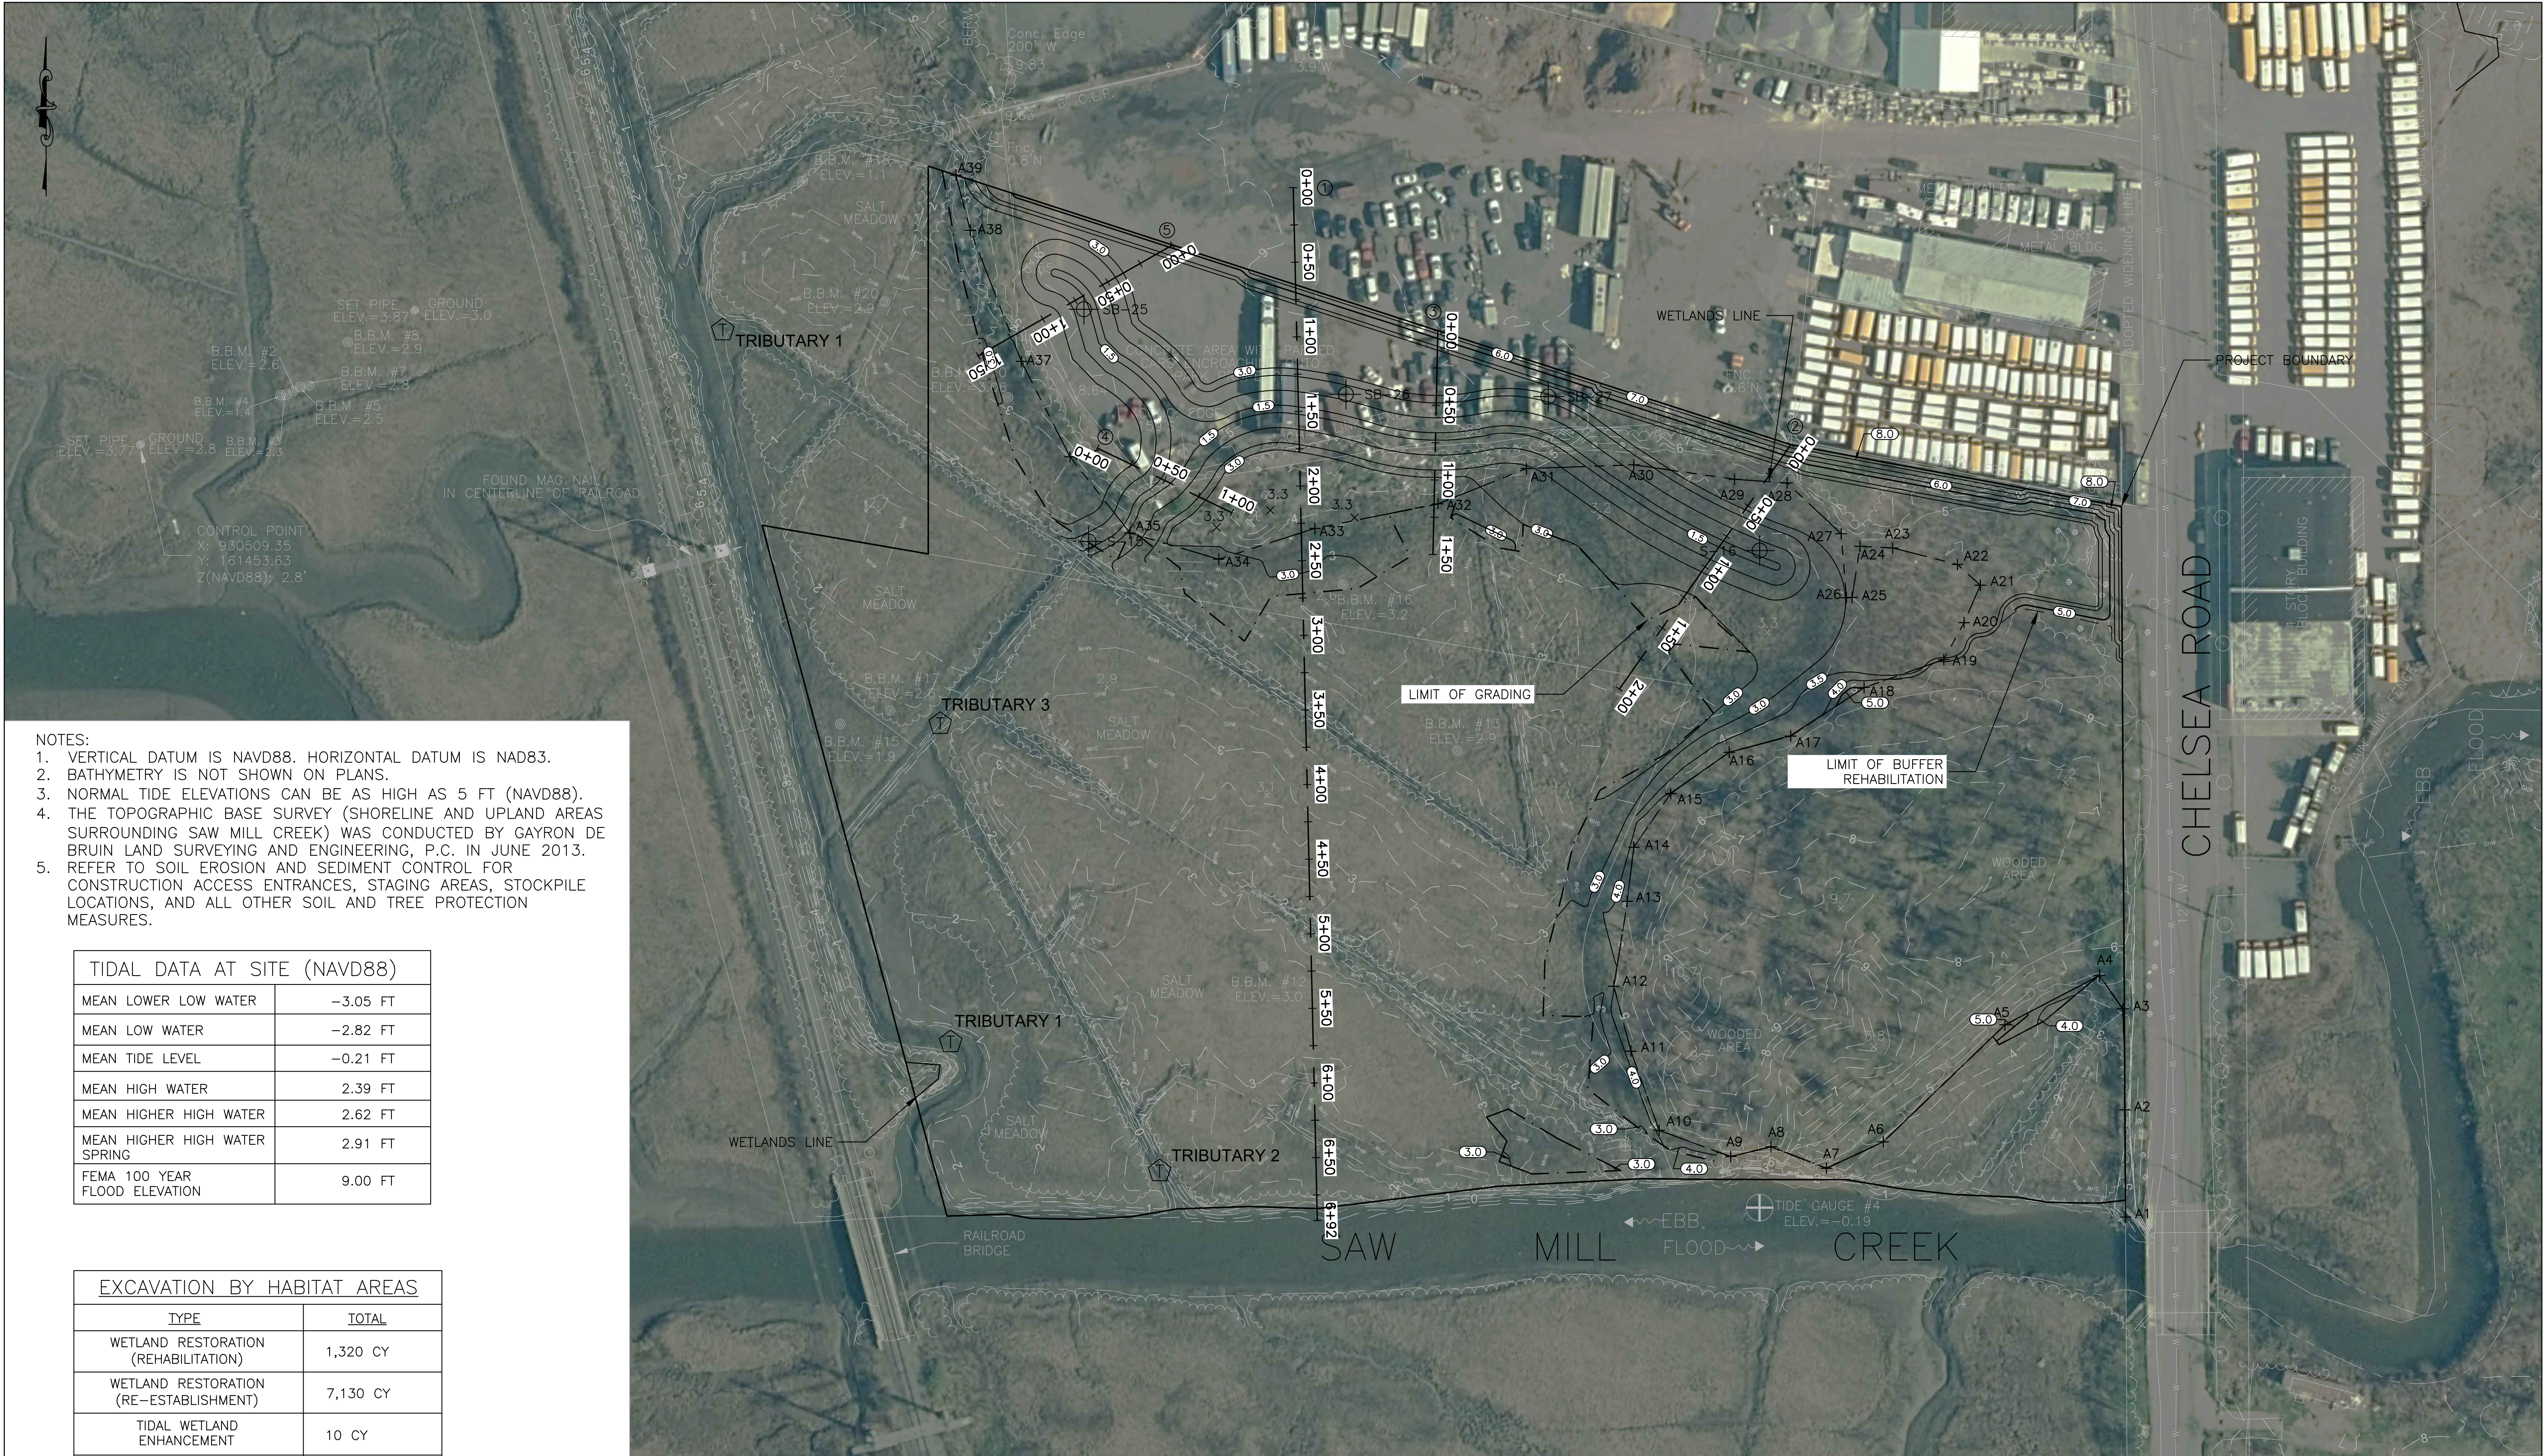
EXCAVATION BY HABITAT AREAS	
TYPE	TOTAL
WETLAND RESTORATION (REHABILITATION)	1,320 CY
WETLAND RESTORATION (RE-ESTABLISHMENT)	7,130 CY
TIDAL WETLAND ENHANCEMENT	10 CY
UPLAND SLOPE	200 CY
TOTAL	8,660 CY

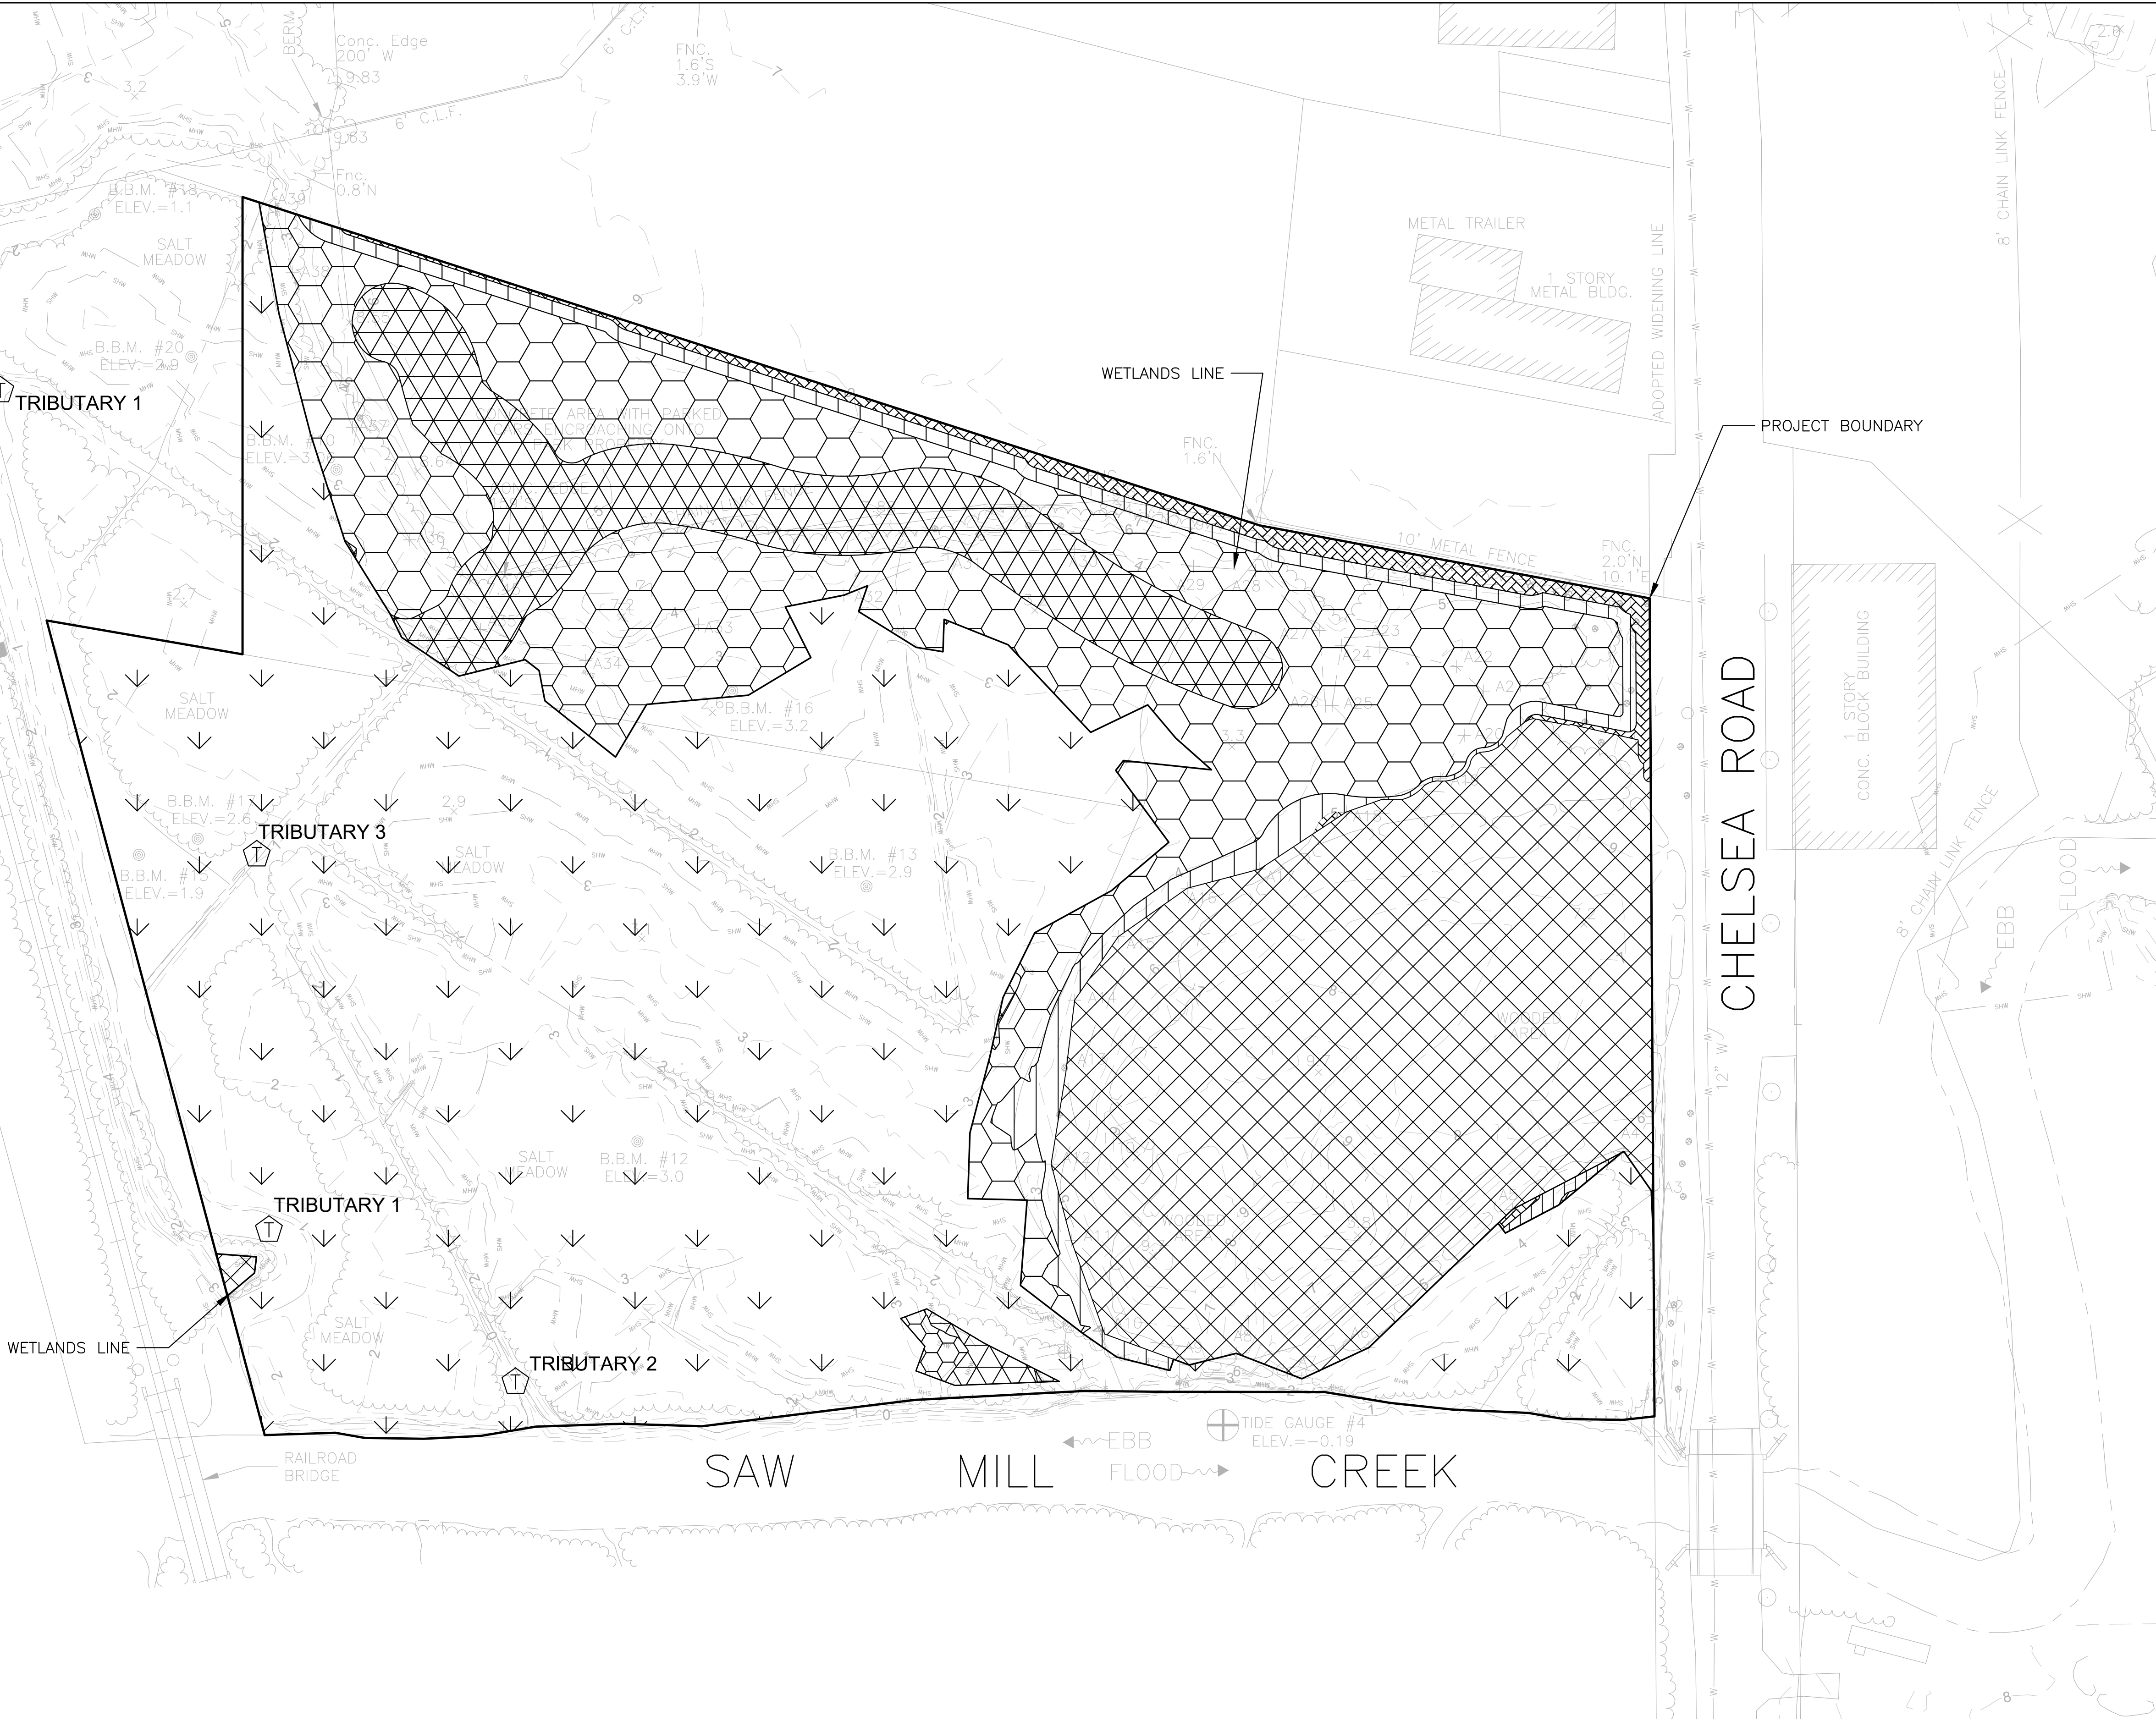
HABITAT ZONES			
HABITAT_ZONE	HABITAT_ELEVATION_RANGE	HATCHING	EAST
WETLAND RESTORATION LOW MARSH	1.5 FEET - 2.5 FEET		0.75 AC
WETLAND RESTORATION HIGH MARSH	2.5 FEET - 3.5 FEET		1.97 AC
WETLAND RESTORATION SCRUB SHRUB	3.5 FEET - 5.0 FEET		0.31 AC
UPLAND SLOPE	> 5.0 FEET		0.14 AC
TIDAL WETLAND ENHANCEMENT	NO SPECIFIC ELEVATION		5.68 AC
BUFFER REHABILITATION	NO SPECIFIC ELEVATION		2.05 AC
TOTAL			10.90 AC
