Public Notice

Applicant:
The Wetland Trust
(Mohawk River Preserve ILF Site)

Application No: LRB-2019-00486 & LRB-2010-00963
Section: NY

**Wetland Mitigation Plan
Mohawk River Preserve
Mohawk Service Area, HUA 02020004**

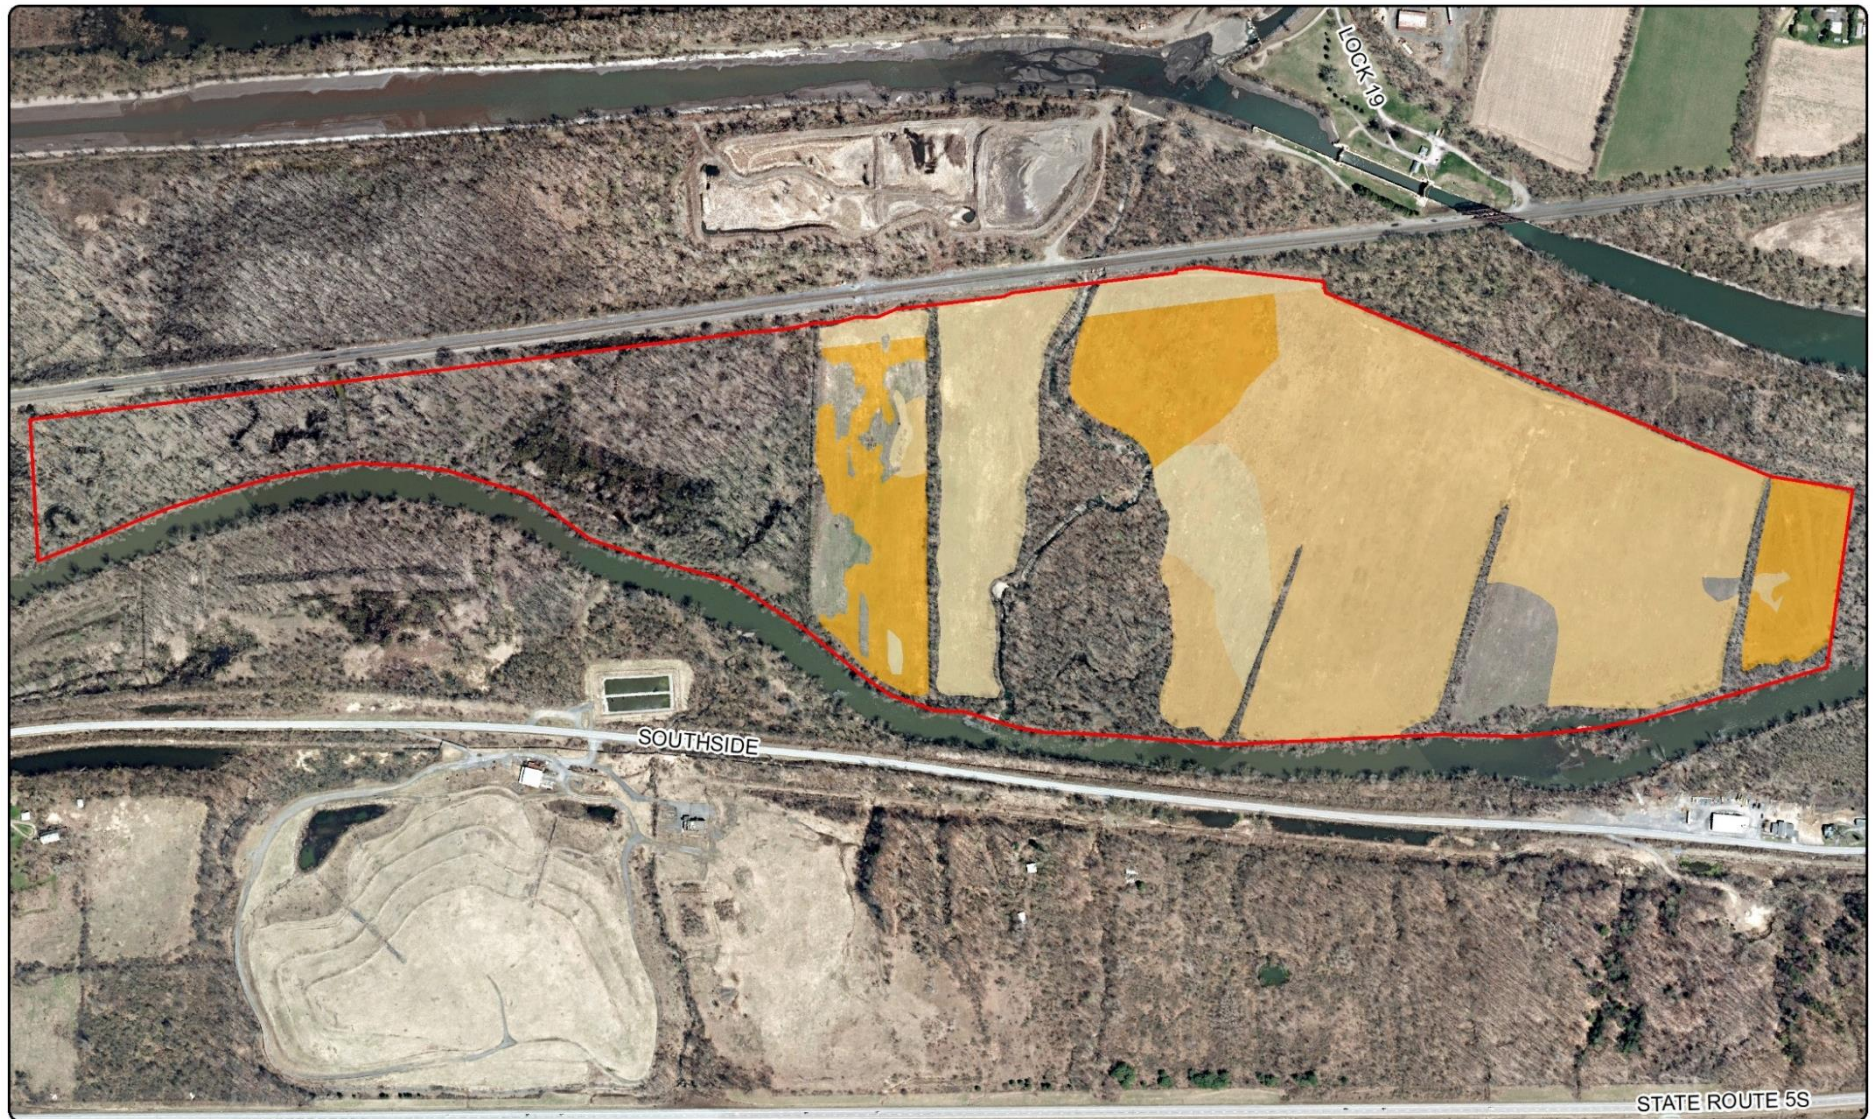
Figure 6: Mohawk River Preserve Invasive Species Cover Estimates, *Artemisia vulgaris*, Common Mugwort

Invasive species coverage was developed using data collected from vegetative data points, stand mapping, Vegetative Index of Biotic Integrity (VIBI) data, and drone photo interpretation. The results for ten invasive species across the entire property are provided in Table 2a. These data were also used to determine the invasive species coverage in the wetland reestablishment and preservation areas (Table 2b). Figures 6 through 9 depict coverage for the four most common invasive species: common mugwort, purple loosestrife, reed canarygrass, and giant reed.

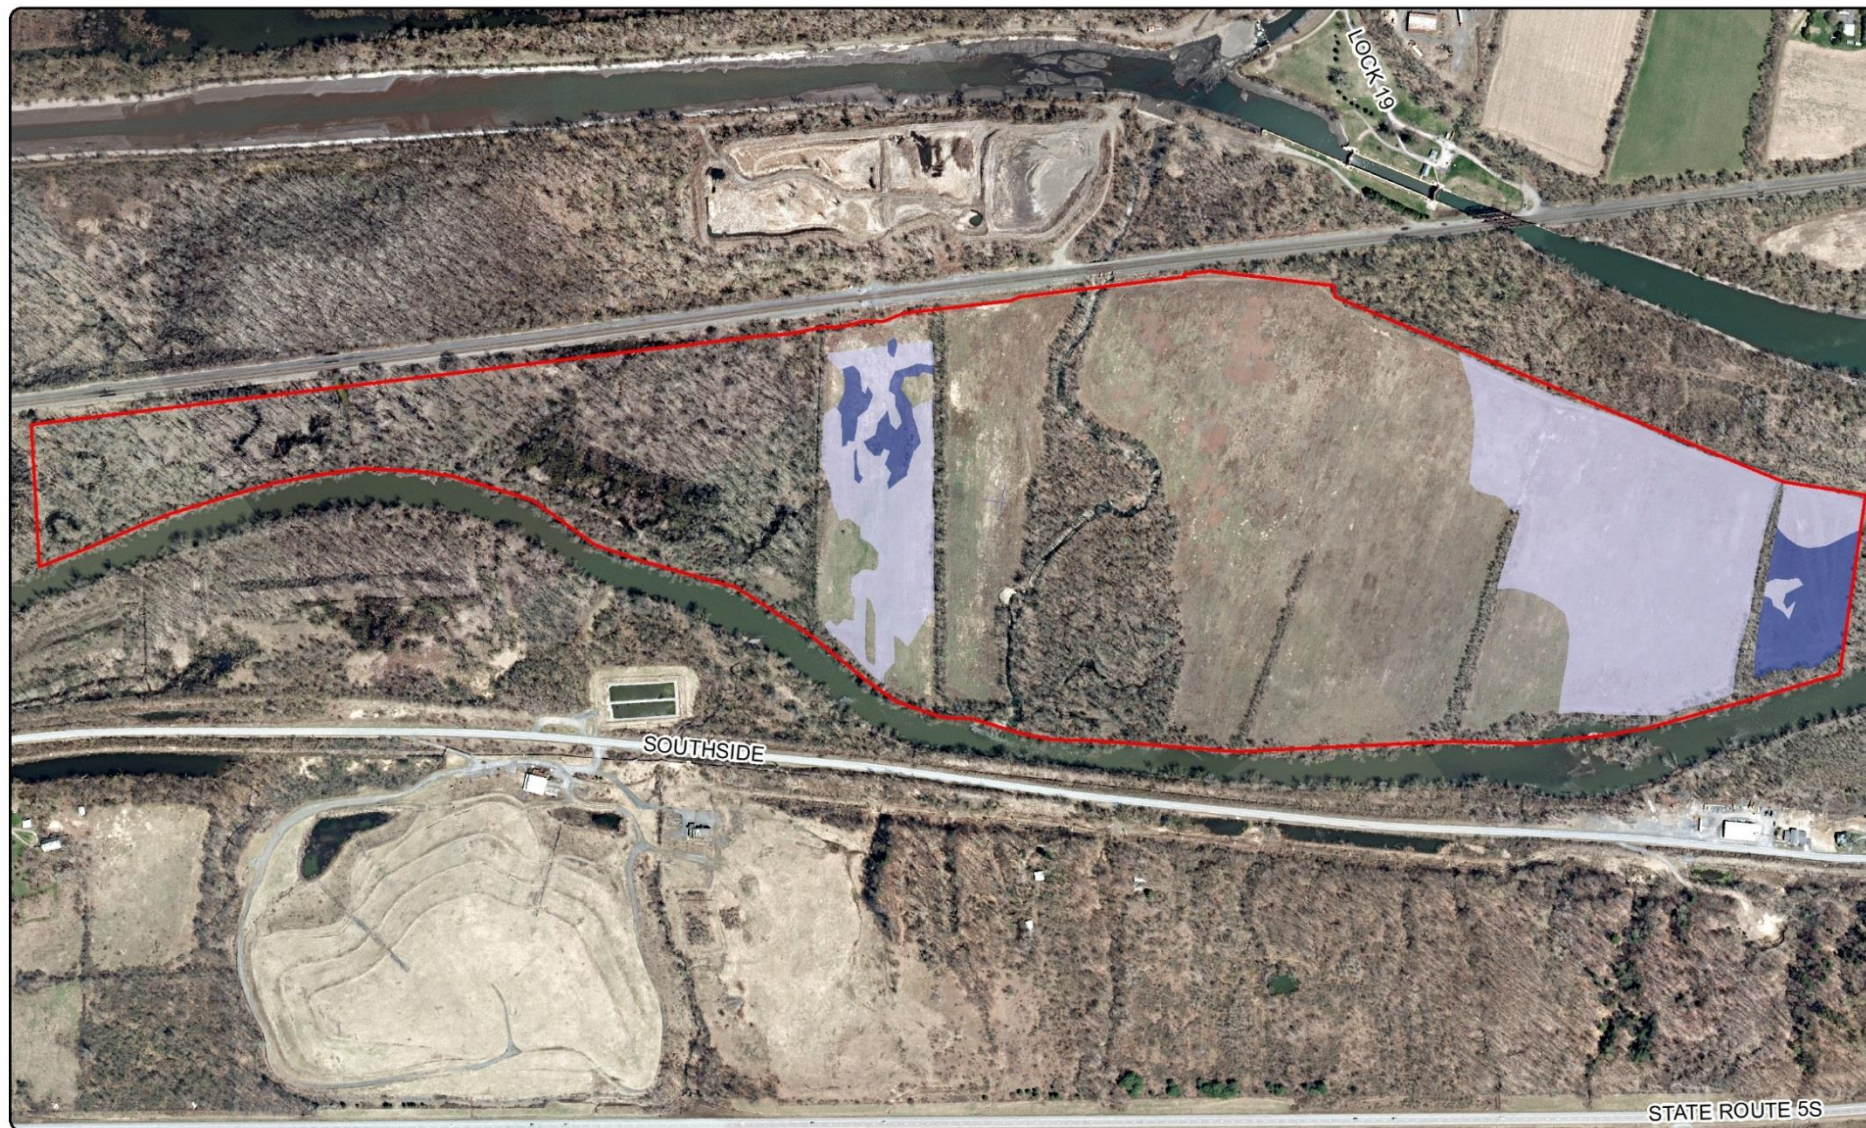
Figure 7: Mohawk River Preserve Invasive Species Cover Estimates, *Lythrum salicaria*, Purple Loosestrife.

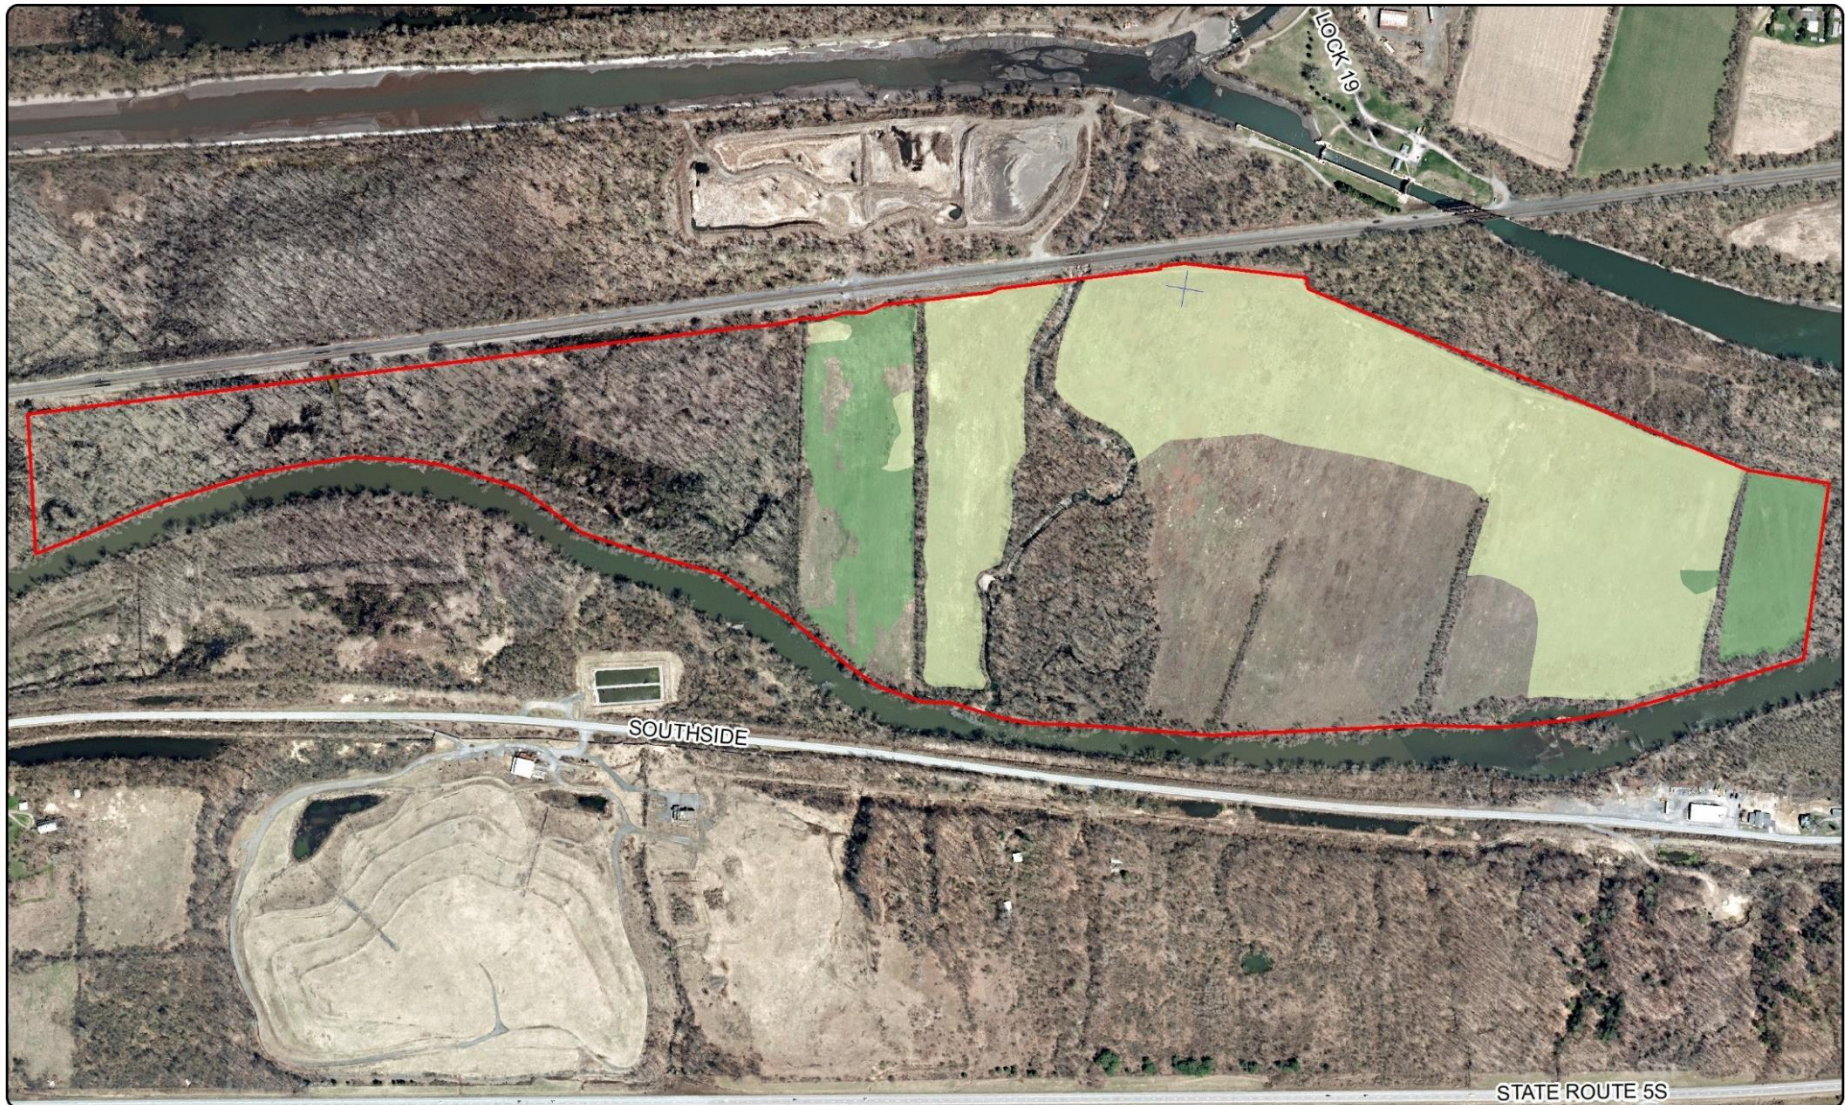
Figure 8: Mohawk River Preserve Invasive Species Cover Estimates, *Phalaris arundinacea*, Reed Canarygrass.

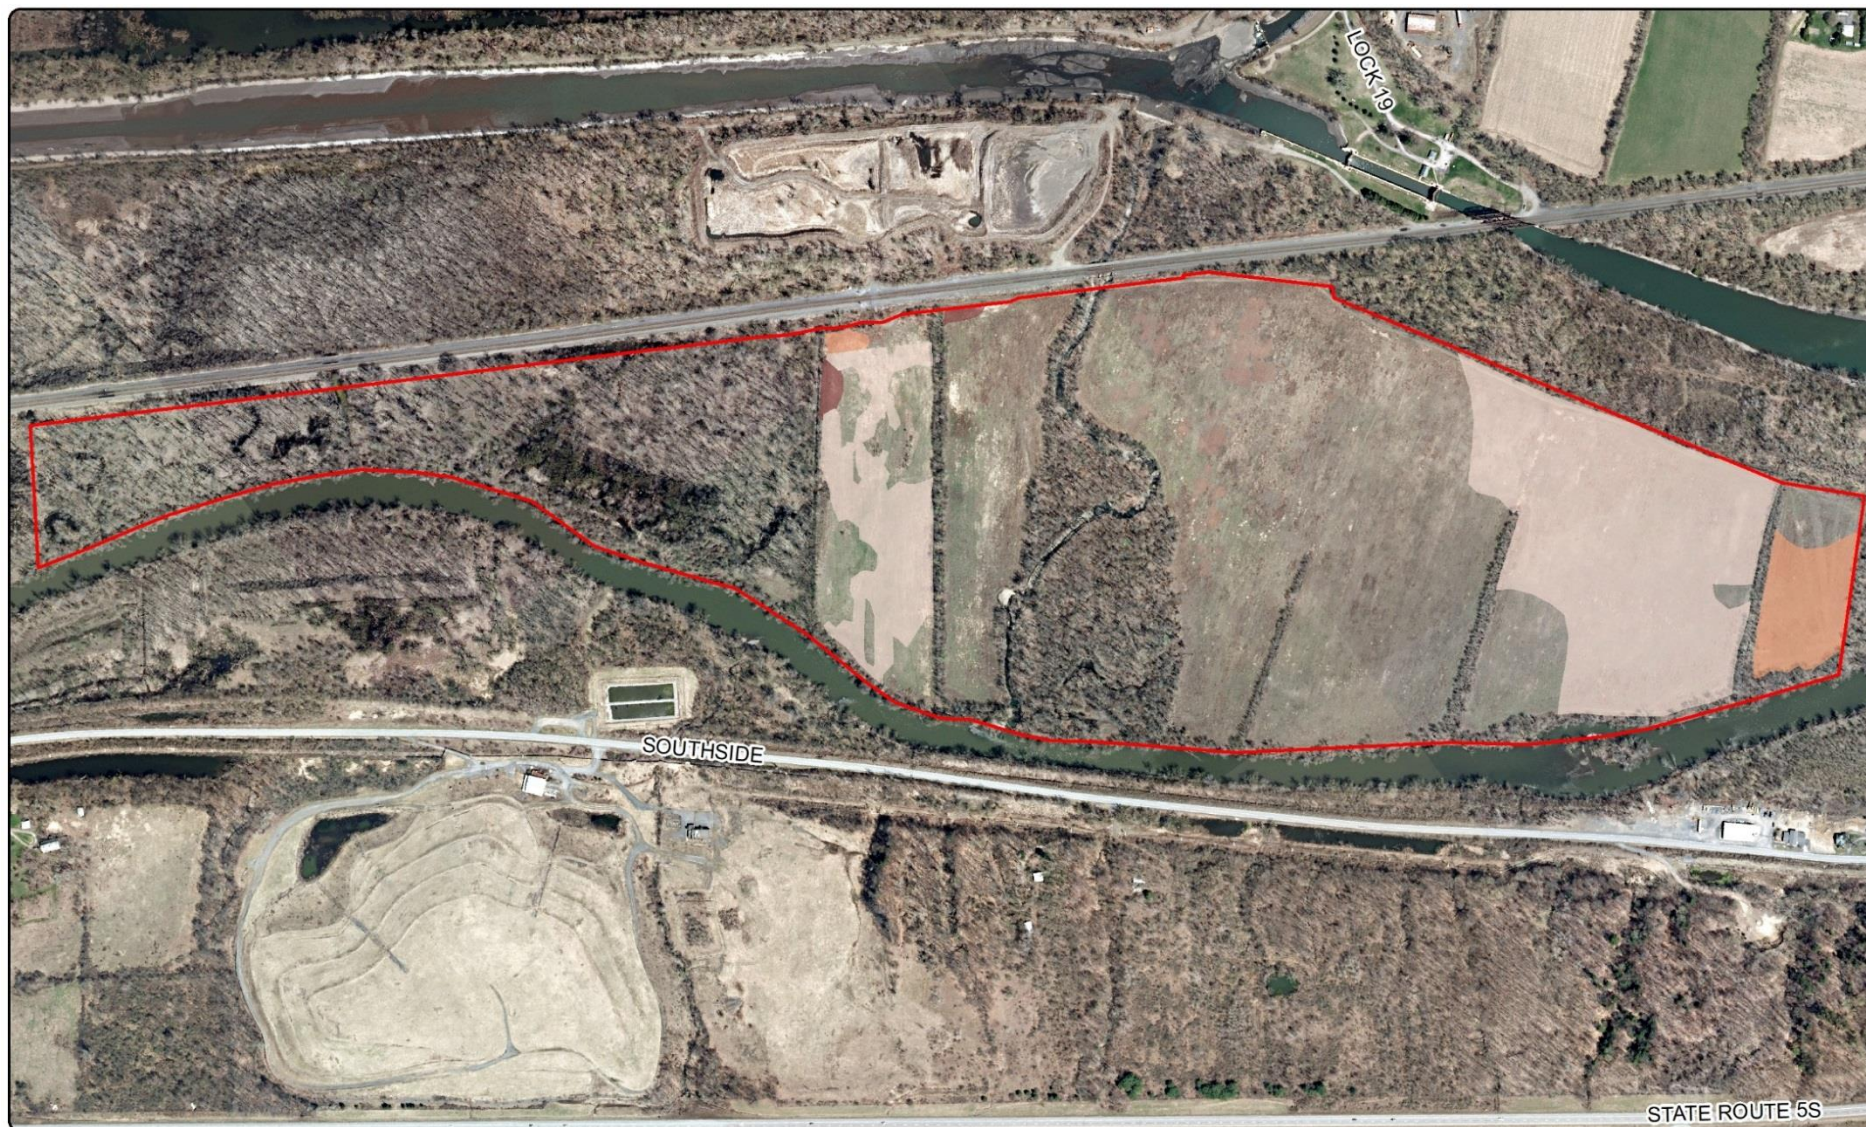
Figure 9: Mohawk River Preserve Invasive Species Cover Estimates, *Phragmites australis*, Giant Reed.

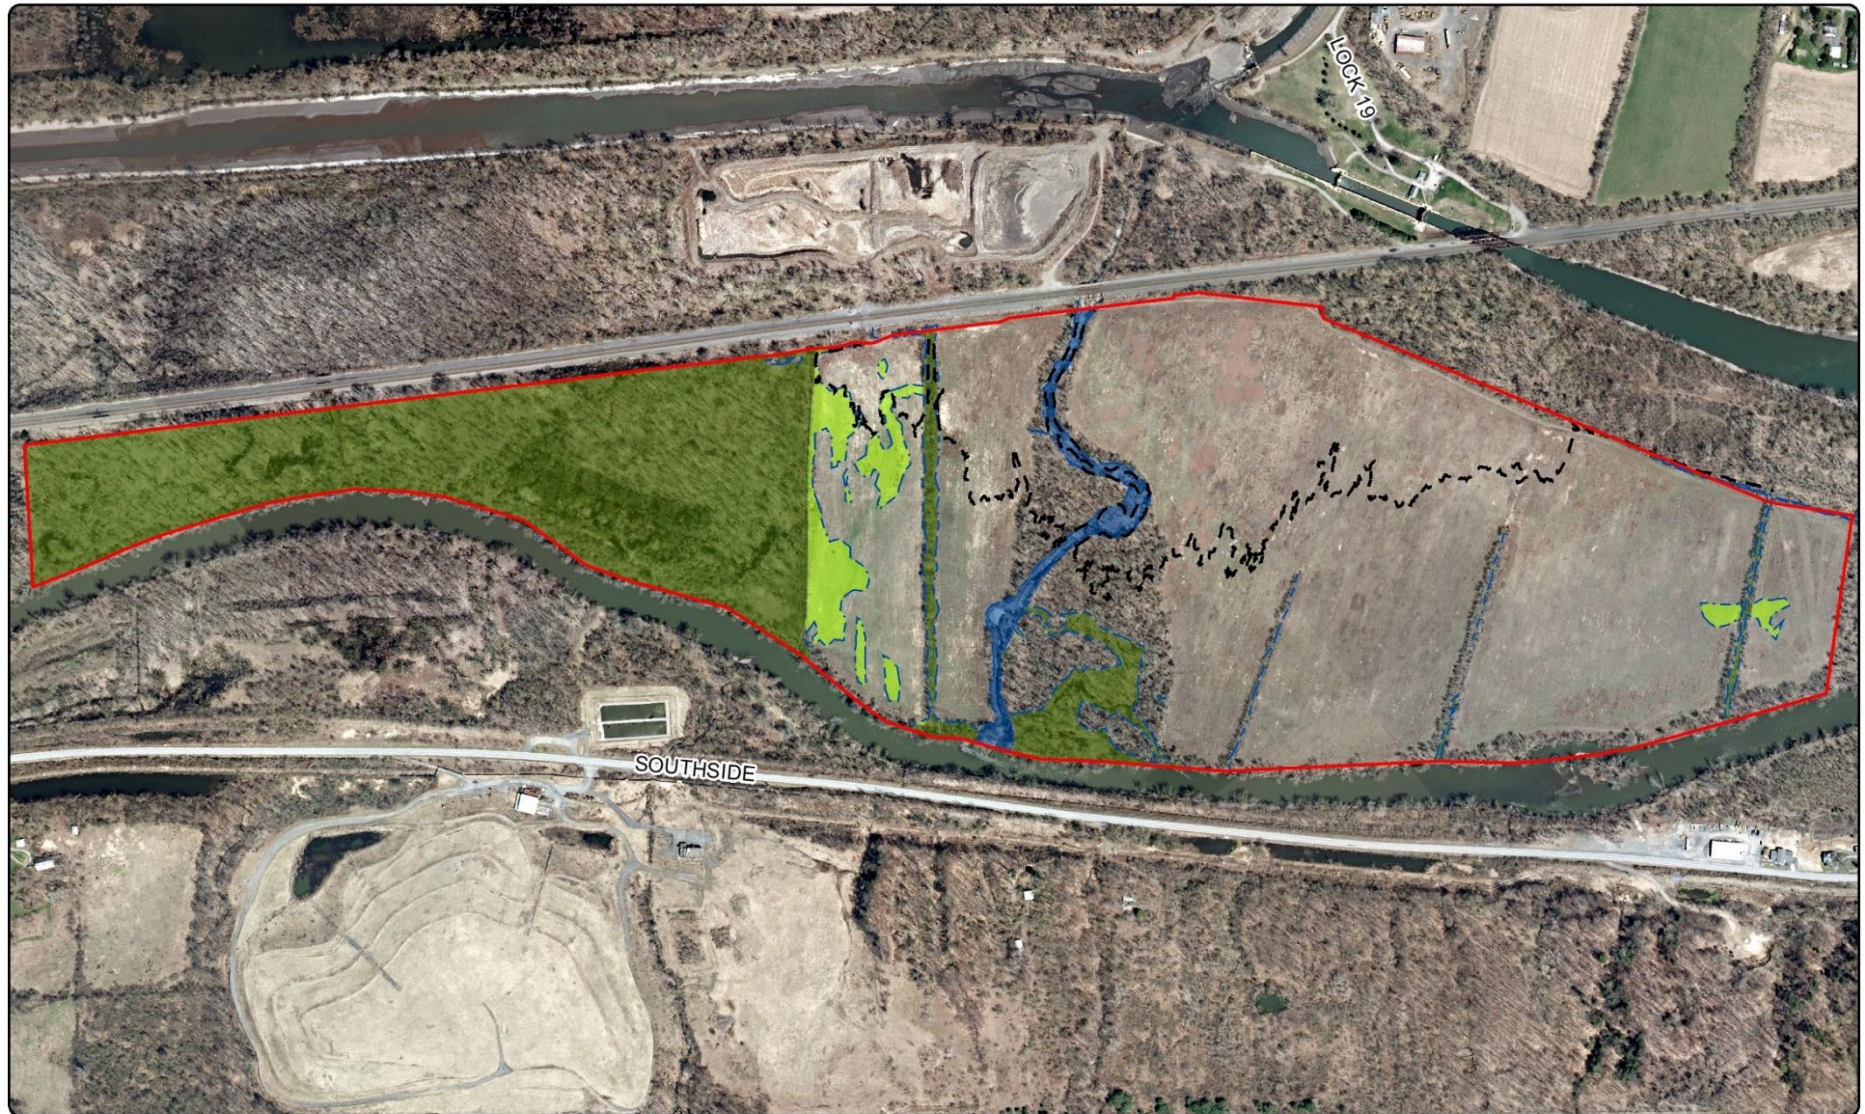
Figure 16. Extent of Flooding During a November 2019 Event.

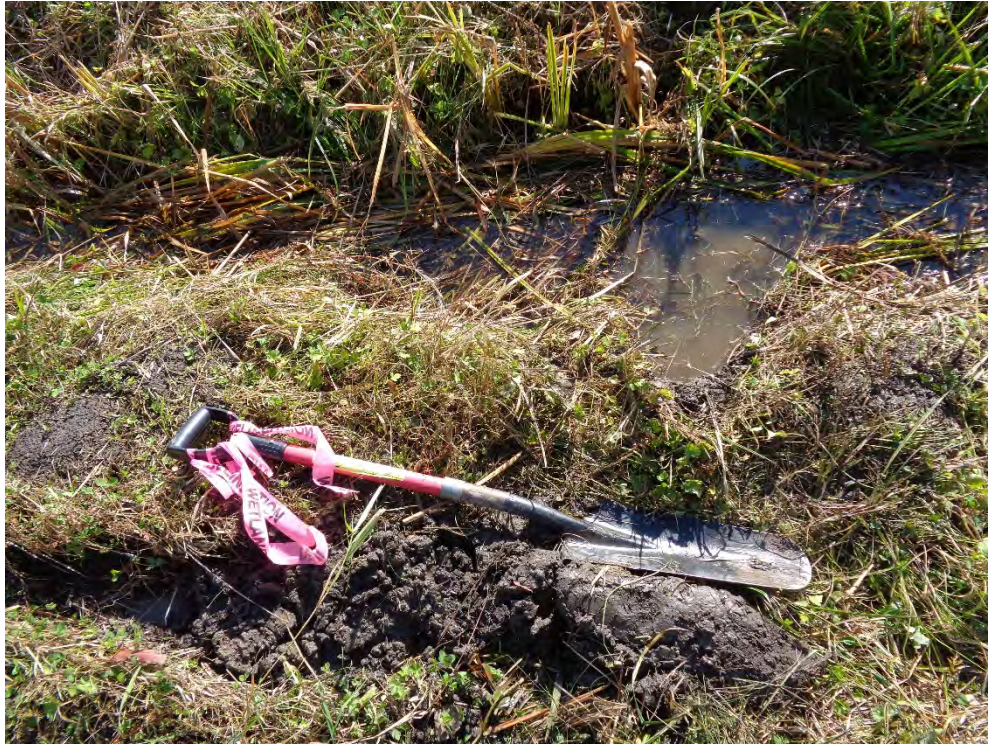
PHOTO 3 Atypical soil profile found at Wetland Point W1-Wet-1 within tilled field

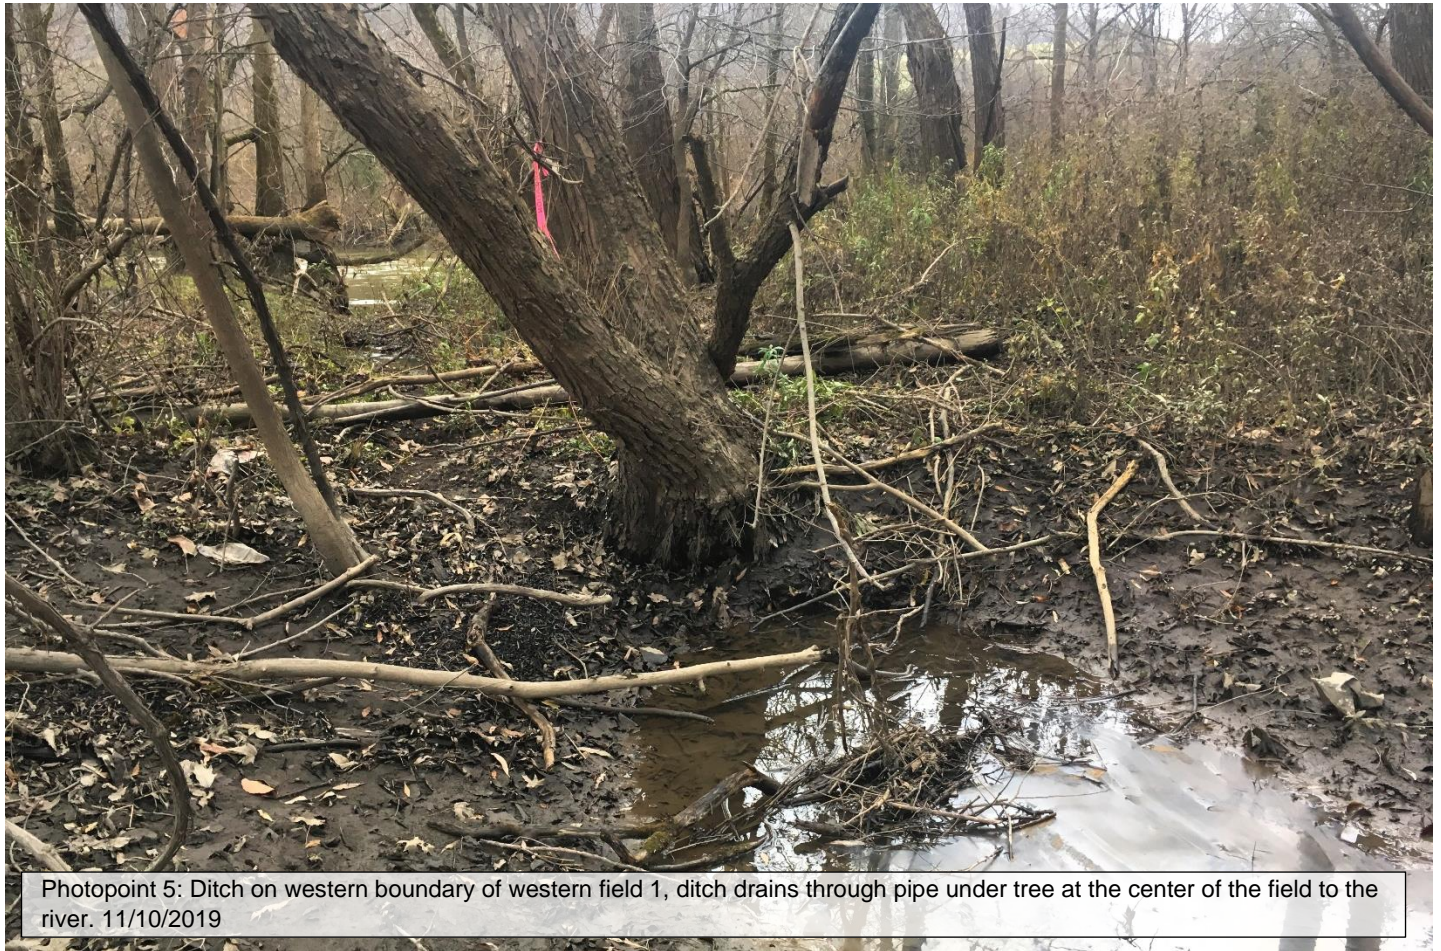
Photopoint 5: Ditch on western boundary of western field 1, ditch drains through pipe under tree at the center of the field to the river. 11/10/2019

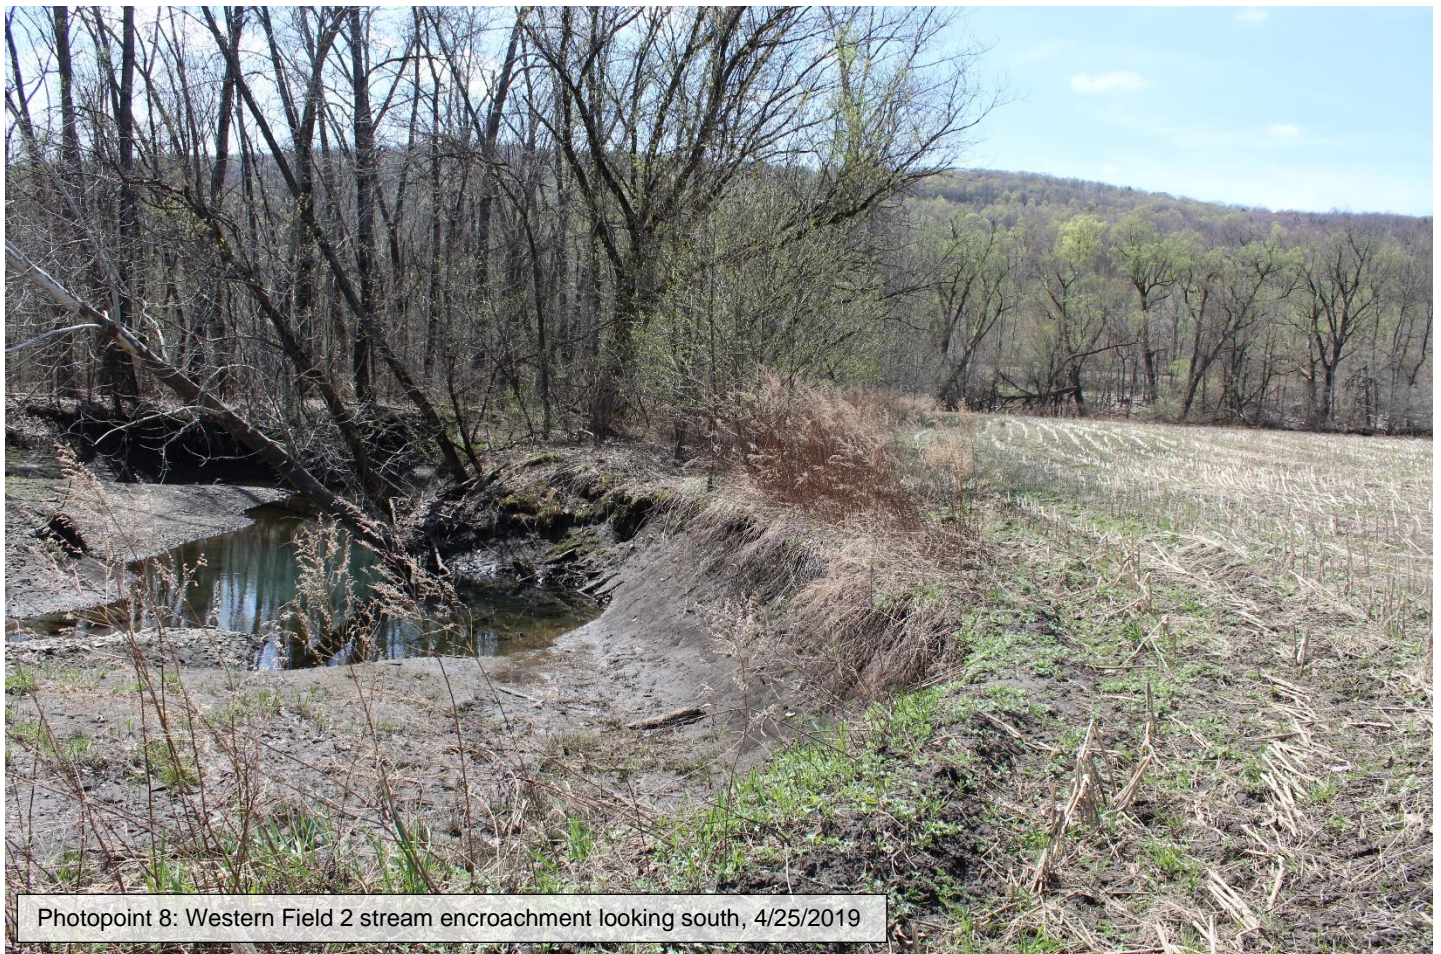
Photopoint 8: Western Field 2 stream encroachment looking south, 4/25/2019

A portion of Sterling Creek (Figure 2) centrally bisects the parcel and has a failing bank that is in need of corrective action. The streambank has eroded and is migrating into the adjacent field and destabilizing the stream reach. TWT will use a root-wad revetment technique that involves layering whole tree logs with attached root balls into the stream bank. All woody material will be sourced on-site. The root masses will be approximately 4 feet in diameter and attached to logs of at least 15-20 feet in length, with minimum diameter of 12 inches, and free from excessive rot. The entire tree will be used on the project site, to include the root mass/butt log, upper logs of the tree or lengths of wood to be used as foundation logs, and the tops to be used as brush filler material. Coir fabric will be utilized to retain soil layers required for the project. A combination of hardwood stakes and native willow cuttings will be utilized to secure the fabric into the soil lifts. All work will be done during low flow conditions, avoiding periods during or immediately following precipitation events. Work will be kept to a minimum and will be done as quickly as possible to minimize environmental impacts. As per DEC regulations, the in-stream work period for this site is from May 15th to September 30th. The sequence of construction activities is as follows:

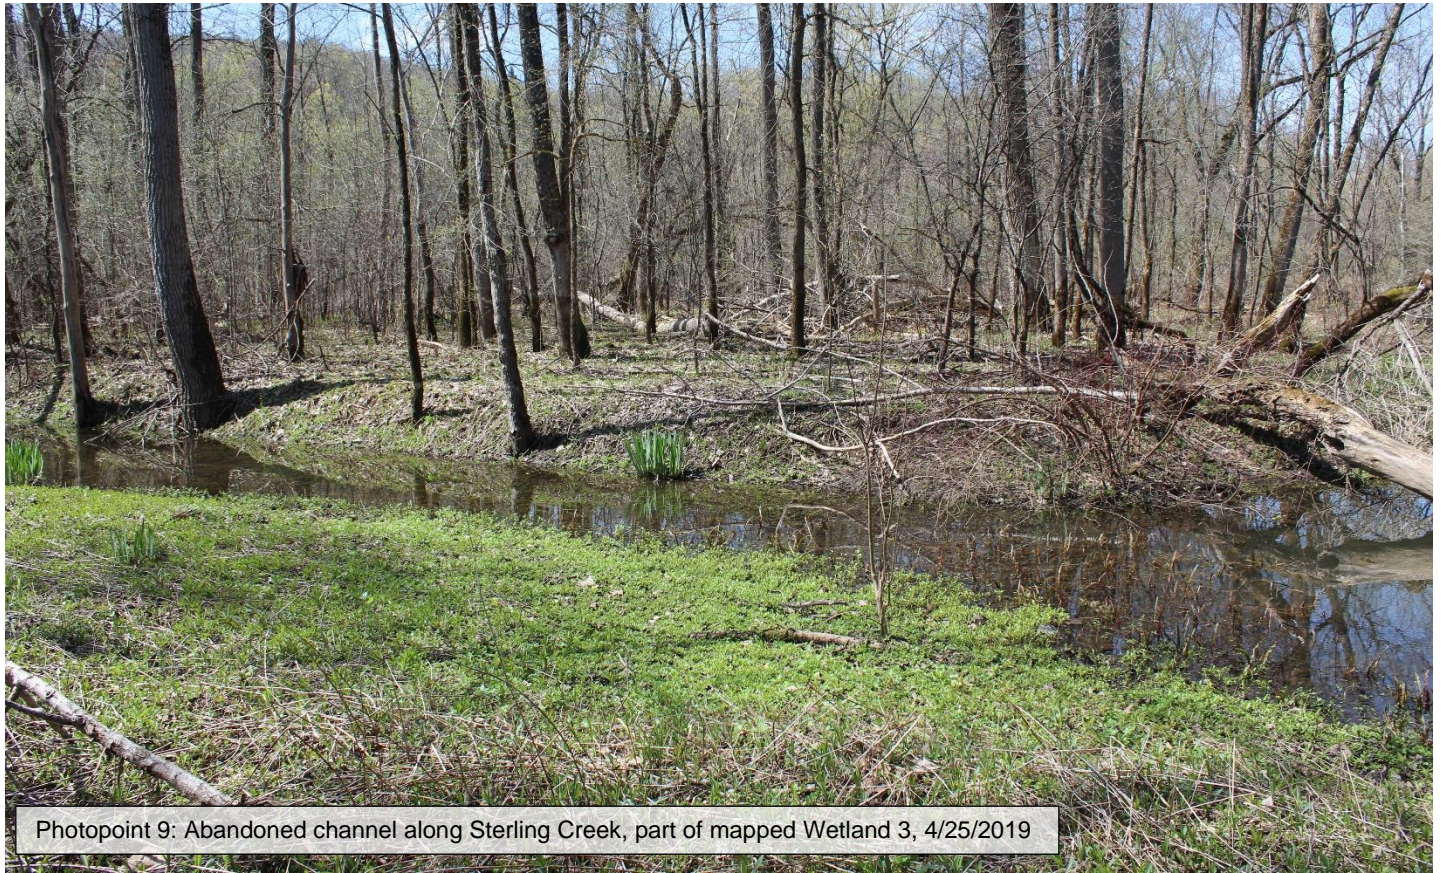
Photopoint 9: Abandoned channel along Sterling Creek, part of mapped Wetland 3, 4/25/2019

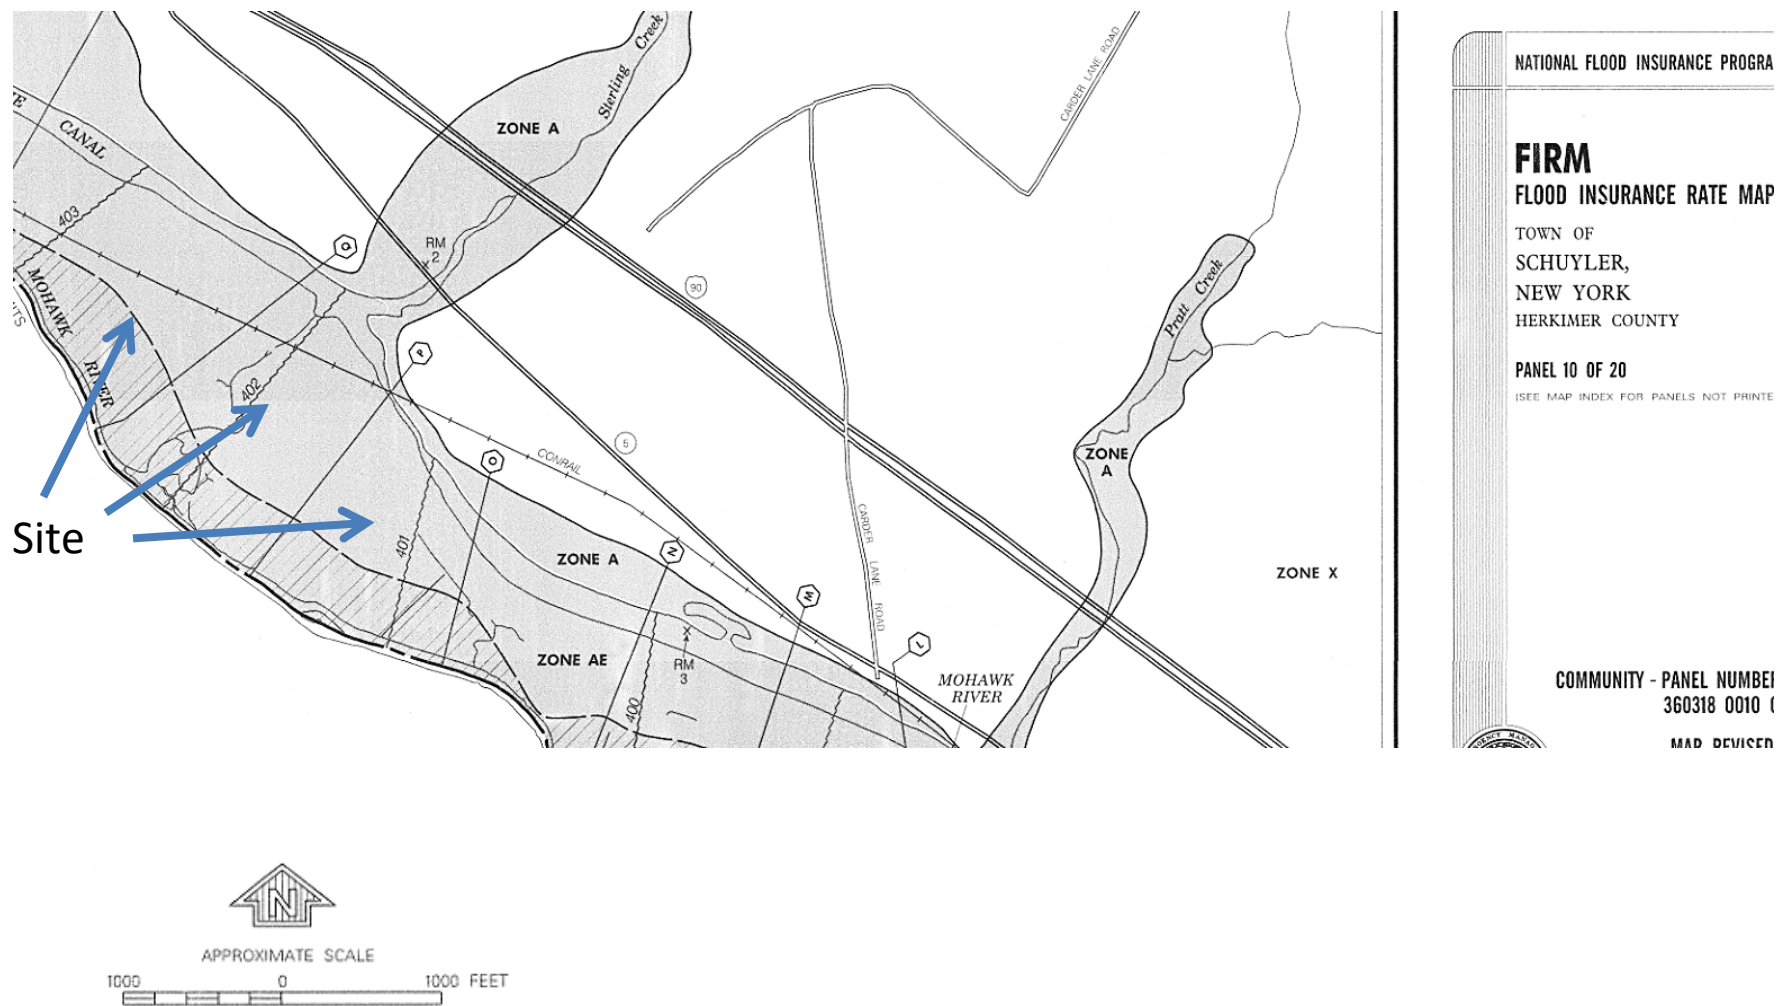
Figure 2: Portion of FEMA flood zone mapping that includes site. The entire property is within the 100-yr flood zone, with a few hundred feet along the Mohawk River in the floodway, where floodwaters are moving. [Elevations in this figure are in feet using Barge Canal Datum.]

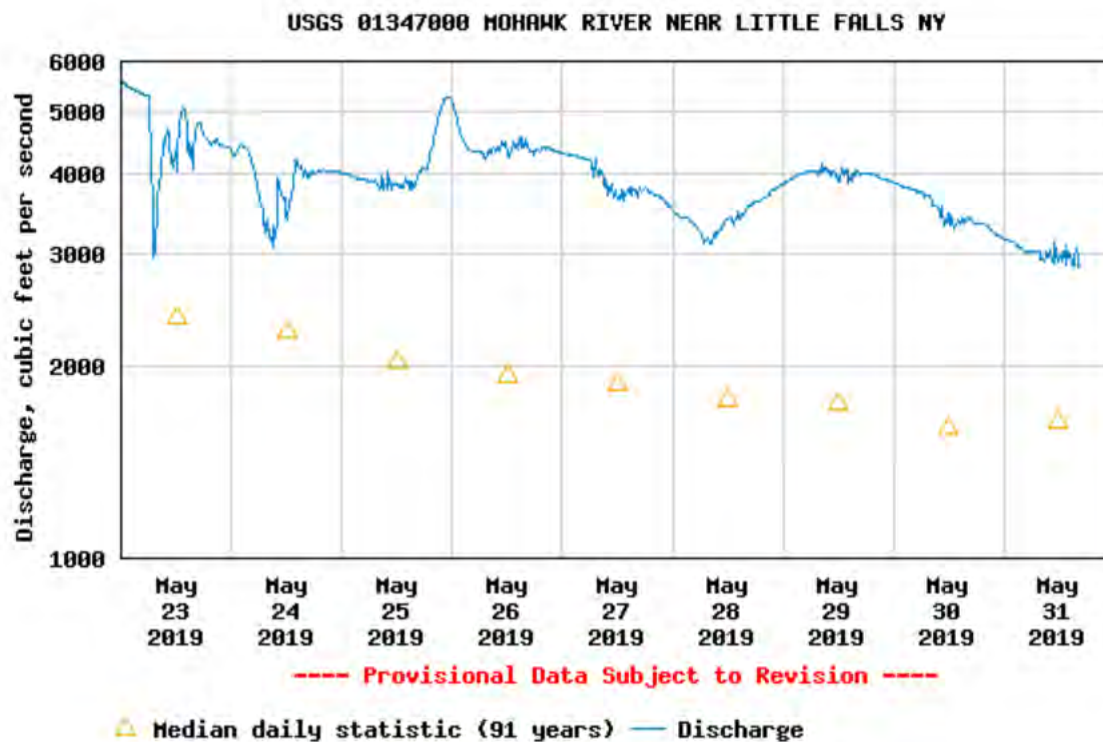
Discharge, cubic feet per second

Most recent instantaneous value: 2880 05-31-2019 16:30 EST

Daily discharge, cubic feet per second -- statistics for May 31 based on 91 years of record [more](#)

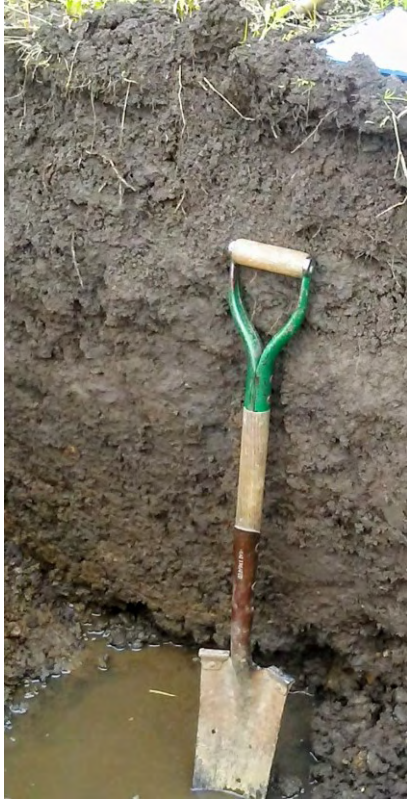
<u>Horizon</u>	<u>Depth</u>	<u>Description</u>
Ap	0-8"	Very dark grayish brown (10Y 3/2) silt loam; strong medium granular structure; many fine & medium roots; abrupt smooth boundary.
Bg1	8-18"	Very dark grayish brown (10Y 3/2) silt loam; 10% medium distinct 7.5YR 4/4 Fe accumulations as soft masses, plus 1% as fine root stains); moderate medium blocky structure; few very fine roots; clear smooth boundary.
Bg2	18-27"	Dark gray (10YR 4/1) silt loam, with 10% coarse distinct 10YR 6/6 Fe concentrations as soft masses; weak medium subangular blocky structure; few fine roots; clear smooth boundary.
2C	27-36"	Dark brown (7.5Y 3/2) gravelly silt loam; 30% coarse distinct 7.5YR 5/6 Fe concentrations as soft masses, with 5% coarse faint 10YR 4/2 depletions on ped faces; weak medium subangular blocky structure; few fine roots; clear wavy boundary.

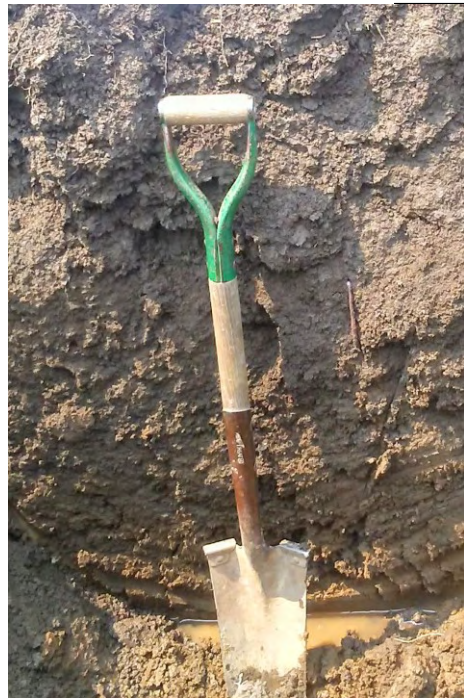
<u>Horizon</u>	<u>Depth</u>	<u>Description</u>
Ap	0-7"	Very dark gray (7.5YR 3/1) silt loam; strong medium granular structure; common fine and medium roots; abrupt smooth boundary.
Bw	7-15"	Very dark gray (7.5YR 3/1) silt loam; moderate medium subangular blocky structure; common fine roots; clear smooth boundary.
Bg1	15-26"	Dark gray (7.5YR 4/1) silt loam, with 15% fine distinct 7.5YR 5/4 Fe concentrations as soft masses and few root stains; moderate medium subangular blocky structure; few fine roots; clear smooth boundary.
Bg2	26-40"	Dark gray (7.5YR 4/1) silt loam, with 20% fine distinct 7.5YR 5/4 Fe concentrations as soft masses; weak medium subangular blocky structure; clear smooth boundary.
Cg	40-42"	Mixed dark gray (7.5Y 4/1) and brown (7.5YR 5/4) silt loam, with Fe concentrations as soft masses; silt loam; weak medium subangular blocky structure.

This is not a hydric soil.
