ARTHUR KILL 3

US Army Corps of Engineers
NEW YORK DISTRICT

NOISE MONITORING REPORT
EASTERN SHORE

(WEEK OF APRIL 15, 2013– APRIL 21, 2013)

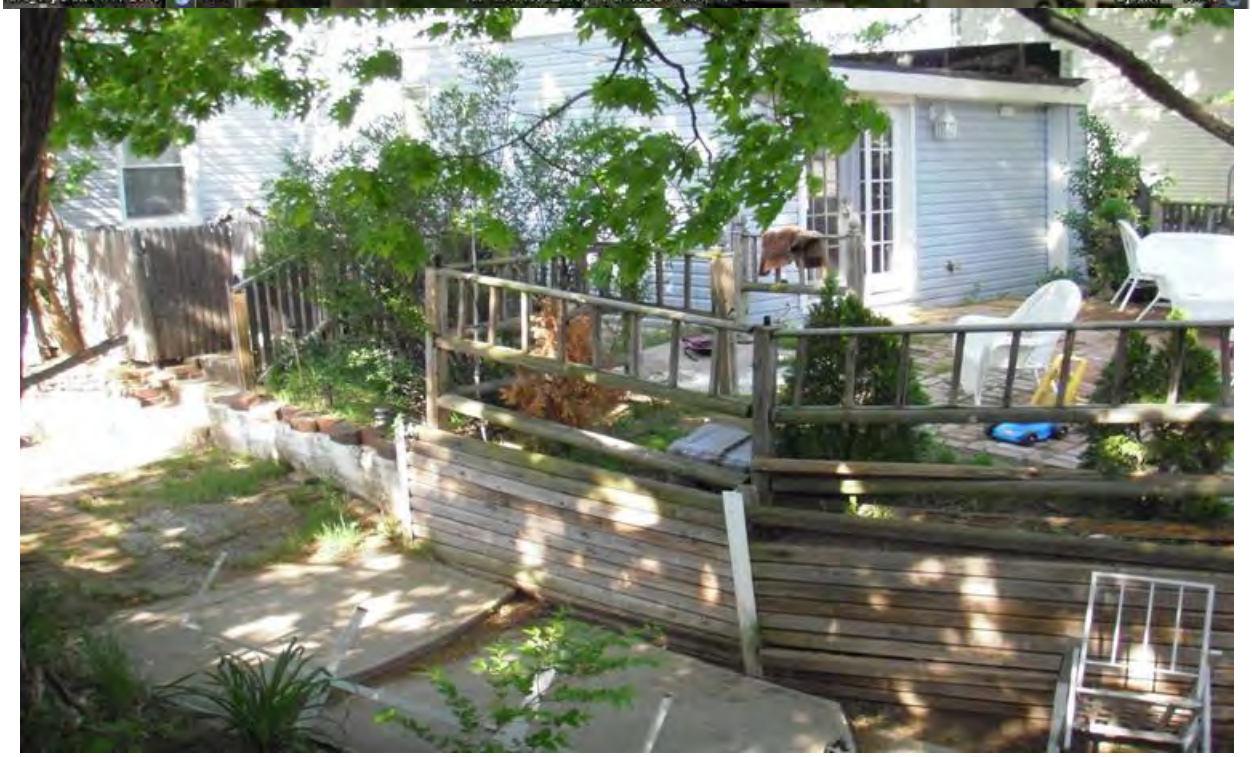
Site NAK-4: 3290 Richmond Terrace, (KVK 9 - Staten Island, NY)

This area includes single family residences. This site was retained in case of dredge activities in the AK2 area of the project grid. The location is within the first block of residences, slightly set back from Richmond Terrace. The microphone is located in the backyard of the house located in the southeast corner of Northfield and Richmond Terrace.
