ARTHUR KILL 1 AND 2

US Army Corps of Engineers
NEW YORK DISTRICT

NOISE MONITORING REPORT
EASTERN SHORE

(WEEK OF JANUARY 28, 2013– FEBRUARY 3, 2013)

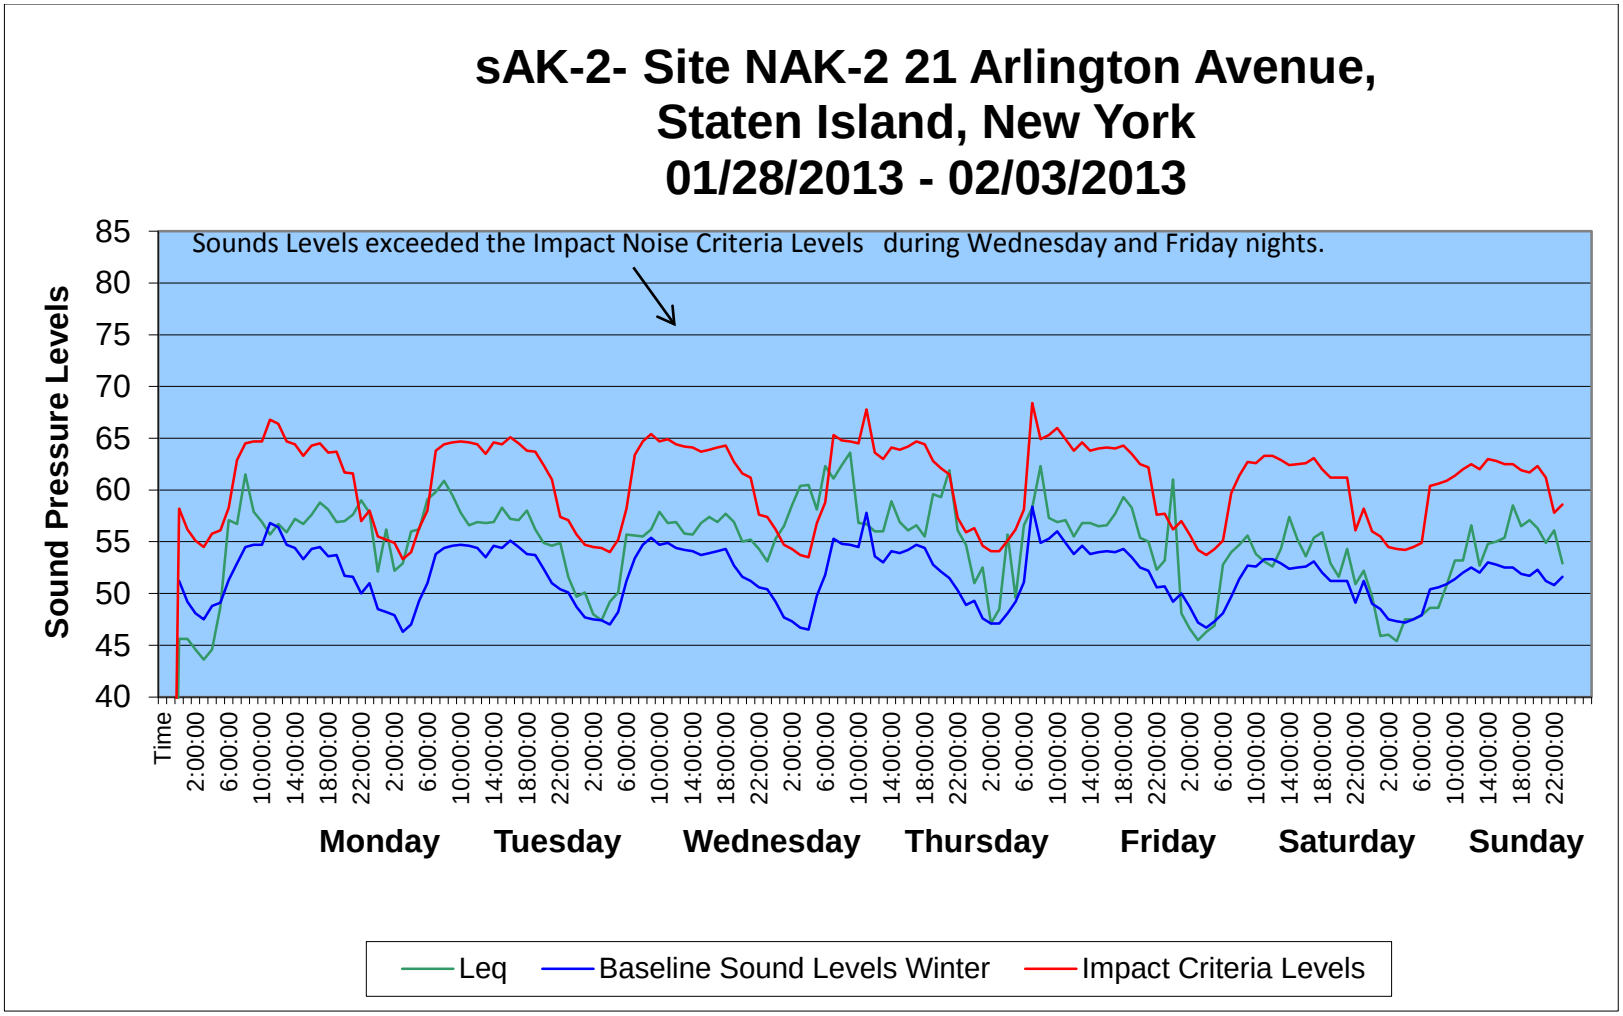
sAK-2- Site NAK-2 21 Arlington Avenue,
Staten Island, New York
01/28/2013 - 02/03/2013
Sounds Levels exceeded the Impact Noise Criteria Levels during Wednesday and Friday nights.
Sound Pressure Levels
85
80
75
70
65
60
55
50
45
40
Time
Monday
Tuesday
Wednesday
Thursday
Friday
Saturday
Sunday
Leq
Baseline Sound Levels Winter
Impact Criteria Levels
