**US Army Corps  
of Engineers®**  
New York District

# **NEW YORK AND NEW JERSEY HARBOR DEEPENING CHANNEL IMPROVEMENTS**

### **INTEGRATED FEASIBILITY REPORT & ENVIRONMENTAL ASSESSMENT**

## **APPENDIX B3: Structural**

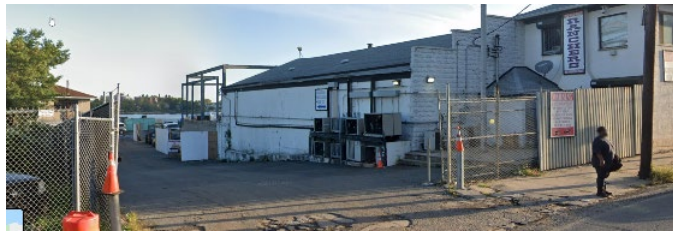
*Figure 1.4.1- 18: New addition under construction at the location of **KVK-302**.*

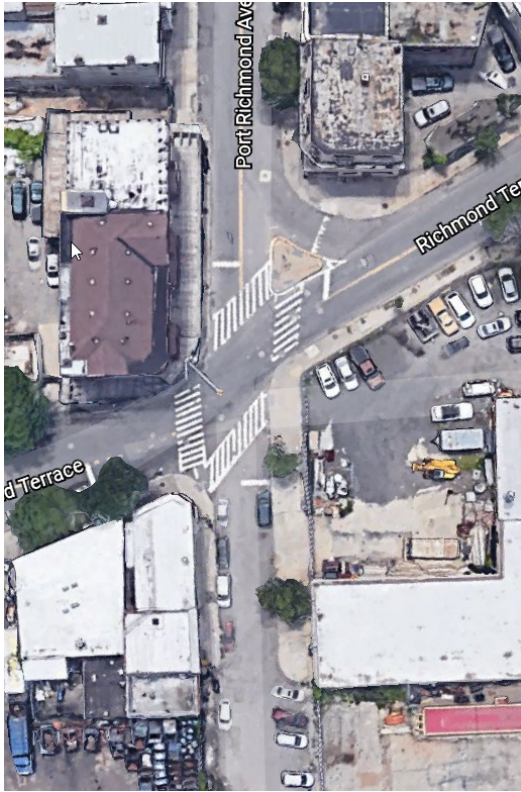
Figure 1.4.1-26: This is an aerial blowup of the buildings north of Construction Co., KVK-307.

**Building 3.** The shorter portion of the building is approximately half a story taller than the building that was documented in the report by the Master Harbor Partnership. The taller portion of Building 3 appears to remain unchanged from the condition captured in the report by the Master Harbor Partnership. (Yellow outline from Figure 1.4.1-27)

**Building 4.** The building remains largely unchanged from the condition captured in the report by the Master Harbor Partnership. (Green outline from Figure 1.4.1-27)

**Building 5.** The building appears to be currently undergoing a façade repair and has sidewalk bridging installed. (Blue outline from Figure 1.4.1-27)

Building 7. This building appears to be in similar condition to what was documented in the report by the Master Harbor Partnership. (Pink outline from Figure 1.4.1-27)

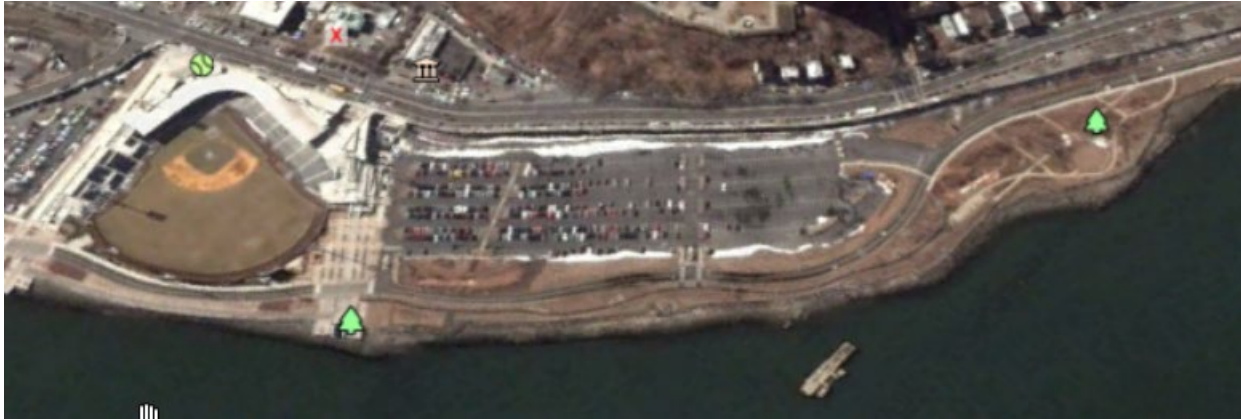
*Figure 1.4.2- 3: The above photo captures the area to the west of the Staten Island Yankees Baseball Stadium in 2004.*

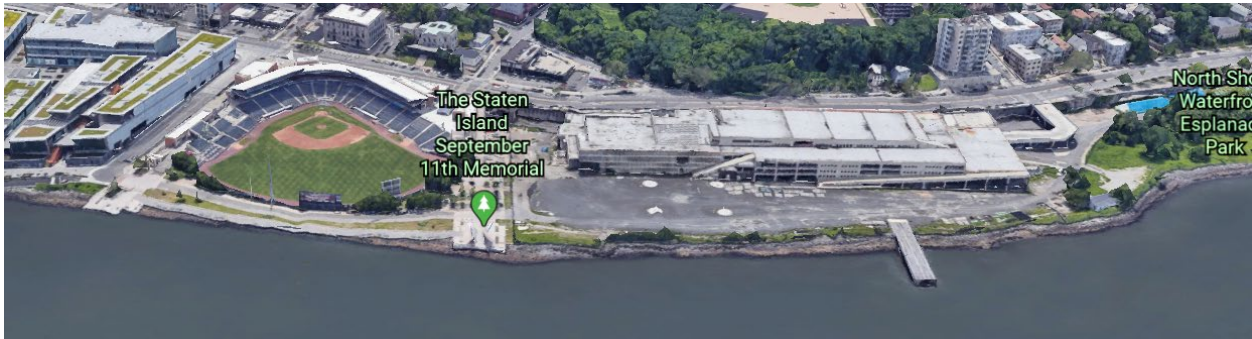
*Figure 1.4.2- 4: The above photo captures the area to the west of the Staten Island Baseball Stadium.*

The Staten Island September 11<sup>th</sup> Memorial has been installed along the shoreline since the Master Harbor Partnership report. A small pier or bulkhead was constructed to the west of the Memorial that will require more information to confirm if there is any impacts to the blasting/dredging efforts..
