HUDSON RIVER HABITAT RESTORATION

**ECOSYSTEM RESTORATION
FINAL INTEGRATED FEASIBILITY REPORT AND
ENVIRONMENTAL ASSESSMENT**

Appendix C: Plan Formulation

**U.S. ARMY CORPS OF ENGINEERS
NEW YORK DISTRICT**
August 2020

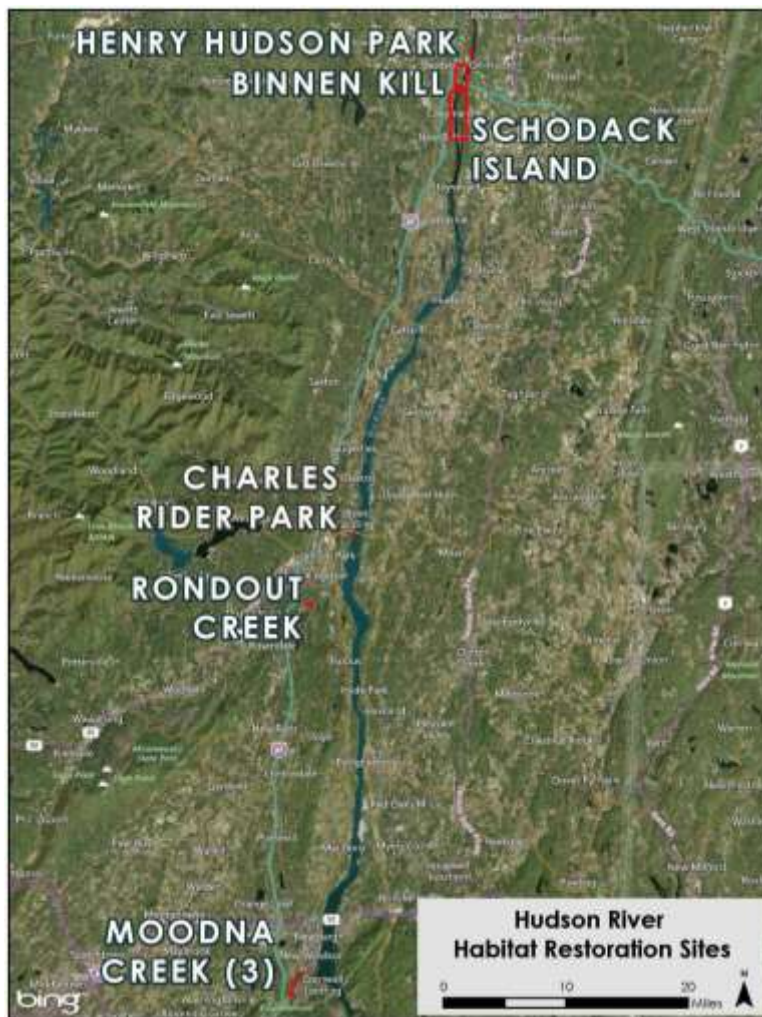
Figure 1-1: Final Array of Six Sites.

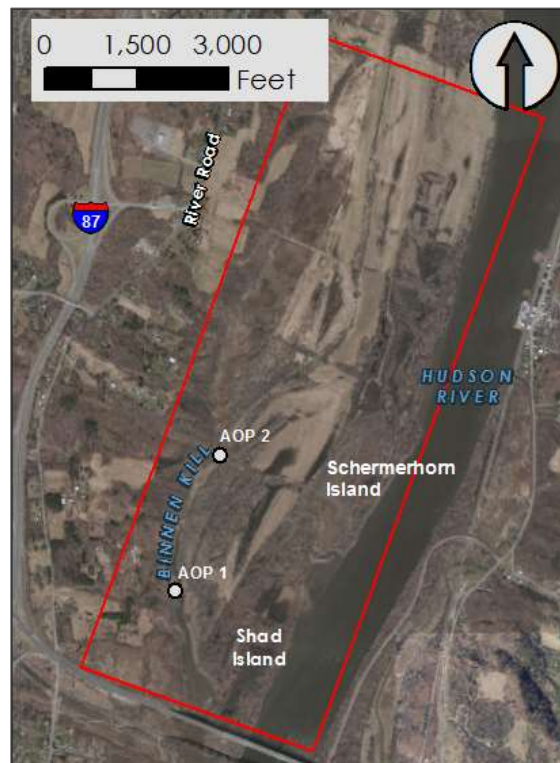
Figure 2-1: Binnen Kill site overview.

The Binnen Kill site is located on the western shore of the Hudson River on the border of the Towns of Bethlehem and Selkirk, NY, and encompasses approximately 1,000 acres of publicly- and privately-owned lands (Figure 2-1). The eastern edge of the site originally included islands that were separated from the historic shoreline by side channels in the 1800s but that are now contiguous with the site due to dredged material infilling. Binnen Kill is a tidal freshwater tributary that is surrounded by a complex of on-site tidal wetlands, upland forests, non-tidal wetlands and swamps, farmland, and farm roads. The original islands, Shad and Schermerhorn, are designated a Significant Coastal Fish and Wildlife Habitat by NY State, and include resident and migratory fish spawning and nursery habitat, habitat for protected birds, and rare plant species and communities (NYSDEC, 2017; USFWS, 1997).

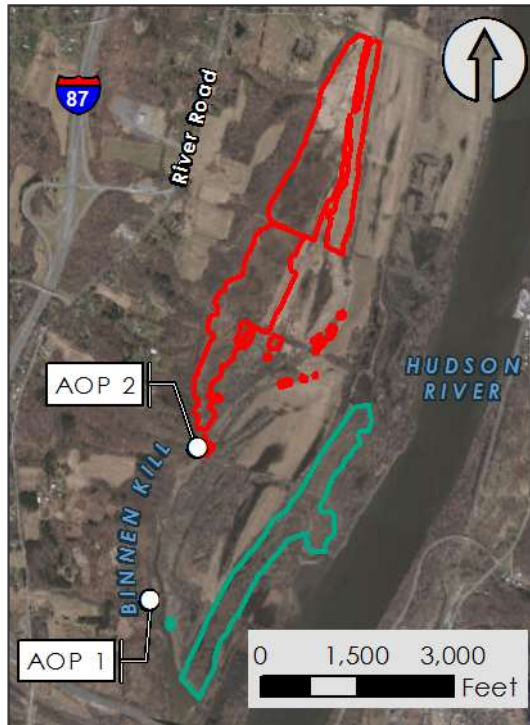
Figure 2-3: Binnen Kill site project components, north (red) and south (green), and AOP locations.

For the purpose of this project, the Binnen Kill site was broken into two components, north and south (Figure 2-3). The north component includes AOP 2 and approximately 90 acres of various vegetation communities including *Phragmites australis* (common reed) and *Phalaris arundinacea* (reed canary grass). The land is privately held, however Scenic Hudson, an environmental group that preserves land and farms, owns the majority of land or holds conservation or access easements on some of the privately-owned land within the project footprint (Appendix I - Real Estate). Topographic data derived from LiDAR (Light Detection and Ranging) indicates that the average ground elevation in the north project footprint is 5.5 to 6 feet (NAVD88) with elevations up to 8 feet (NAVD88). The south component footprint is on New York State-owned lands and roughly overlaps the historic side channels that were infilled with dredged material. The footprint is comprised of emergent and forested non-tidal wetlands, tidal wetlands, and forested uplands with a dense understory of *Phragmites australis*. According to LiDAR data, the ground elevation ranges from 0.5 to 7 feet (NAVD88).

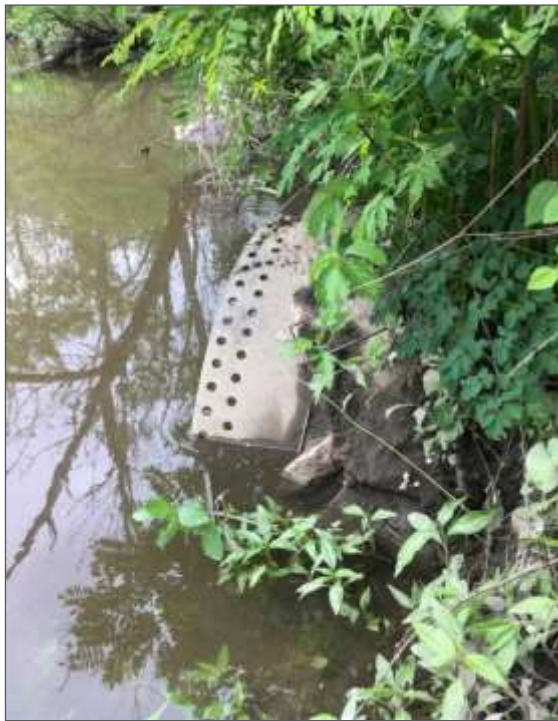
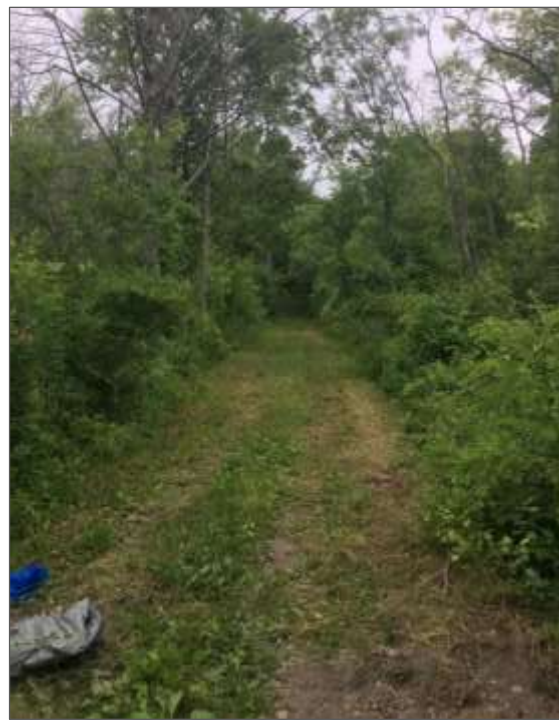
Photograph 1 (Top). View of AOP 1 top of bridge. Photograph 2 (Below). View of AOP 2 metal pipe (left) and earthen road above the pipe (right).

Binnen Kill proper has both tidal and non-tidal portions. The tidal portion begins at its confluence with the Hudson River below Castleton Bridge and extends upstream for approximately 7,500 feet. A bridge (AOP 1) and culvert crossing (AOP 2) span this segment of the stream (Photographs 1 and 2). Monitoring of water surface elevations immediately upstream of each crossing from June to November 2018 confirms that the tidal datum (e.g. MLLW and MHHW) elevations are not truncated by the infrastructure. The head of tide is upstream of AOP 2 and outside of the project area.

Supplemental site survey cross sections were collected at AOP 1 and AOP 2; refer to Appendix B - Engineering for additional information. AOP 1 is a steel girder supported bridge with a clear span approximately 45 feet in width (Photograph 1). Based on the cross sections and field observations, it is the professional opinion of the study team that AOP

1 does not affect the hydrology of Binnen Kill and does not function as a barrier to aquatic organism passage during normal flows. AOP1 was therefore removed from consideration. AOP 2 is a round metal pipe with an approximate diameter of 56 inches that conveys flow under a primitive earthen road (Photograph 2). During low to normal flows the crossing could be a barrier to aquatic organism passage.

The culvert at AOP 2 would be enhanced to ensure passage by aquatic organisms and was thought to improve hydrology within the Binnen Kill tributary. The metal pipe would be replaced with a box culvert with a stream substrate bottom. The road surface over the culvert would support farm equipment and all-terrain vehicles. Floodplain culverts would be installed on either side of the culvert to increase flow conveyance.

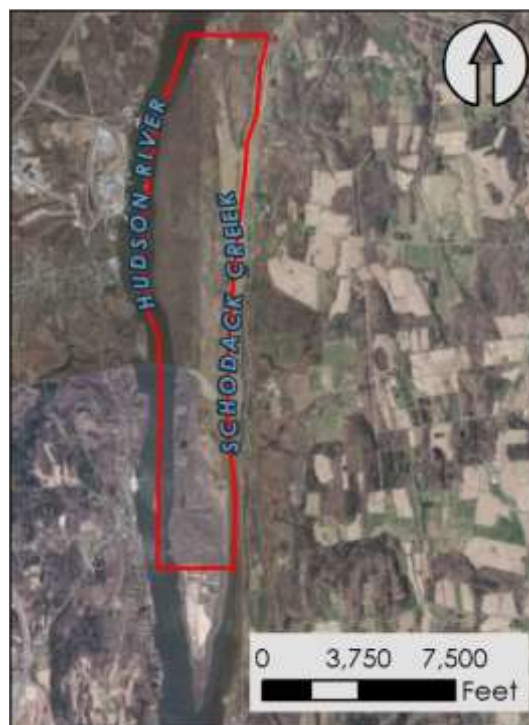
Figure 2-4: Schodack Island site overview.

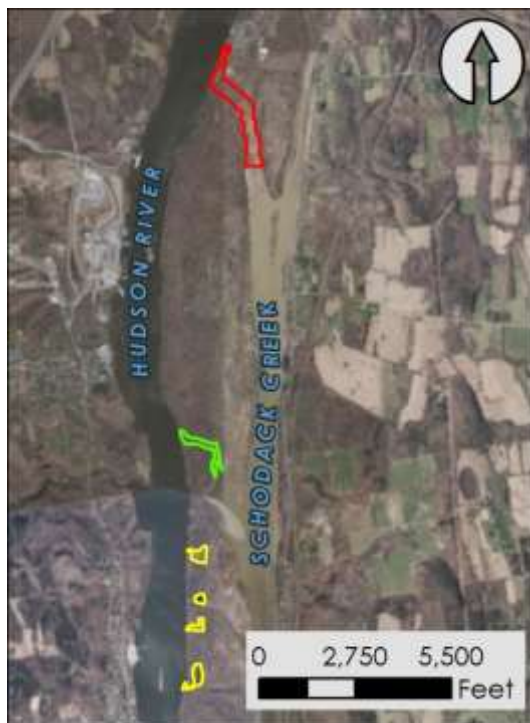
Figure 2-6: Schodack Island project components, north (red), south (green), and pocket wetlands (yellow).

For the purpose of this project, the project site was broken into three components: north, south, and pocket wetlands (Figure 2-6). The north and south component footprints each overlap with historic side channels that were infilled with dredged material. Currently, the north footprint includes marginal tidal pocket wetlands along the Hudson River, tidal floodplain wetlands along a Schodack Creek tributary (Photograph 3), and upland separating the aforementioned wetland areas. The south footprint includes timber and rock bulkhead reinforced shoreline with marginal

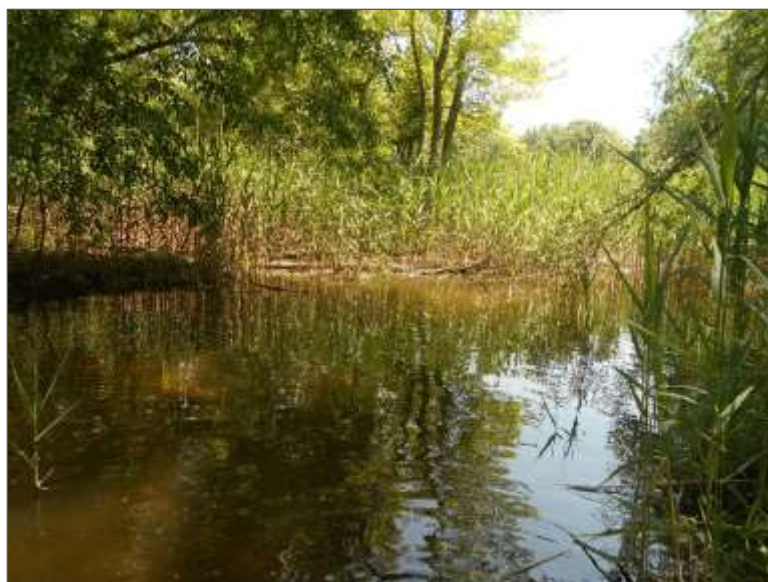
Photograph 3: Typical Schodack Creek tributary conditions. View from north component footprint.

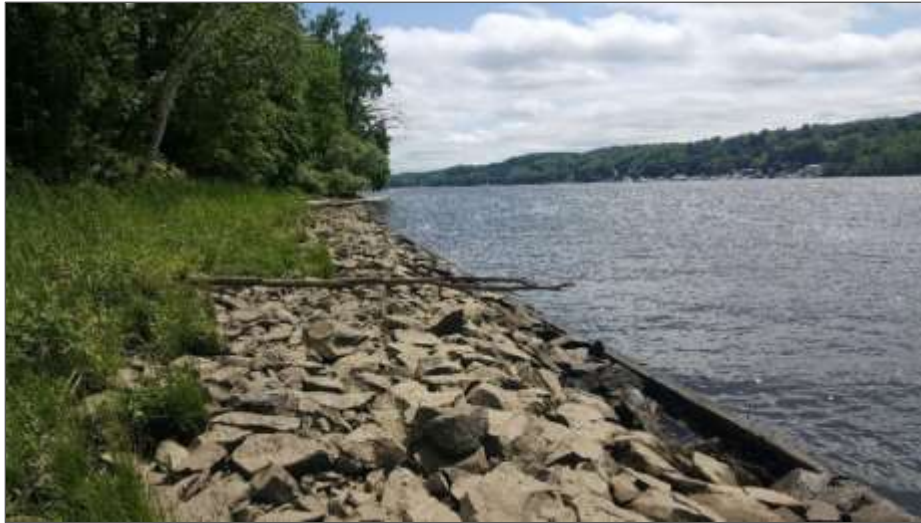
Photograph 4: Typical Hudson River shoreline with intact bulkhead.

Field investigations were conducted within the Park boundary which included collection of supplemental topographic cross sections along the Hudson River shoreline, a visual assessment of bulkhead condition, and an inventory of shoreline cover types. A timber and rock bulkhead is present along the majority of the Hudson River shoreline (Photograph 4). The bulkhead structure is mostly intact, however, there is an approximately 2,000-foot-long shoreline segment where incipient structural failure has occurred. In areas where the bulkhead is intact or failing, either a narrow band of wetland vegetation or upland forest is landward of the structure. For approximately 2,300-

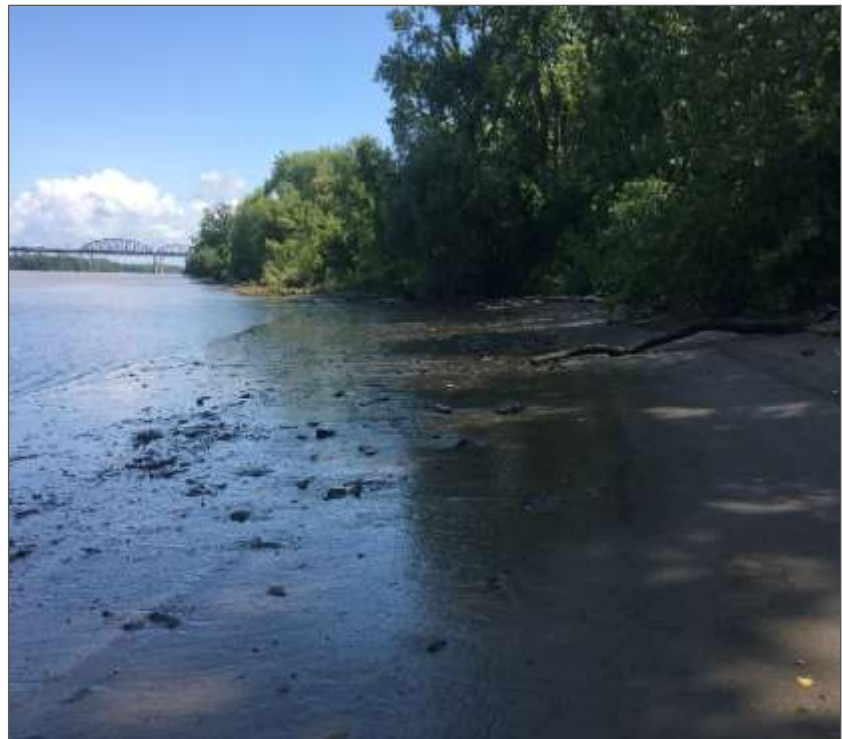
Photograph 5: Typical Hudson River unprotected shoreline.

feet just south of the north component footprint, the shoreline is unprotected (Photograph 5) and consists of a sandy/silt beach of varying slope. Results of field investigations conducted in June 2018 are presented in Appendix B - Engineering.

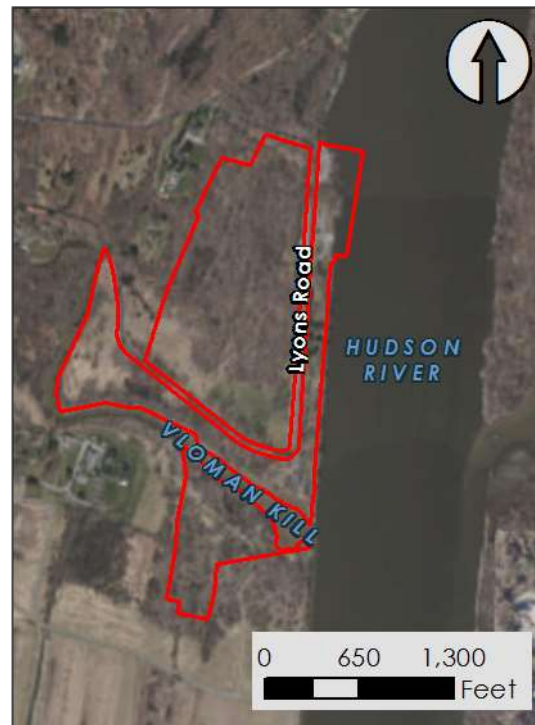
Figure 2-7: Henry Hudson Park Property Boundary.

Henry Hudson Park is public open space owned by the Town of Bethlehem and is located on the western shore of the Hudson River (Figure 2-7). The park's amenities include parking areas, a pavilion, boat launches for motorized craft, kayaks, canoes and other hand-powered craft, picnic areas, a softball field, a playground, a volleyball court, and a floating fishing platform. The park serves as the only public access location to the Hudson River within the Town of Bethlehem. Lyons Road traverses the park connecting it to other local residential roads and to NY Route 144 - River Road. The Vloman Kill traverses through the southern portion of the park and drains to the Hudson River; the area of the park to the south of the Vloman Kill is inaccessible by foot from the main area of the park.

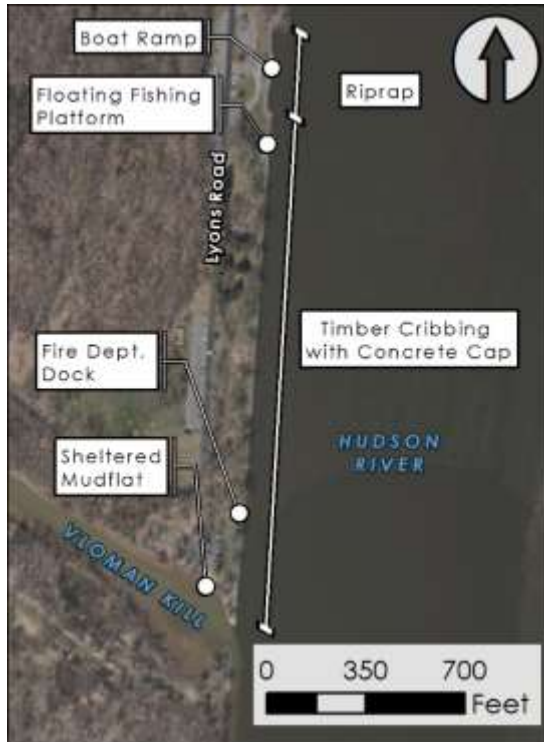
Figure 2-9: Shoreline Condition.

The park's shoreline varies in condition (Figure 2-9). The northern section of the Hudson River shoreline is lined with riprap and established vegetation

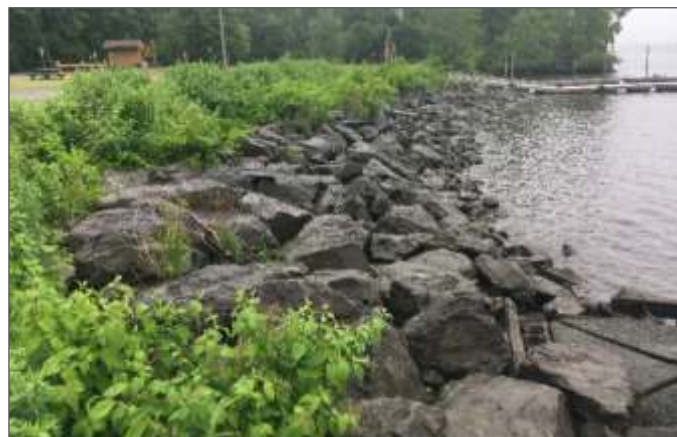
Photograph 6: View looking north at the riprap portion of the shoreline.

(Photograph 6). The riprap in this section is in good condition and no significant signs of erosion are present. Based on a supplemental site survey, the riprap portion of the shoreline has a slope of approximately 30 percent before transitioning to the river channel. Refer to the Engineering Appendix for detailed cross sections of the site. This portion of the shoreline also contains a boat ramp which, based on historic aerial imagery, was constructed between 1994 and 2004.

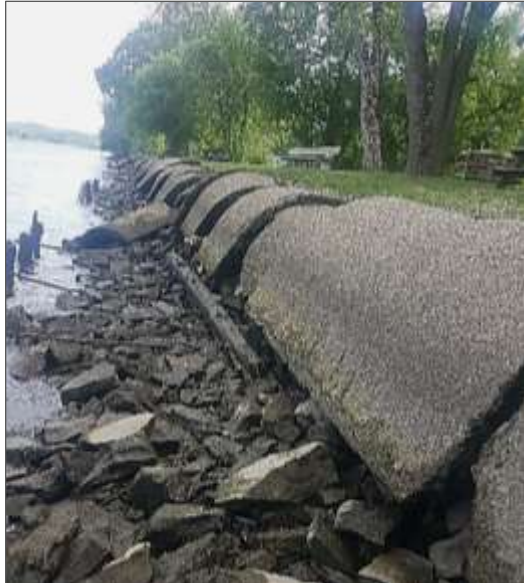
Photograph 7: View looking south at the timber cribbing with riprap and concrete capping.

The southern section of the Hudson River shoreline consists of a dilapidated timber cribbing structure, filled with riprap between two timber crib walls, and capped with convex concrete segments (Photograph 7). The majority of the structure has either partially or completely failed. The crib walls are severely decomposed, the concrete cap has detached and displaced, and riprap has moved from

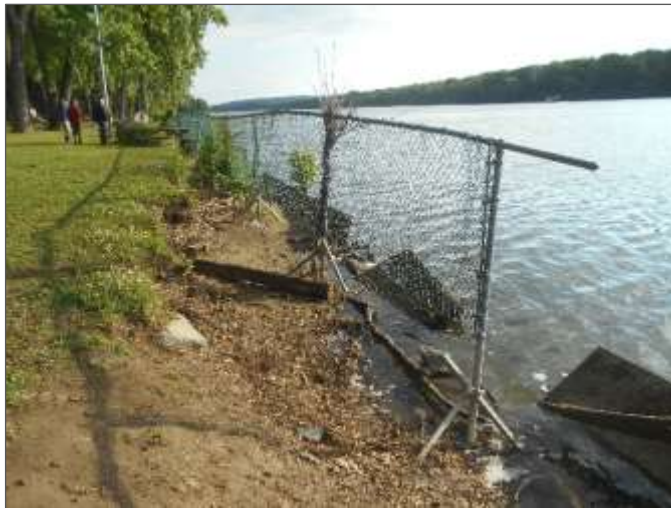
Photograph 8: View of upland areas of erosion.

between the crib walls into the river. In sections of complete structural failure, upland areas show signs of erosion and are inundated during high tides (Photograph 8). Supplemental site survey indicates that the grass area adjacent to the shoreline ranges in elevation from 5 to 9 feet (NAVD88) with an average slope of four percent. At the waterward edge of the grass, the topography undulates with the concrete capping and riprap decreasing 7 feet in elevation over approximately 15 to 20 feet. There is another steep drop off from the edge of the timber cribbing structure to the river channel.

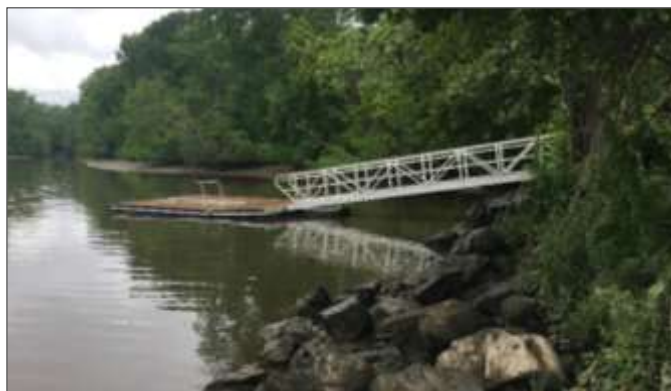
Photograph 9: View of cove area on the Vloman Kill.

The cove on the Vloman Kill contains an unvegetated, tidal mudflat area showing signs of erosion (Photograph 9). A floating dock with a kayak and canoe ramp is also anchored to the land.

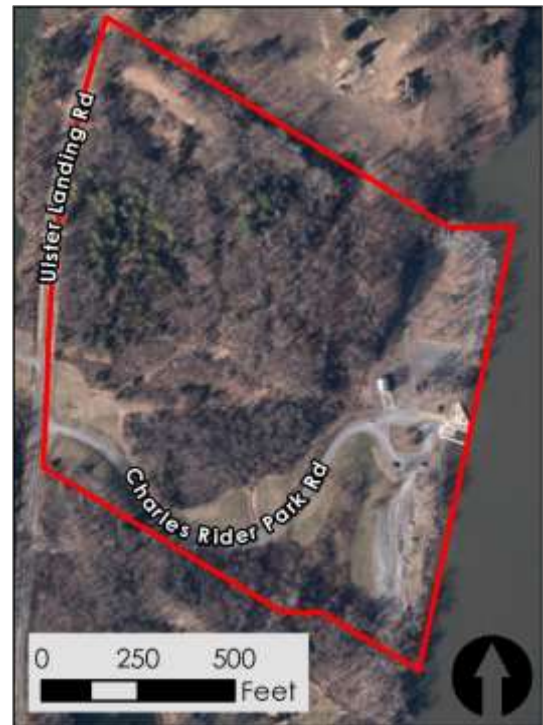
Figure 2-10: Charles Rider Park Property Boundary.

Charles Rider Park is a 29.6-acre public open space, located on the west shore of the Hudson River, owned by the Town of Ulster. The park's amenities include a paved access road and parking areas, a picnic area, and a boat ramp/docking structure. The only access road to the park is Charles Rider Park Road which runs east from Ulster Landing Road (Figure 2-10). Approximately 5.5 acres of the park is actively managed while the remaining area is primarily forested. The actively managed area of the park is located immediately adjacent to the Hudson River and is relatively flat, ranging in elevation from approximately 5 to 7 feet (North American Vertical Datum of 1988, NAVD88). The actively managed area is bounded to the west by forested steep slopes, quickly reaching elevations of 30 to 65 feet (NAVD88). Parking areas and internal roadways run close to the shoreline, separated from the shoreline edge by 15 to 50 feet of maintained grass.

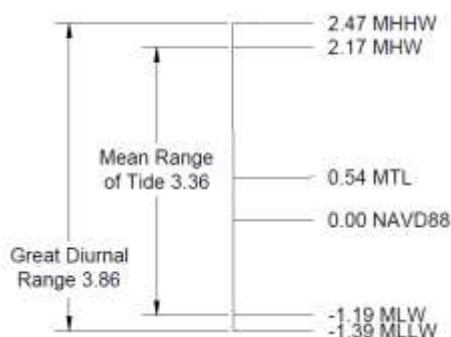
Figure 2-11: Tidal Stages Relative to NAVD88, feet.

The Hudson River is tidal in this area; semidiurnal tides at the park range in elevation from 2.47 feet (NAVD88) at Mean Higher High Water (MHHW) to -1.39 feet (NAVD88) at Mean Lower Low Water (MLLW) (Figure 2-11) based on USGS gage 01372043 near Poughkeepsie, NY. Shoreline width ranges from approximately 5 to 25 feet at mean high tide and approximately 20 to 50 feet at mean low tide.

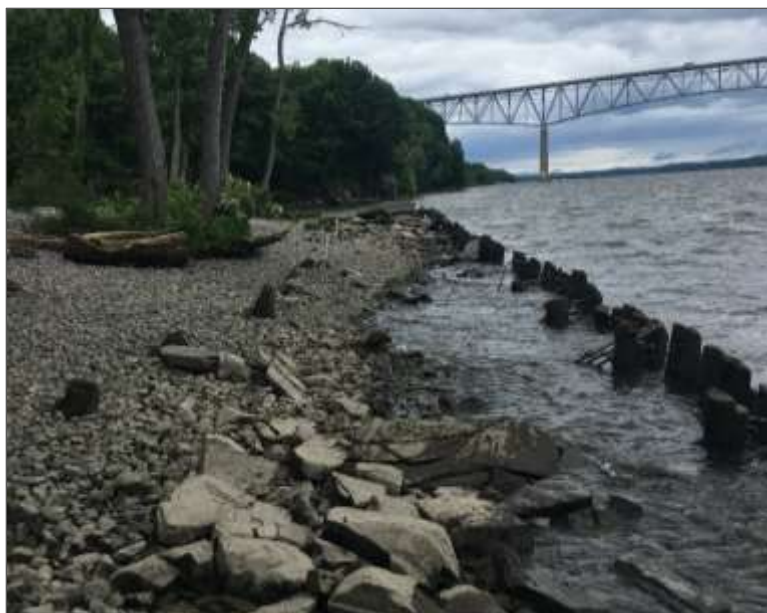
Photograph 11: View looking north at the eastern shoreline north of the boat ramp.

The park's shoreline varies in condition (Figure 2-12). The northern most portion of the shoreline is part of a small cove, partially protected by large rock material at the cove's mouth (Photograph 10). Based on a supplemental site survey, the beach portion of the cove has a slope of approximately 17 percent and a sandy gravel substrate. Refer to Appendix B - Engineering for detailed cross sections of the site. The eastern shoreline, north of the boat ramp, consists of a stone filled timber cribbing which is dilapidated and has predominantly failed (Photograph

11). A steep drop-off ranging from 7 to 10 feet is present at the riverward face of the cribbing; riverbed elevations at the base of the cribbing reach -6.7 to -9.7 feet (NAVD88).

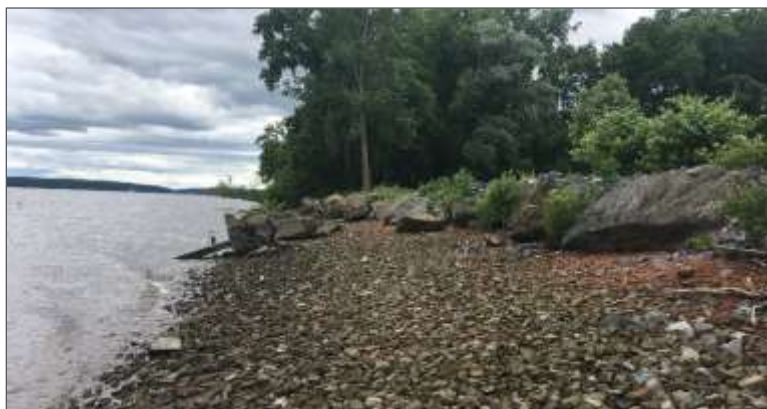
Photograph 12: View looking south at the eastern shoreline south of the boat ramp.

The eastern shoreline, south of the boat ramp, also consists of a stone filled timber cribbing which is dilapidated. However, large boulders were placed along the shoreline, adjacent to existing erosional scour (Photograph 12). These boulders appear to have been placed recently, presumably to stabilize the shoreline. Unlike the area north of the boat ramp, there is a gradual transition from shoreline to riverbed with a slope of approximately 10 percent. Sparse riprap extends riverward of the timber cribbing, mixed with a natural cobble substrate. Heavily worn bricks and water chestnut seeds, are common throughout the shoreline. A remnant boat ramp structure is also present approximately 100 feet south of the active boat ramp.

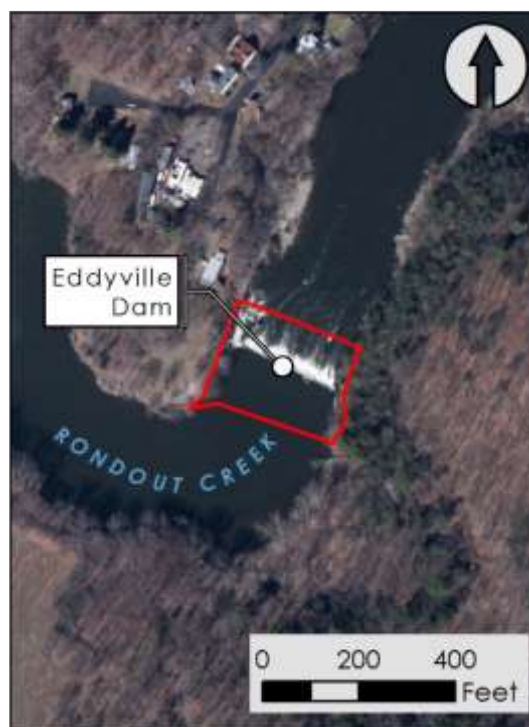
Figure 2-13: Eddyville Dam project area on Rondout Creek.

Eddyville Dam (Figure 2-13) is the first aquatic organism passage (AOP) barrier on Rondout Creek, located approximately 3.6 miles upstream of its confluence with the Hudson River. The dam lies on the boundary between the Towns of Esopus and Ulster in Ulster County and has the following characteristics:

Eddyville Dam – Rondout Creek	
State ID	193-0812
Federal ID	NY01136
Dam Height	12 ft
Dam Length	220 ft
Storage Capacity	90 ac-ft
Surface Area	15 ac
Town	Esopus / Ulster
County	Ulster

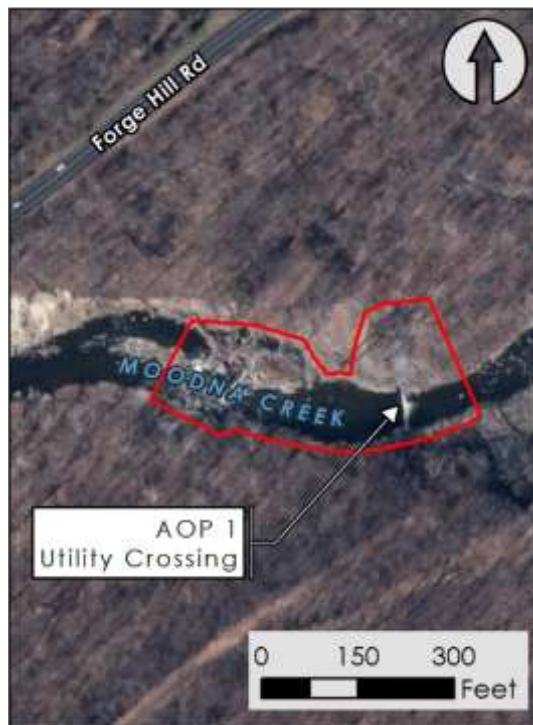
Figure 2-16: Location of AOP #1 Utility Crossing. Note the upstream riffle and landslide.

Approximately 1,000 feet upstream of the Forge Hill Road (Route 74) crossing in the Town of New Windsor and 1.8 miles upstream of the Hudson River confluence, a sewer utility line crosses Moodna Creek, forming a weir that creates a vertical drop of water approximately two feet in height at normal flows (Figure 2-16).

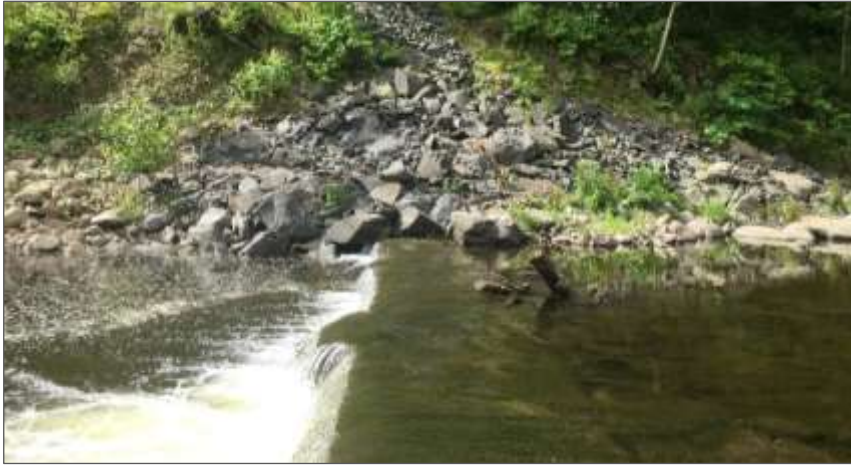
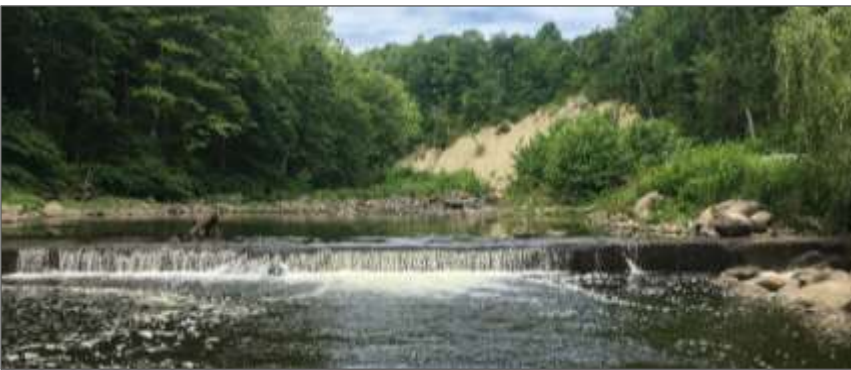
The utility crossing is encased in concrete, and approximately five feet wide (Photograph 13). The encasement has a vertical downstream face with a 6 to 12-inch lip just below water surface elevation. However, the lip is not continuous across the structure and scour is undercutting the concrete encasement. The deepest point in a scour hole downstream of the encasement was observed to be four to five feet below water surface elevation at the time of the investigation. Additionally, water was observed flowing into cavities in the streambed upstream of the structure, suggesting the utility crossing was starting to be undermined. Sediment in the channel was coarse-grained and compact (i.e. bedload), and not manually penetrable with rebar; fine sediment depths are negligible. At the utility crossing, the river left bank is two feet above water surface elevation, while the river right bank is stabilized with large angular rip rap on a slope rising 15-20 feet above water surface elevation.

Photograph 13. View of concrete encased utility line from river left (top) and from downstream looking upstream (bottom).

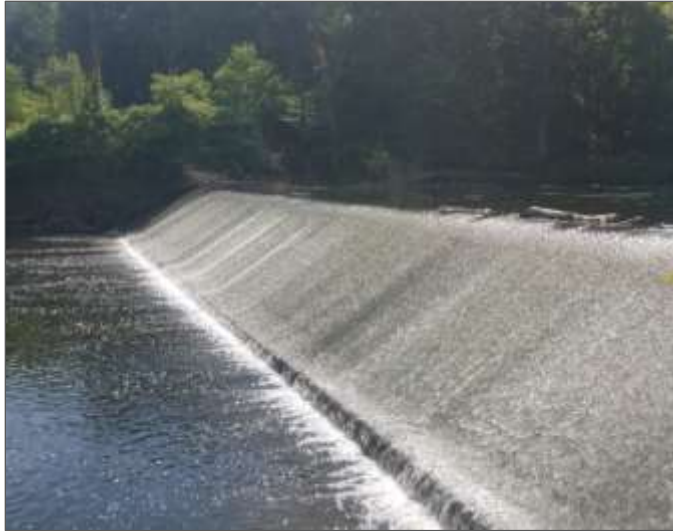
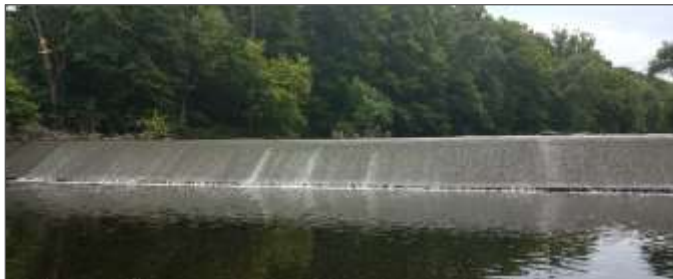
The dam is privately owned. Based on field investigations, the dam crest is two feet wide and the downstream spillway slopes down with an estimated nine feet of elevation change and an additional one-foot estimated lip on the edge of the spillway (Photograph 14). A large abutment straddles each side of the dam. On the river left, the abutment is about 60 feet long and two feet wide. The river left valley wall near the dam is steeply sloped, nearly vertical in places. On the river right immediately beyond the impoundment, is the factory parking lot; the river right abutment also shows evidence of a gate structure which likely included a diversion for a mill race. The gate is on the upstream end of the abutment and was approximately six feet wide and with gate guides that are an estimated three feet high. During the field investigation in June 2018, no evidence of leakage could be seen, suggesting that the dam is intact and in good condition.

Photograph 14: View of Firth Cliff Dam from river left (top) and from downstream looking upstream (bottom).

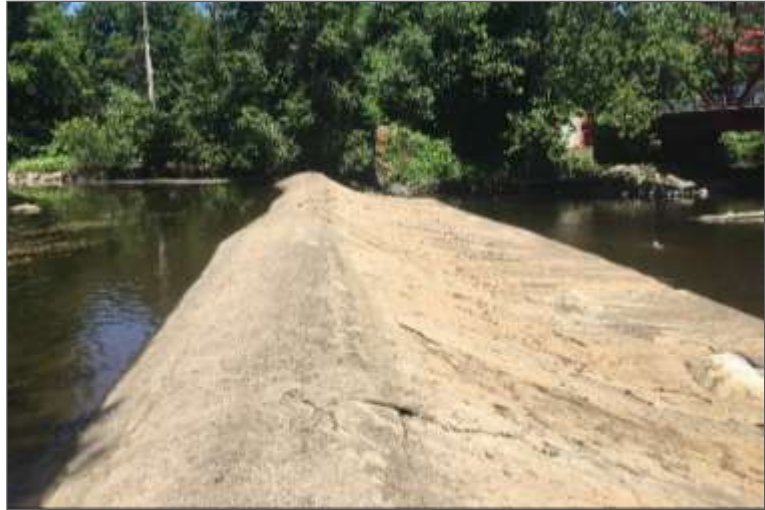
The dam is privately owned. The structure is unique in that the spillway is made of cobbles/boulders with steel I-beams and timbers running longitudinally along the spillway, and capped with a layer of concrete (Photograph 15). Based on a visual assessment, the concrete does not appear to have reinforcement bar and the steel I-beams do not appear to be structurally connected. Historical photographs from circa 1900 confirm that the dam at that time was a stone dam and the reinforcement and concrete were added at a later date. Presently, there are multiple holes in the concrete cap where timber and stone underneath can be observed. The downstream edge of the spillway is elevated two feet above the downstream river bed. During field investigations, water could be seen flowing out of this downstream edge of the spillway clearly indicating that the dam is undermined and leaking.

Photograph 15: View of Orr's Mill Dam from river right
