**Leonardo, Raritan Bay and
Sandy Hook Bay, New Jersey Coastal Storm
Risk Management Feasibility Study**

Appendix C Engineering

March 2015

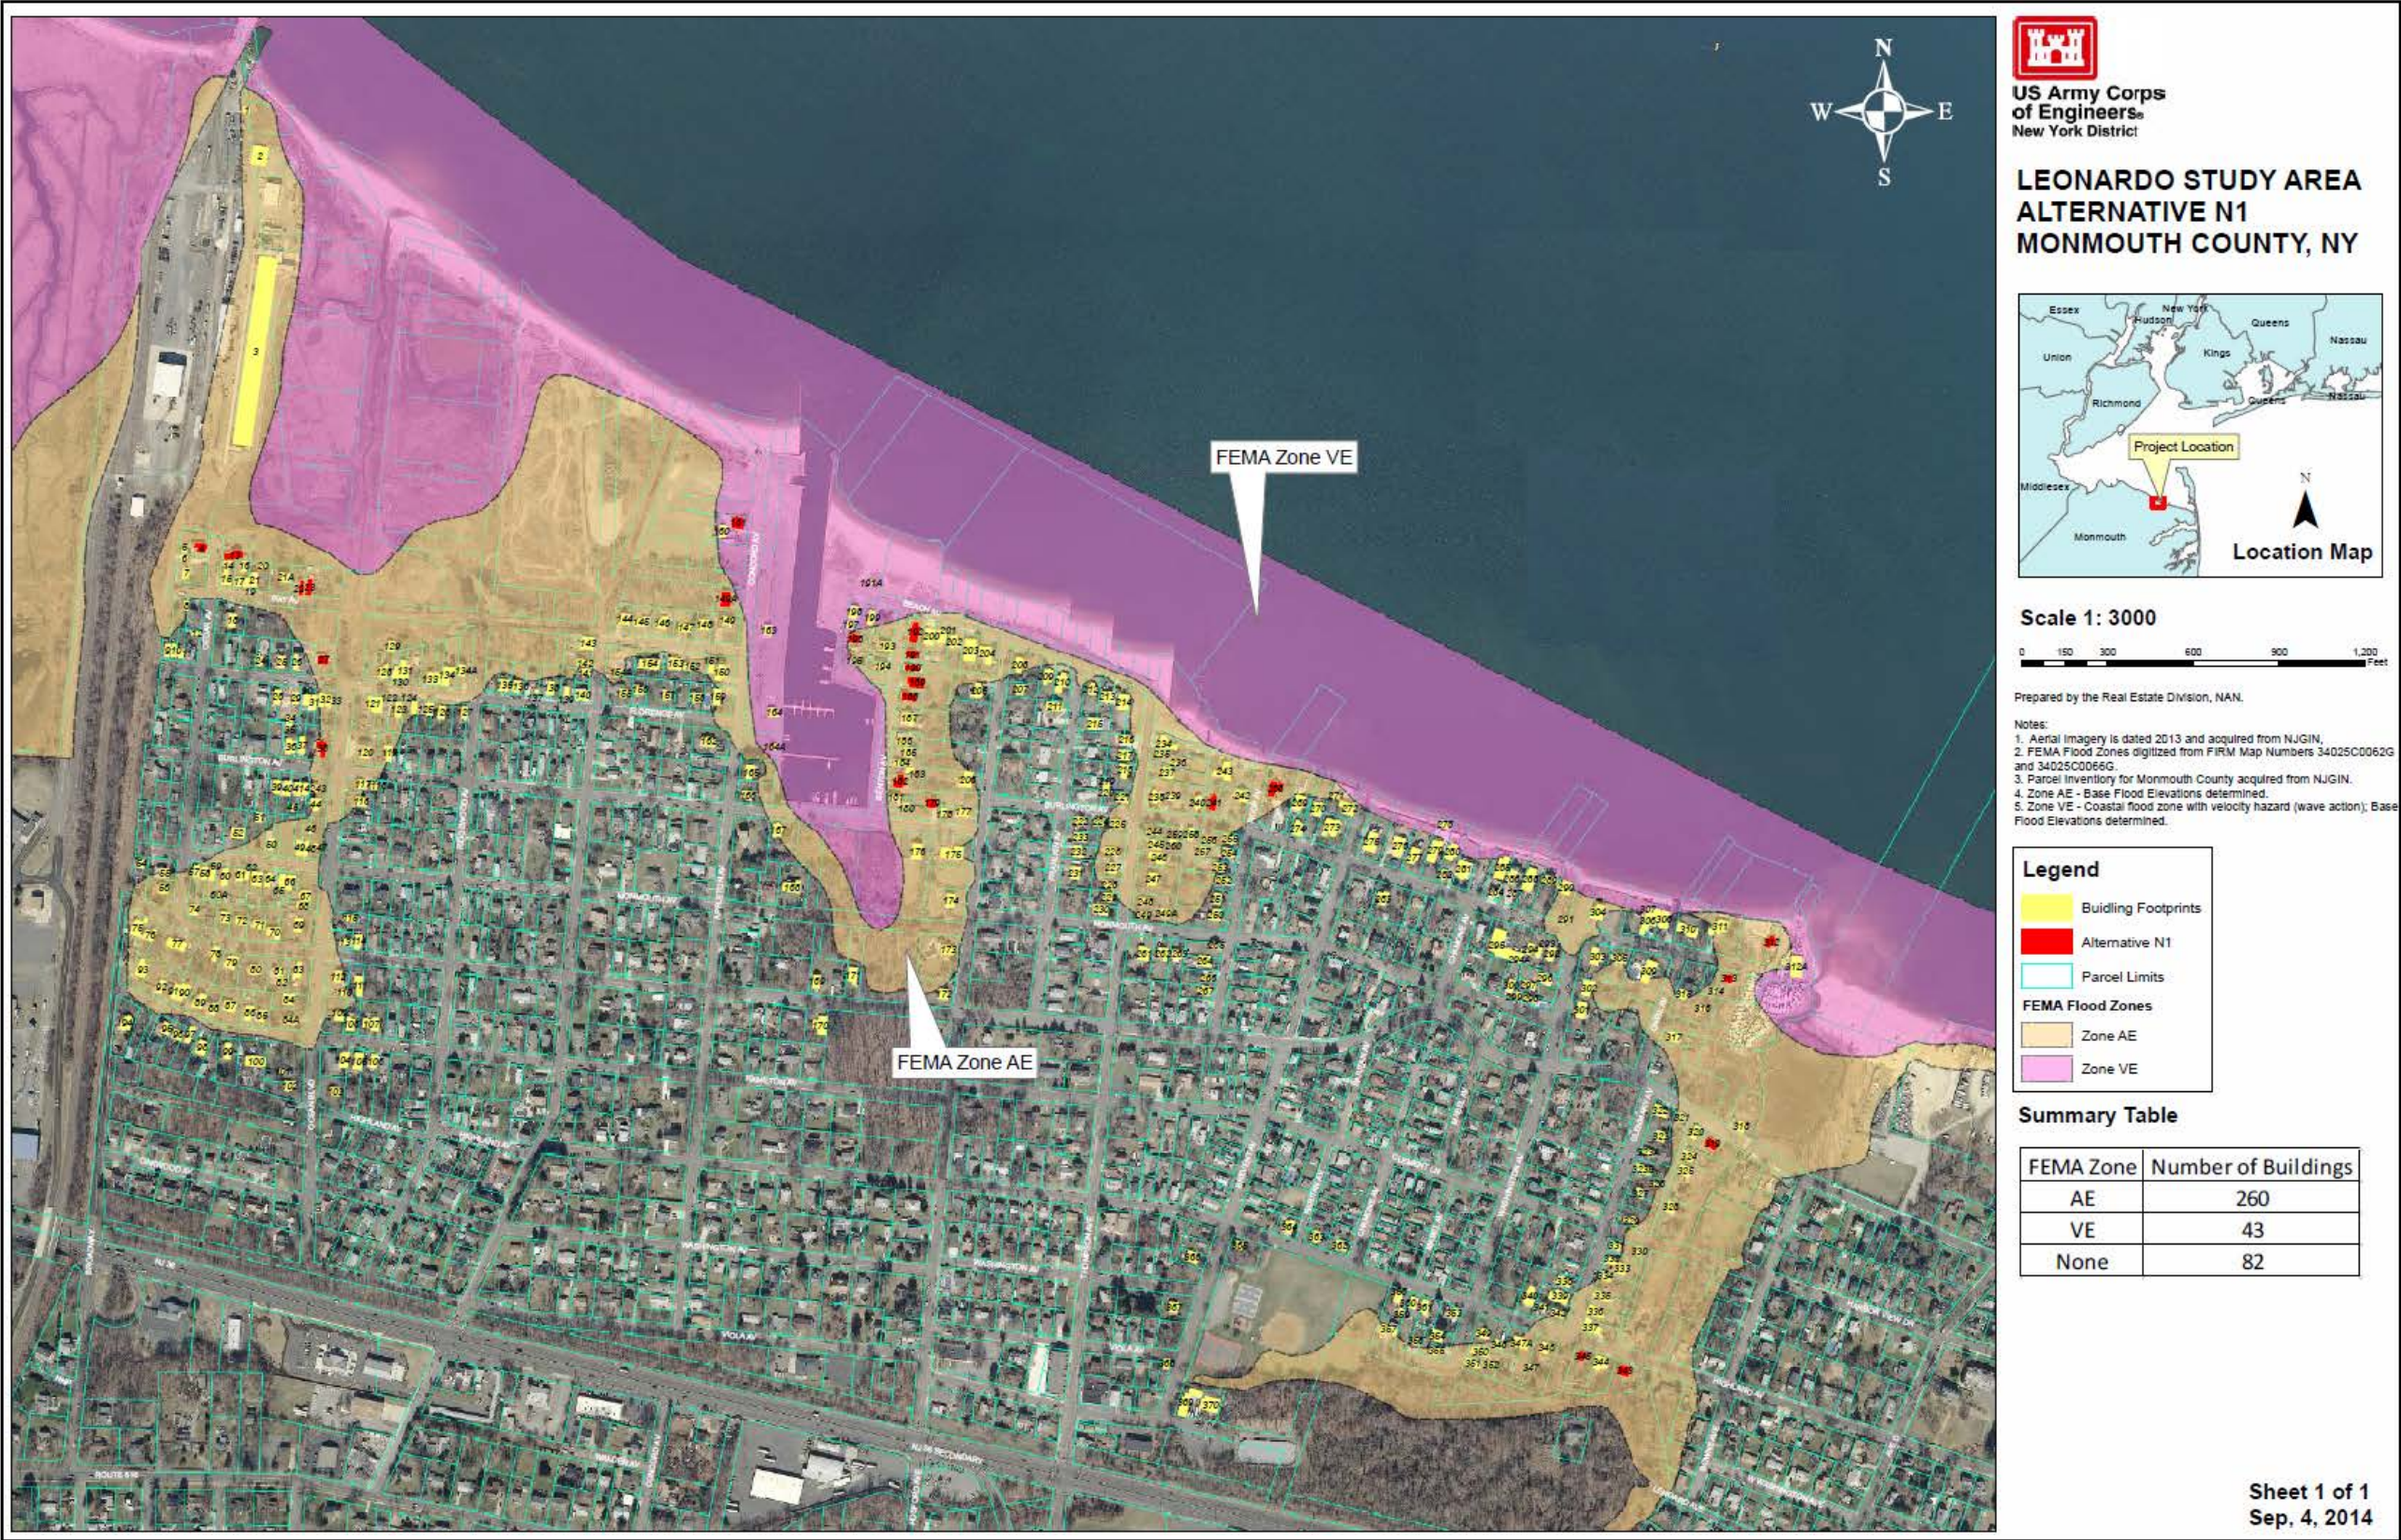
Figure 4: Alternative N1

Limited nonstructural alternatives, such as N1 and N5, are recommended for more detailed development. Figure 4 and Figure 5 show the structures in the project area for Alternatives N1 and N5, respectively.

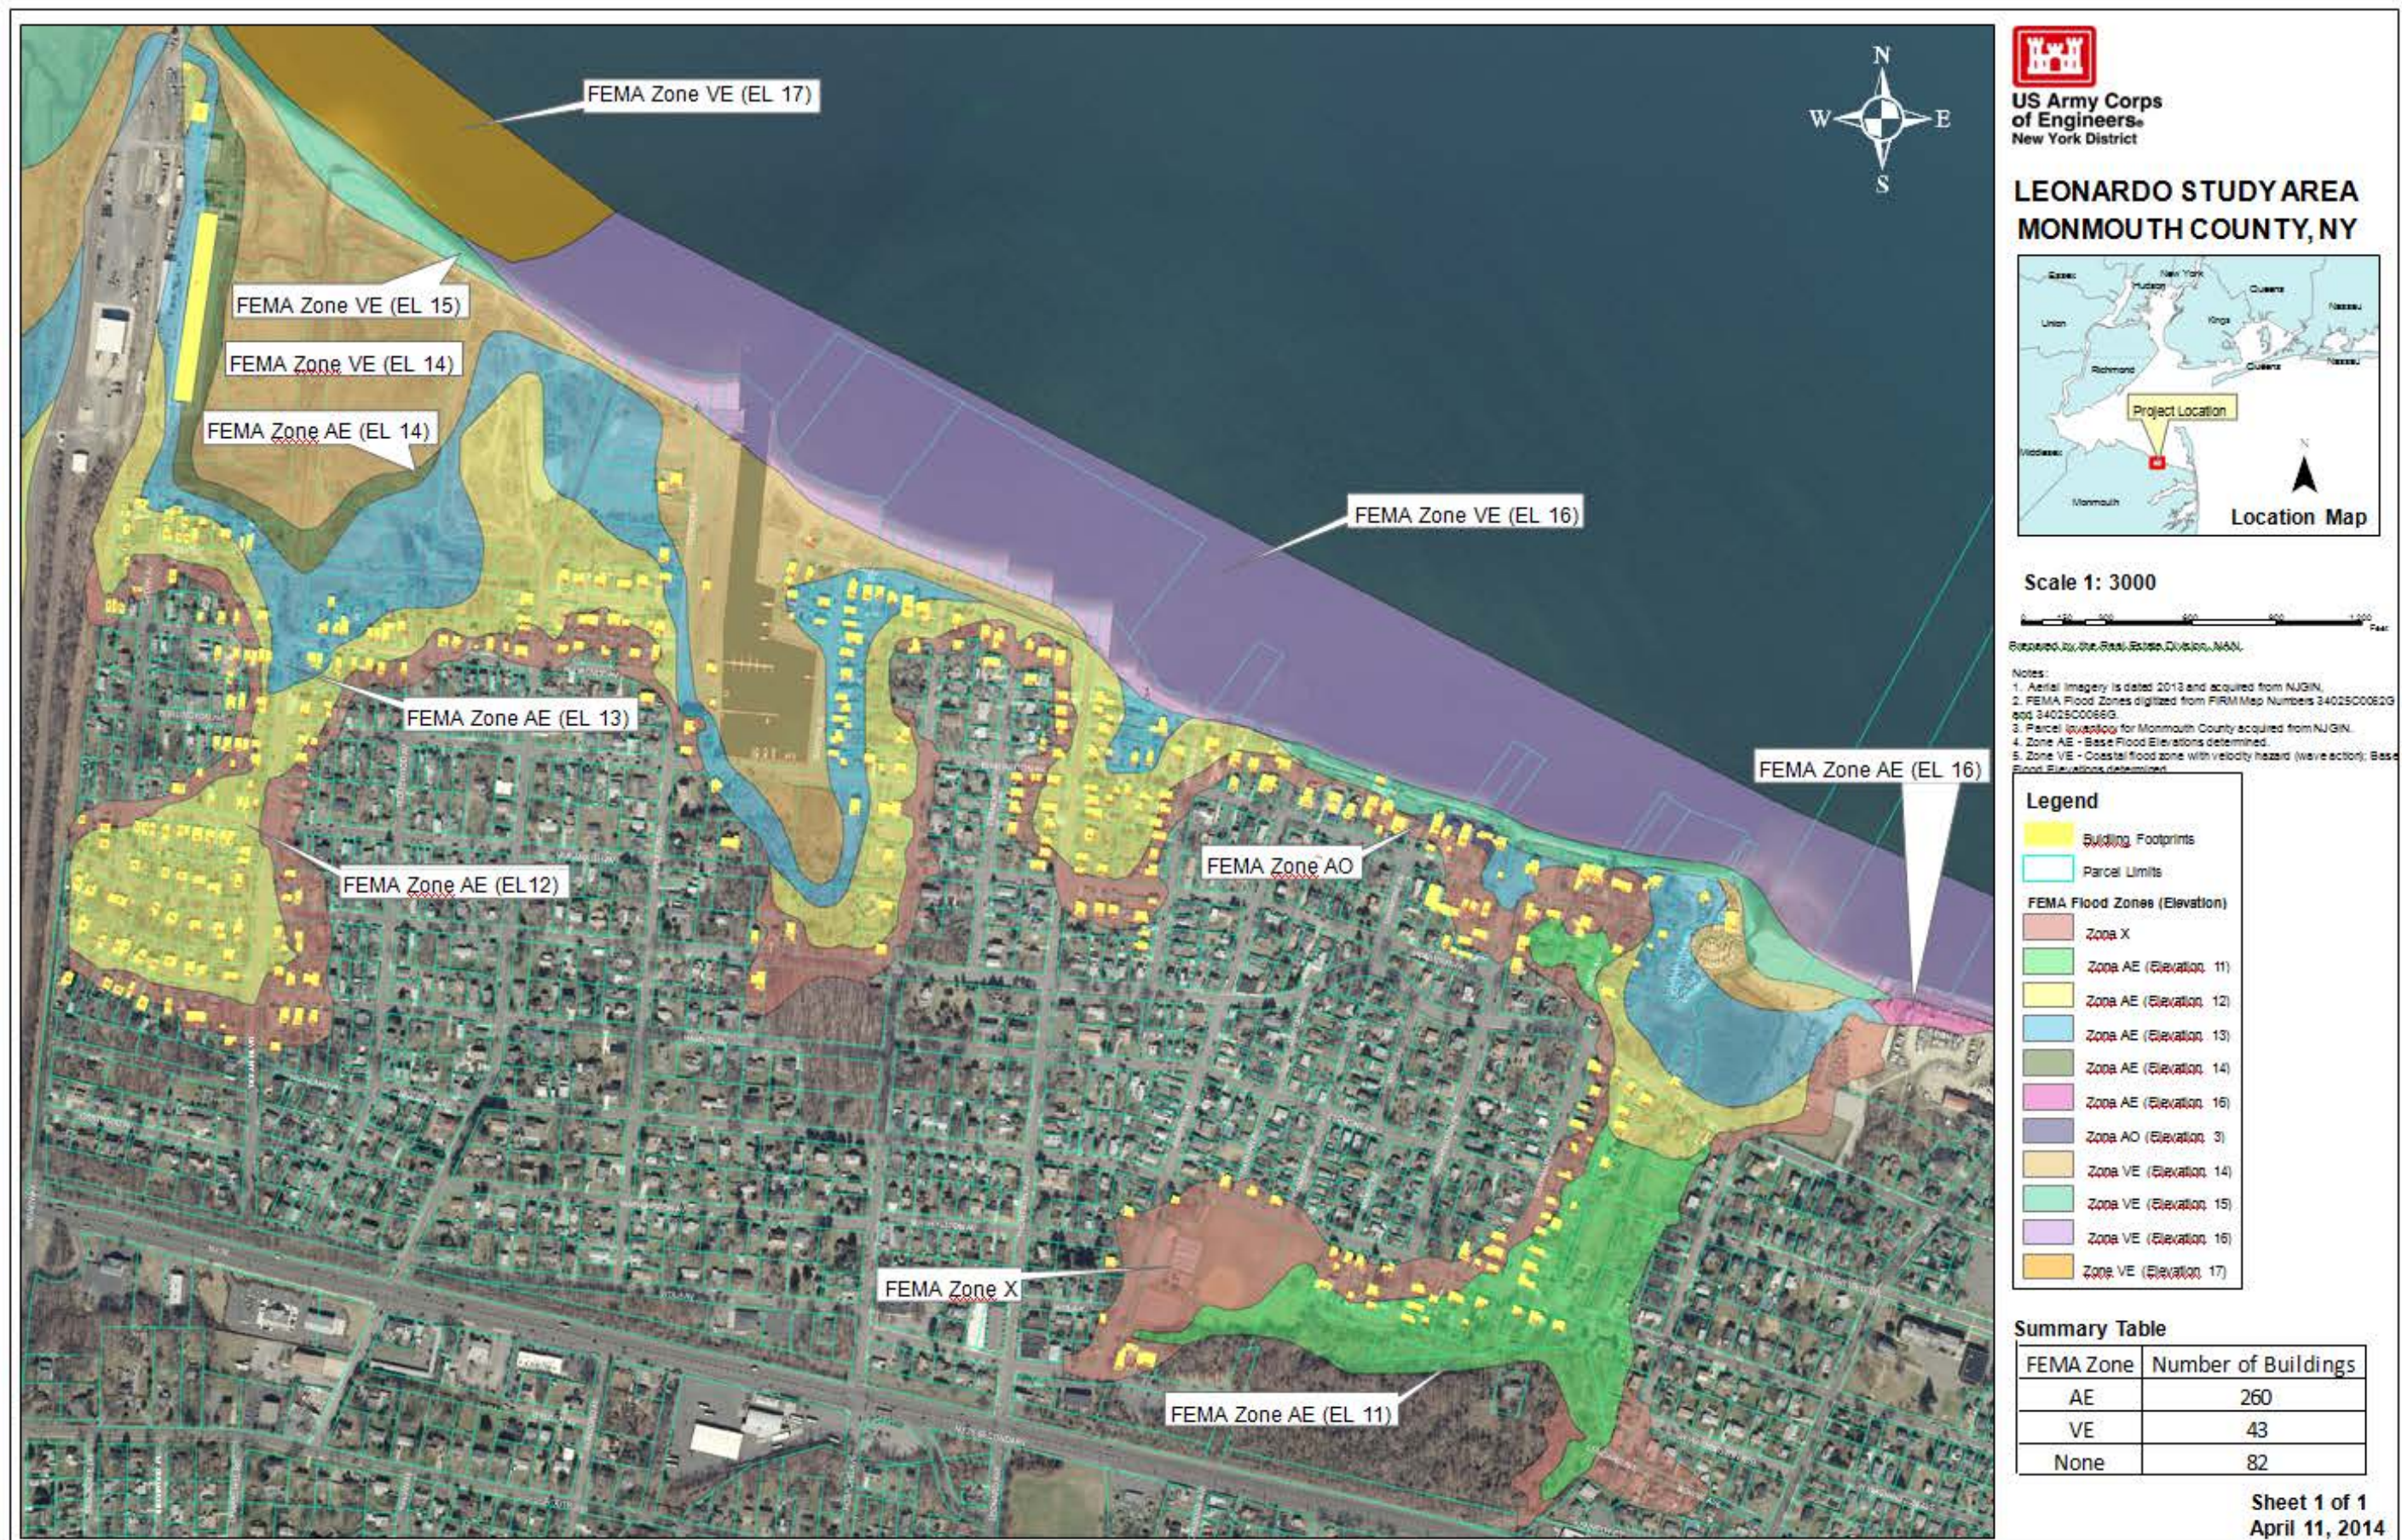
Figure 13: FEMA Sub Zones Map
