**REMEDIAL INVESTIGATION FOR
MUNITIONS AND EXPLOSIVES OF CONCERN**

**MIDDLESEX COUNTY COLLEGE
(AREA 17, AREA 17A, AREA H, AREA W, AREA X,
AND BUILDING 118)**

FORMER RARITAN ARSENAL

**FUDS Project Number C02NJ008403
Contract No. W912WJ-16-D-0002
Task Order W912WJ-17-F-0091**

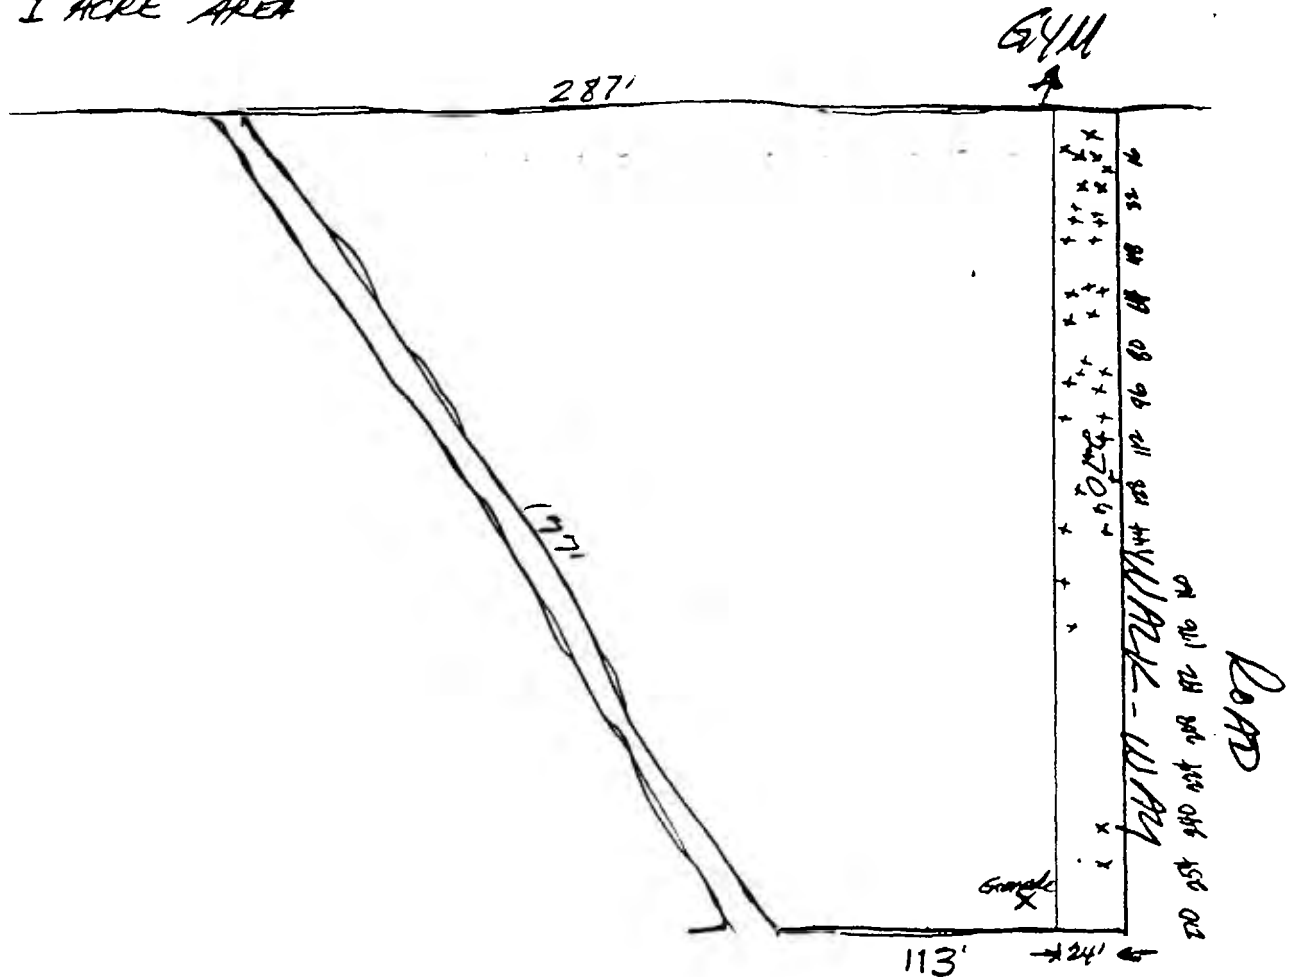
1. PERFORMED SURFACE SWEEP - NOTHING FOUND
2. MAGGED AREA AROUND WHERE GRENADE WAS FOUND (15' RADUS)
NOTHING - ORDNANCE RELATED FOUND
3. MAGGED APP 24' OF EASTERN EDGE ALONG (270') QUICK AND DIRTY,
44 HITS - DUG 25% OF THEM - ROCKS, WIRE, PIPE - NO
ORDNANCE RELATED ITEMS RECOVERED.
4. MAGGED APP 3500 SQ FT WITHIN THE AREA, APP 105 HITS,
DUG THEM ALL, ROCKS, PIPE, ETC. NO ORDNANCE RELATED
SCRAP FOUND.
