# **HUDSON RIVER HABITAT RESTORATION**

**ECOSYSTEM RESTORATION  
DRAFT INTEGRATED FEASIBILITY REPORT AND  
ENVIRONMENTAL ASSESSMENT**

## **Appendix B: Engineering Appendix**

**U.S. ARMY CORPS OF ENGINEERS  
NEW YORK DISTRICT**  
June 2019

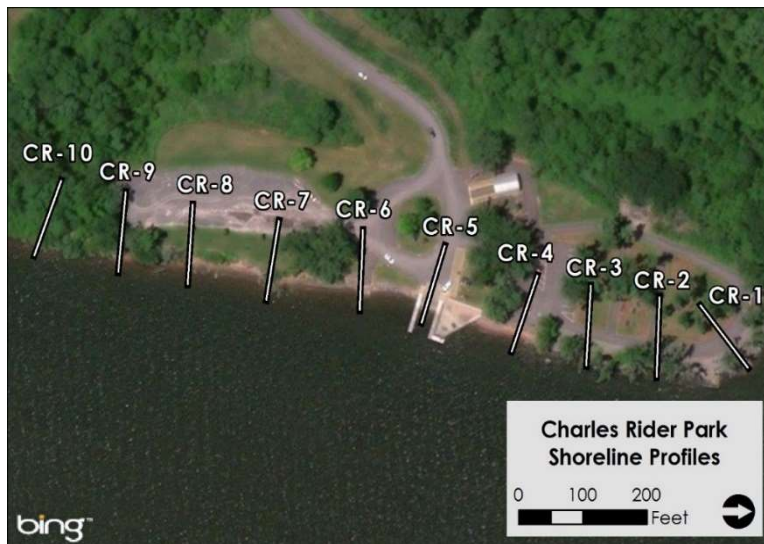
**Figure 3: Surveyed Shoreline Profile locations at Charles Rider Park.**

Topographic data was collected at Charles Rider Park on June 8, 2018. The river water level was approximately at low tide and rising at the time of arrival. In total, data was collected at ten shoreline profiles oriented perpendicular to the shoreline and spaced approximately 110 feet apart (Figure 3). On average, 11 data points were collected per profile at a spacing of approximately 5 to 10 feet.

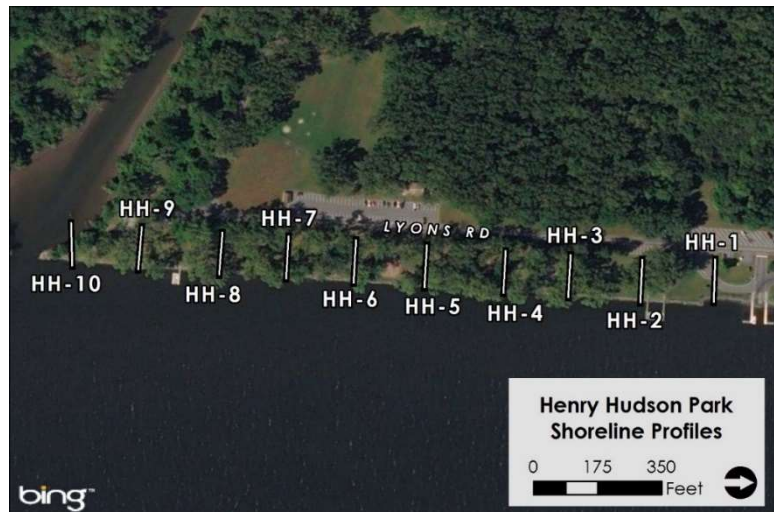
**Figure 4: Surveyed Shoreline Profile locations at Henry Hudson Park**

Topographic data was collected at Henry Hudson Park on June 7, 2018. The river water level was approximately at high tide and falling at the time of arrival. In total, data was collected at ten shoreline profiles oriented perpendicular to the shoreline and spaced approximately 200 feet apart (Figure 4). On average, 12 data points were collected per profile at a spacing of approximately 5 to 10 feet.

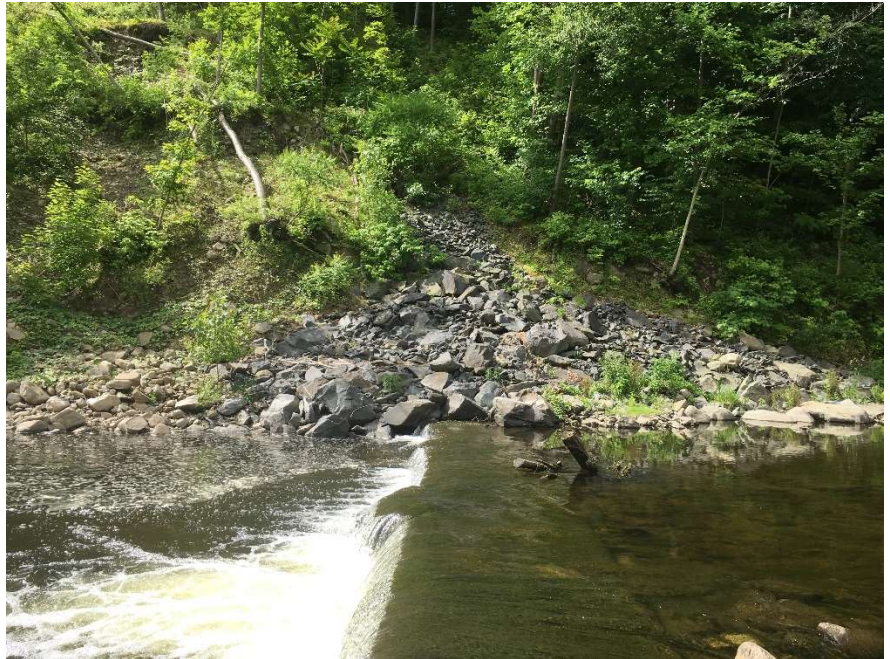
***Photograph 1: AOP #1, view of utility crossing and river right bank.***

The utility crossing is encased in concrete, and approximately five feet wide (Photograph 1). The encasement has a vertical downstream face with a 6 to 12-inch lip just below water surface elevation. However, the lip is not continuous across the structure. Based on a visual assessment, there is limited scour undercutting the concrete encasement. The deepest point in the scour hole downstream of the encasement was observed to be four to five feet below water surface elevation.

At the utility crossing, the river left bank is two feet above water surface elevation, while the river right bank is stabilized with large angular rip rap on a slope rising 15 to 20 feet above water surface elevation (Photograph 1).

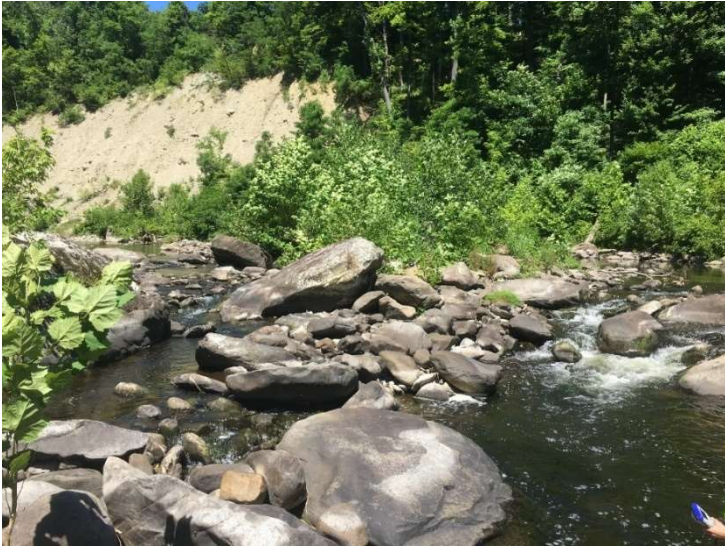
**Photograph 2: View of upstream riffle which may be a natural AOP barrier.**

The riffle upstream of the utility crossing at the location of the upstream landslide, the main flow goes through two steep drops (Photograph 2). One of which is about five feet, the other about four feet. These drops are likely not passable for fish passage and rock configuration may need to be adjusted during construction of any alternatives to ensure fish passability. The secondary flow paths have smaller vertical drops but have lower water depths, and thus remain a fish passage concern, at least at low flows.

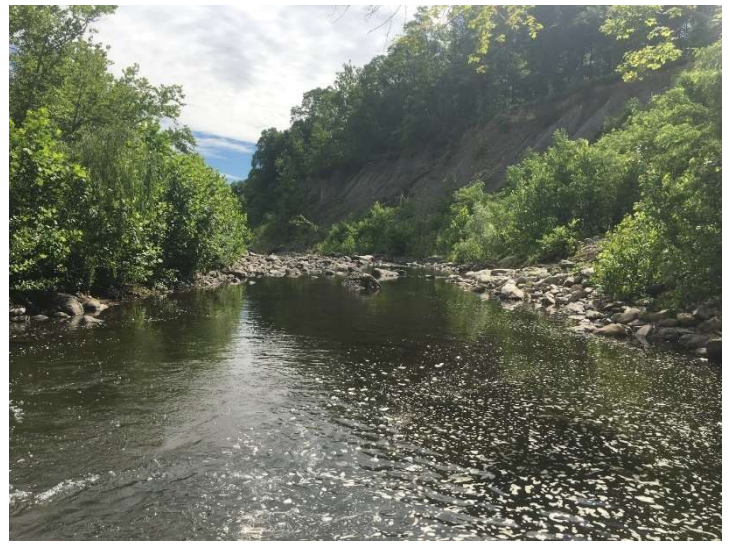
**Photograph 3: View of boulders to tie into rock ramp downstream from the utility crossing.**

Downstream of the utility crossing, there are three to four-foot boulders into which the rock ramp grade could be tied (Photograph 3).

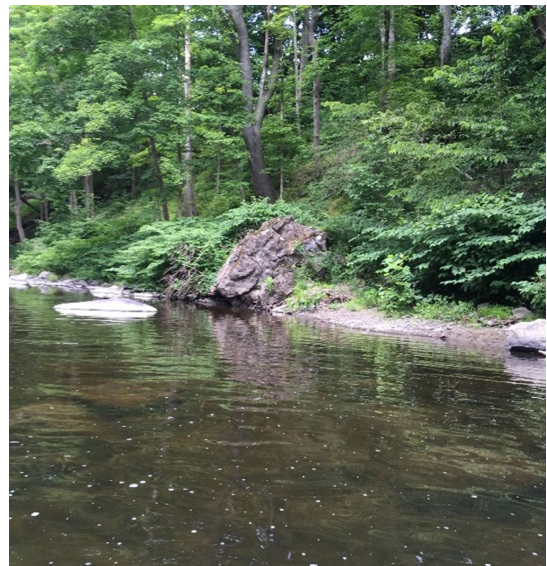
**Photograph 4: View of large glacial erratics on the river left bank.**

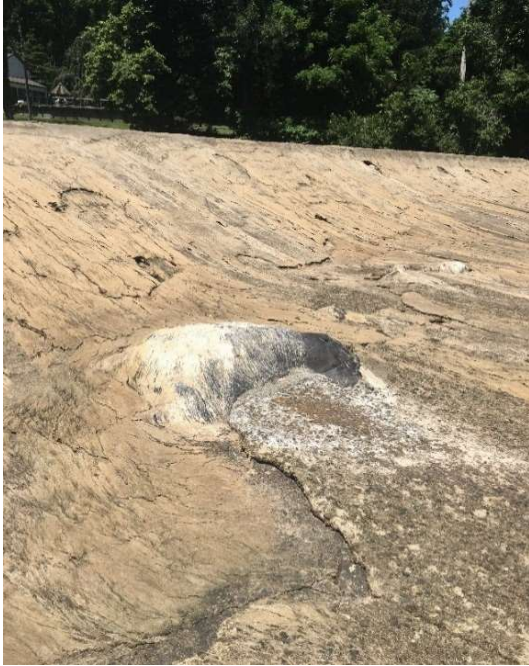
***Photograph 5: Boulder embedded in concrete spillway.***

The dam itself is unique. The spillway is made of boulders with steel I-beams and timbers running longitudinally along the spillway, and capped with a layer of concrete. A historical photo from circa 1900 confirms that the dam at that time was a stone dam and the reinforcement and concrete were added at a later date. There are multiple holes in the concrete cap where timber and stone underneath can be observed (Photographs 5 and 6).

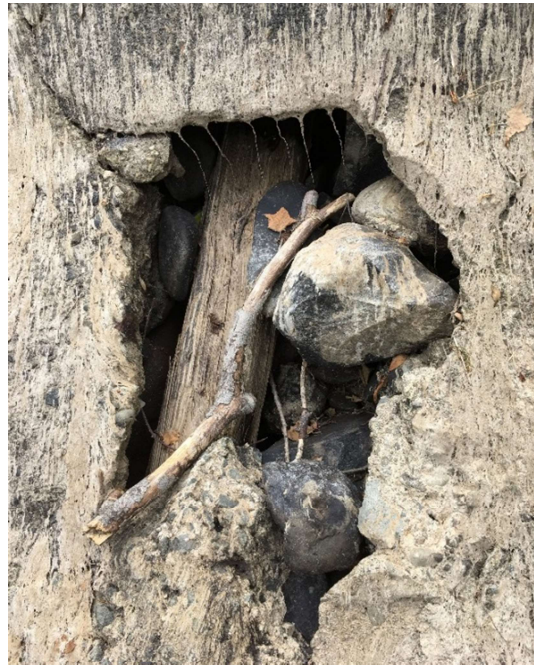
***Photograph 6: hole in concrete spillway revealing timber.***

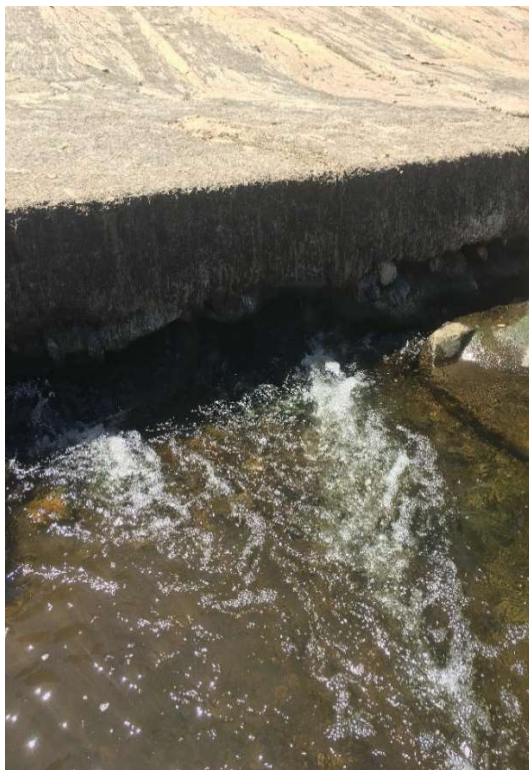
***Photograph 7: Leakage under Spillway Downstream of Dam.***

The downstream edge of the spillway is elevated two feet above the downstream river bed. Water can be seen flowing out of this downstream edge of the spillway clearly indicating the dam is leaking. Additionally, upstream of the dam, water can be seen creating a vortex as it flows into leakage holes (Photographs 7 and 8). Any bypass fishway would necessitate significant improvements and repairs to the dam.

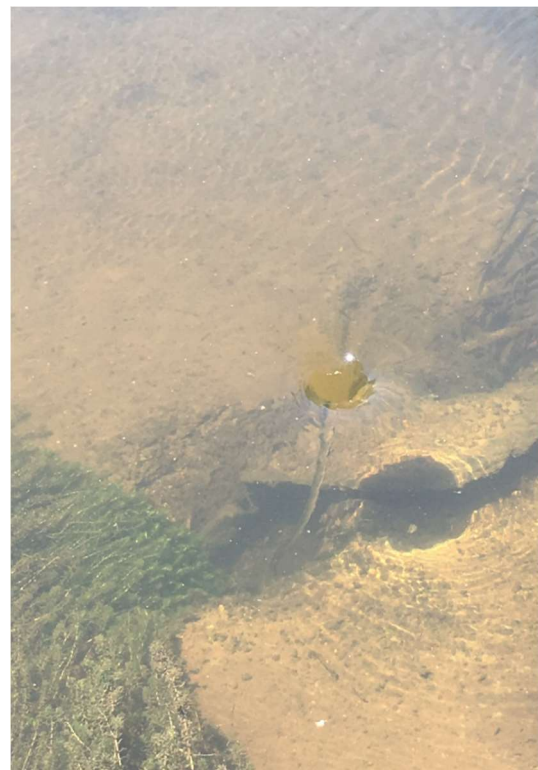
***Photograph 8:1 Vortex Forming in Impoundment due to Leakage.***

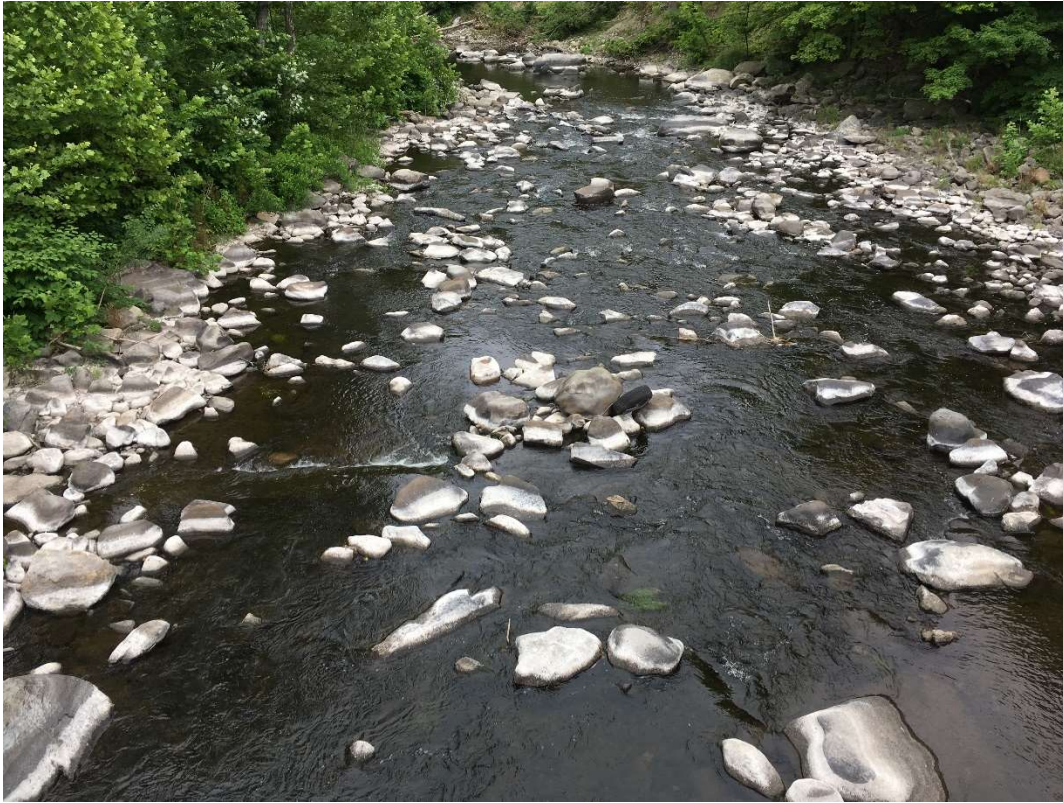
***Photograph 9: 2 Looking downstream***

There are large five to ten-foot boulders immediately downstream of the dam across the channel. On river left, there is a scour pool with a maximum depth of 5.5 feet. On the downstream side of the bridge, there are boulders that would as channel grade control below the bridge (Photograph 9).

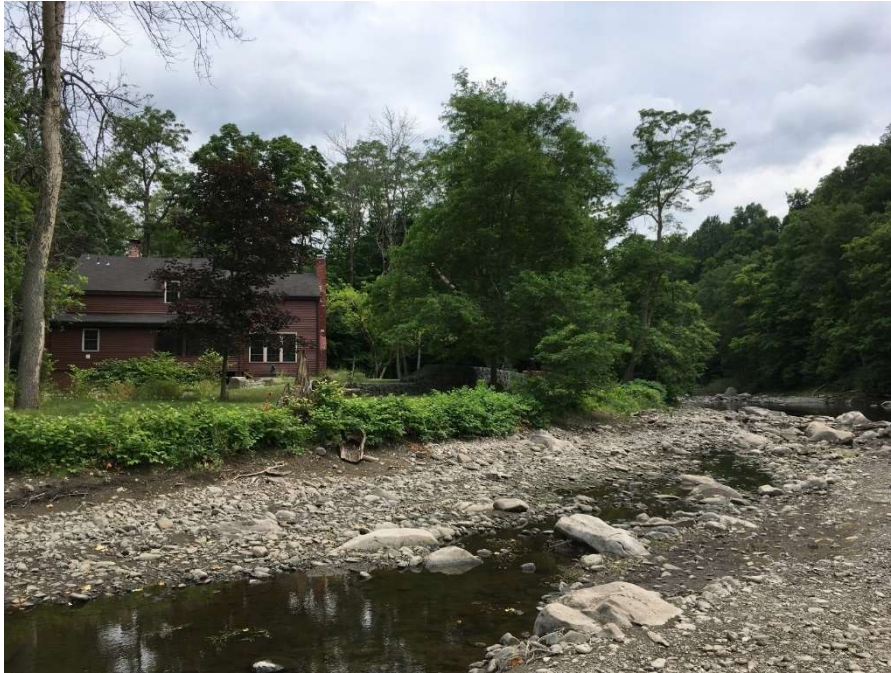
***Photograph 10: Point Bar in Lower Impoundment on River Right.***

On river right above the dam, there is a point bar mostly consisting of sand, gravel, and cobble with some boulders.

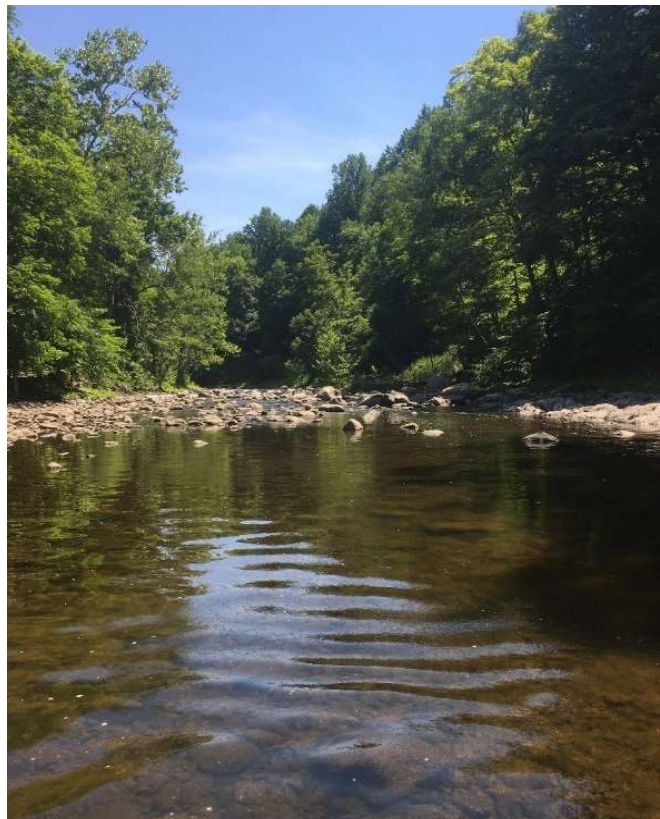
***Photograph 11: Looking Upstream at Edge of Impoundment.***

Upstream, there are large boulders and glacial erratics that would serve as grade control. The change from the cobble/gravel in the impoundment to these large boulders signifies the end of the impoundment and likely serve as an upstream grade control.

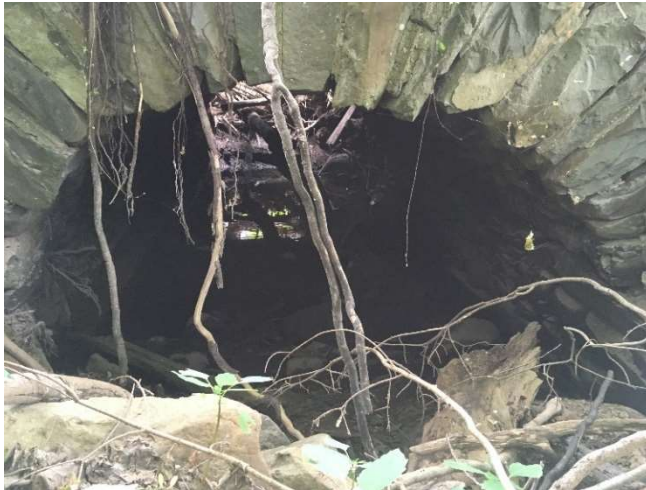
***Photograph 12: River Left Sluiceway under Culvert for Abutment (Left) and Road (Right).***

The legacy millrace on the river left connects upstream of the dam near the dam abutment, and continues into a 15-

foot culvert underneath the abutment and then through a 50-foot-long, 5x5 foot box culvert underneath the road. That culvert and dam spillway each empty into a holding pond approximately four feet deep. The grade continues to drop in elevation, approximately eight feet, until it connects with the river at least 50 feet downstream.

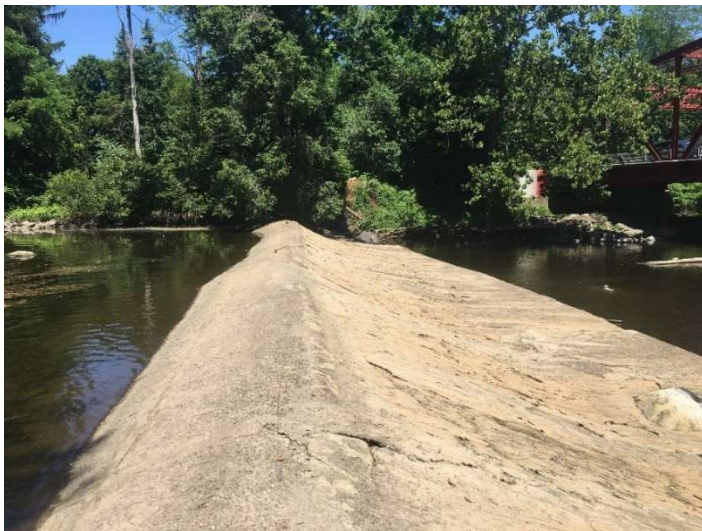
***Photograph 13: River Left Spillway.***

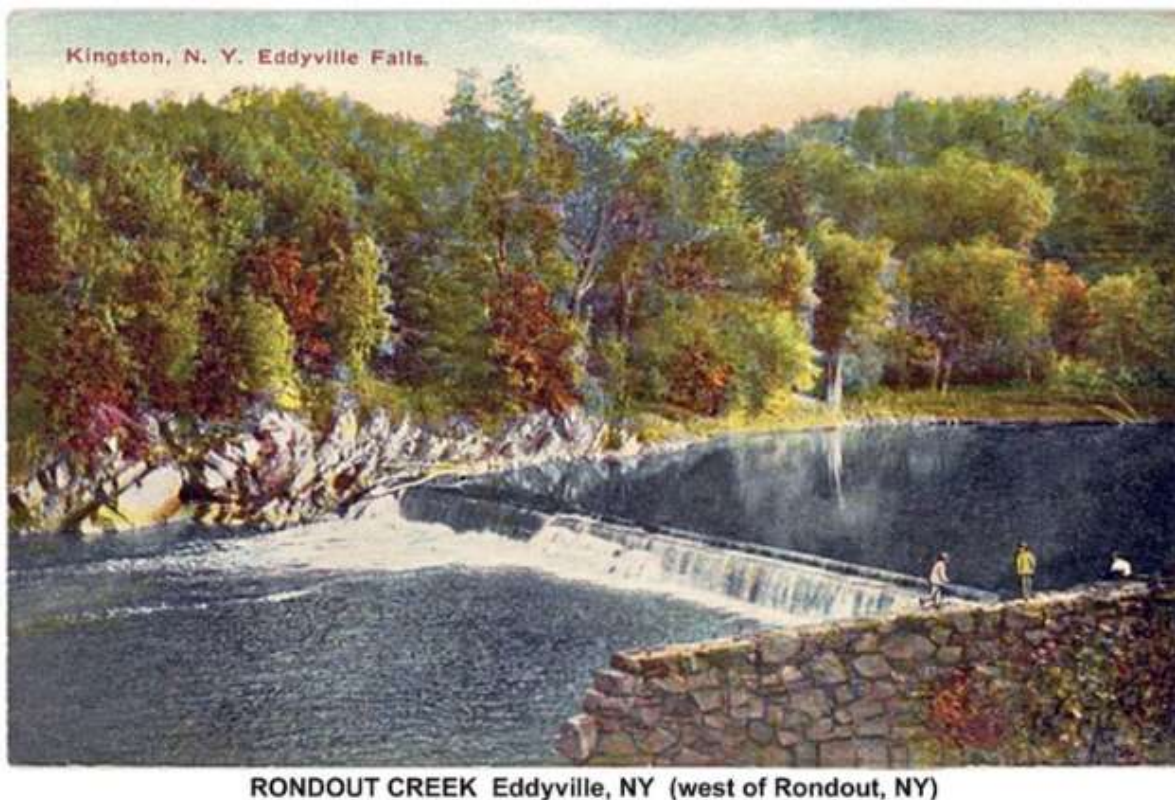
***Photograph 14: Historical Illustration of Eddyville Dam***

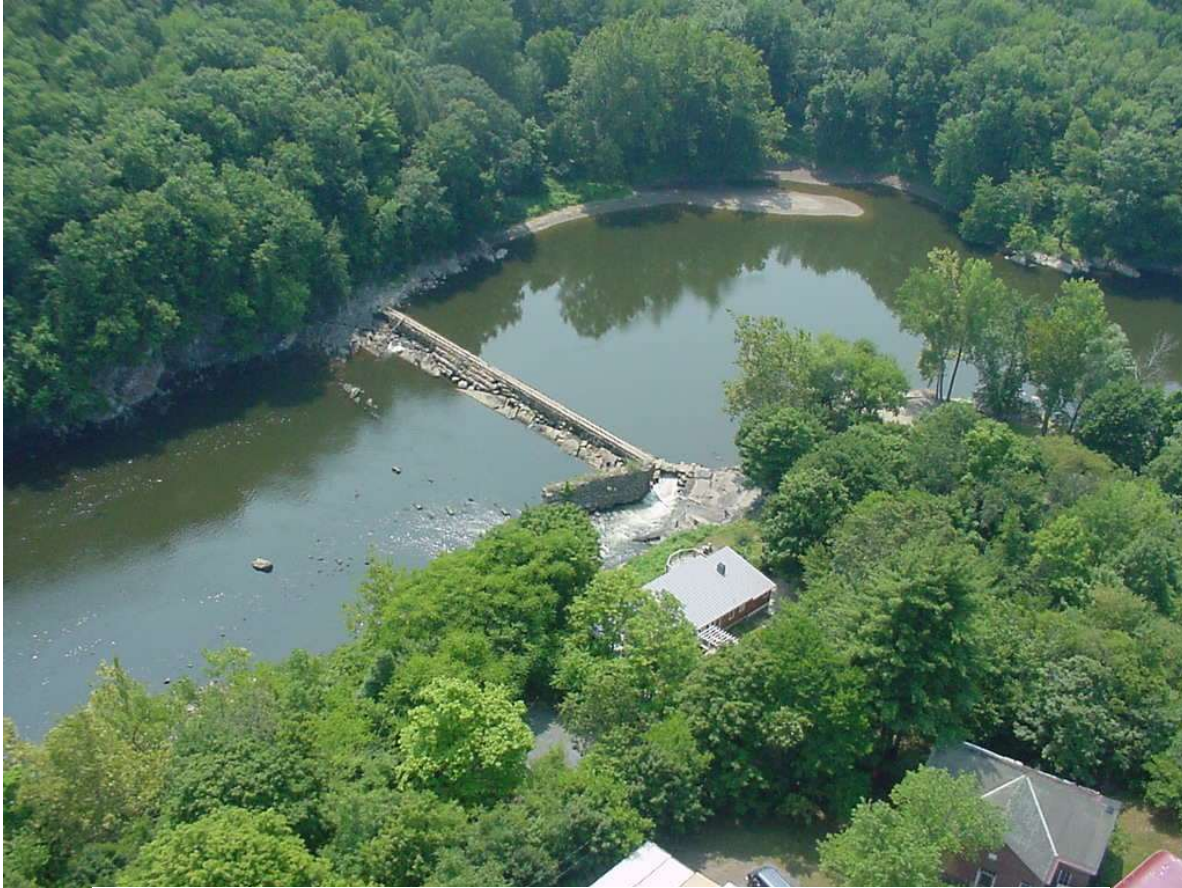
***Photograph 15: Eddyville dam at Low Tide with Low Flows (3 July 2001)***

The dam seems to be a stone masonry dam capped with concrete although an older timber crib structure might also exist along the upstream side of the visible stone masonry but cannot be confirmed at this time. The dam is stone and cement construction with a wood face.

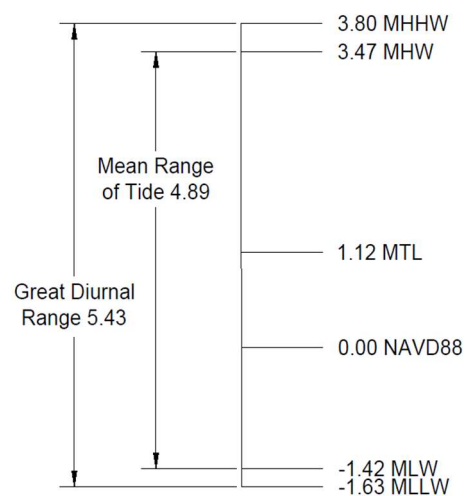
**Figure 6: Henry Hudson Park, Binnen Kill, and Schodack Island Tidal Datum Relative to NAVD88, feet.**

Semidiurnal tides at the site range in elevation from 3.80 feet at Mean Higher High Water (MHHW) to -1.63 feet at Mean Lower Low Water (MLLW) (Figure 6) based on HRECOS monitoring station located at Schodack Island approximately 1,300 feet downstream of the Binnen Kill confluence with the Hudson River.

Semidiurnal tides at the site range in elevation from 3.80 feet at MHHW to -1.63 feet at MLLW (Figure 6) based on the HRECOS monitoring station located on-site. Tidal influence likewise extends into Schodack Creek based on monitoring of water surface elevations within Schodack Creek from June to November 2018 in the monitored area which included stations at the southern extent of the north and south components. In other words, the tidal elevations in Schodack Creek are comparable to those of the Hudson River.

Semidiurnal tides at the park, range in elevation from 3.80 feet at MHHW to -1.63 feet at MLLW (Figure 6) based on the HRECOS, Schodack Island Station.

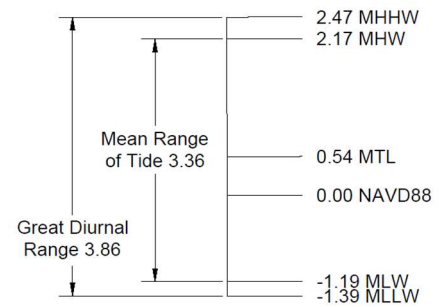
**Figure 7: Charles Rider Tidal Datum Relative to NAVD88, feet.**

Semidiurnal tides at the Park, range in elevation from 2.47 feet at MHHW to -1.39 feet at MLLW (Figure 7).

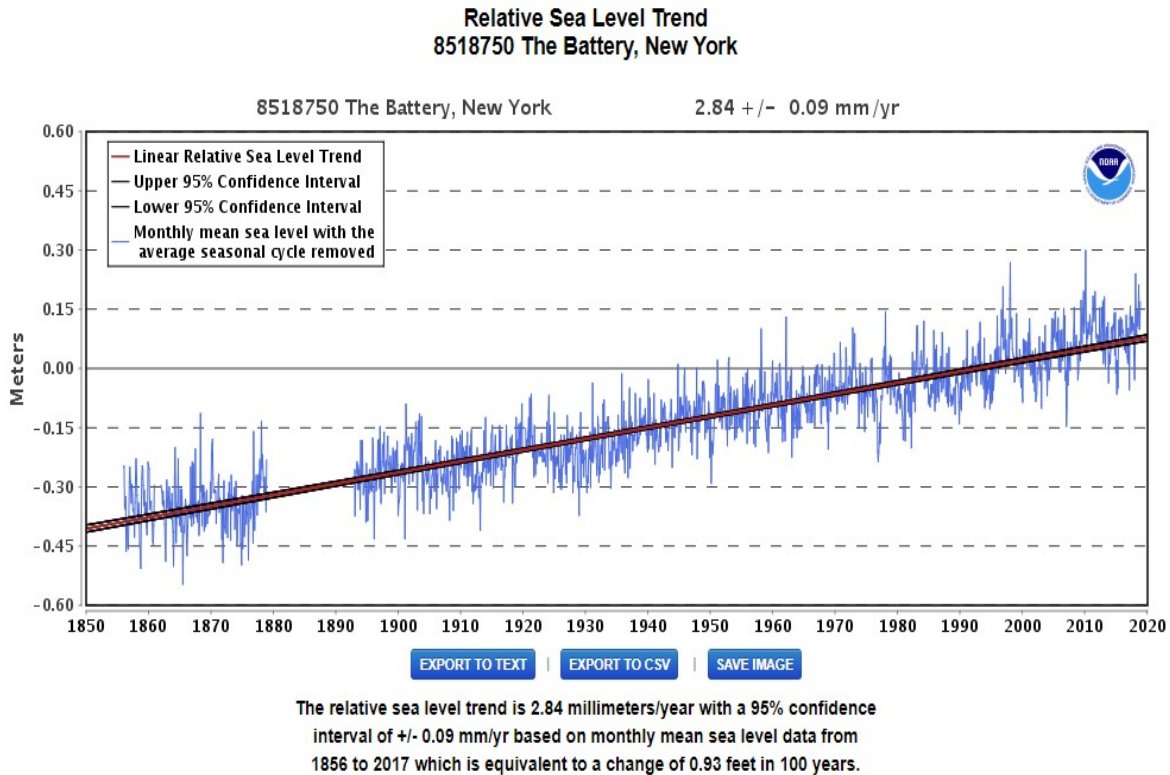
The conducted analysis was done consistent with procedures in ETL 1100-2-1 (Jun 2014.) The relative sea level trend for the NOAA gauge station at The Battery, NY is 2.84 mm/yr, which was applied to the HRECOS Schodack and USGS Poughkeepsie tidal datums. Figure 8 shows the sea level trend at The Battery, NY:

**Figure 8. Relative sea level trend for the NOAA gauge station at The Battery, NY**

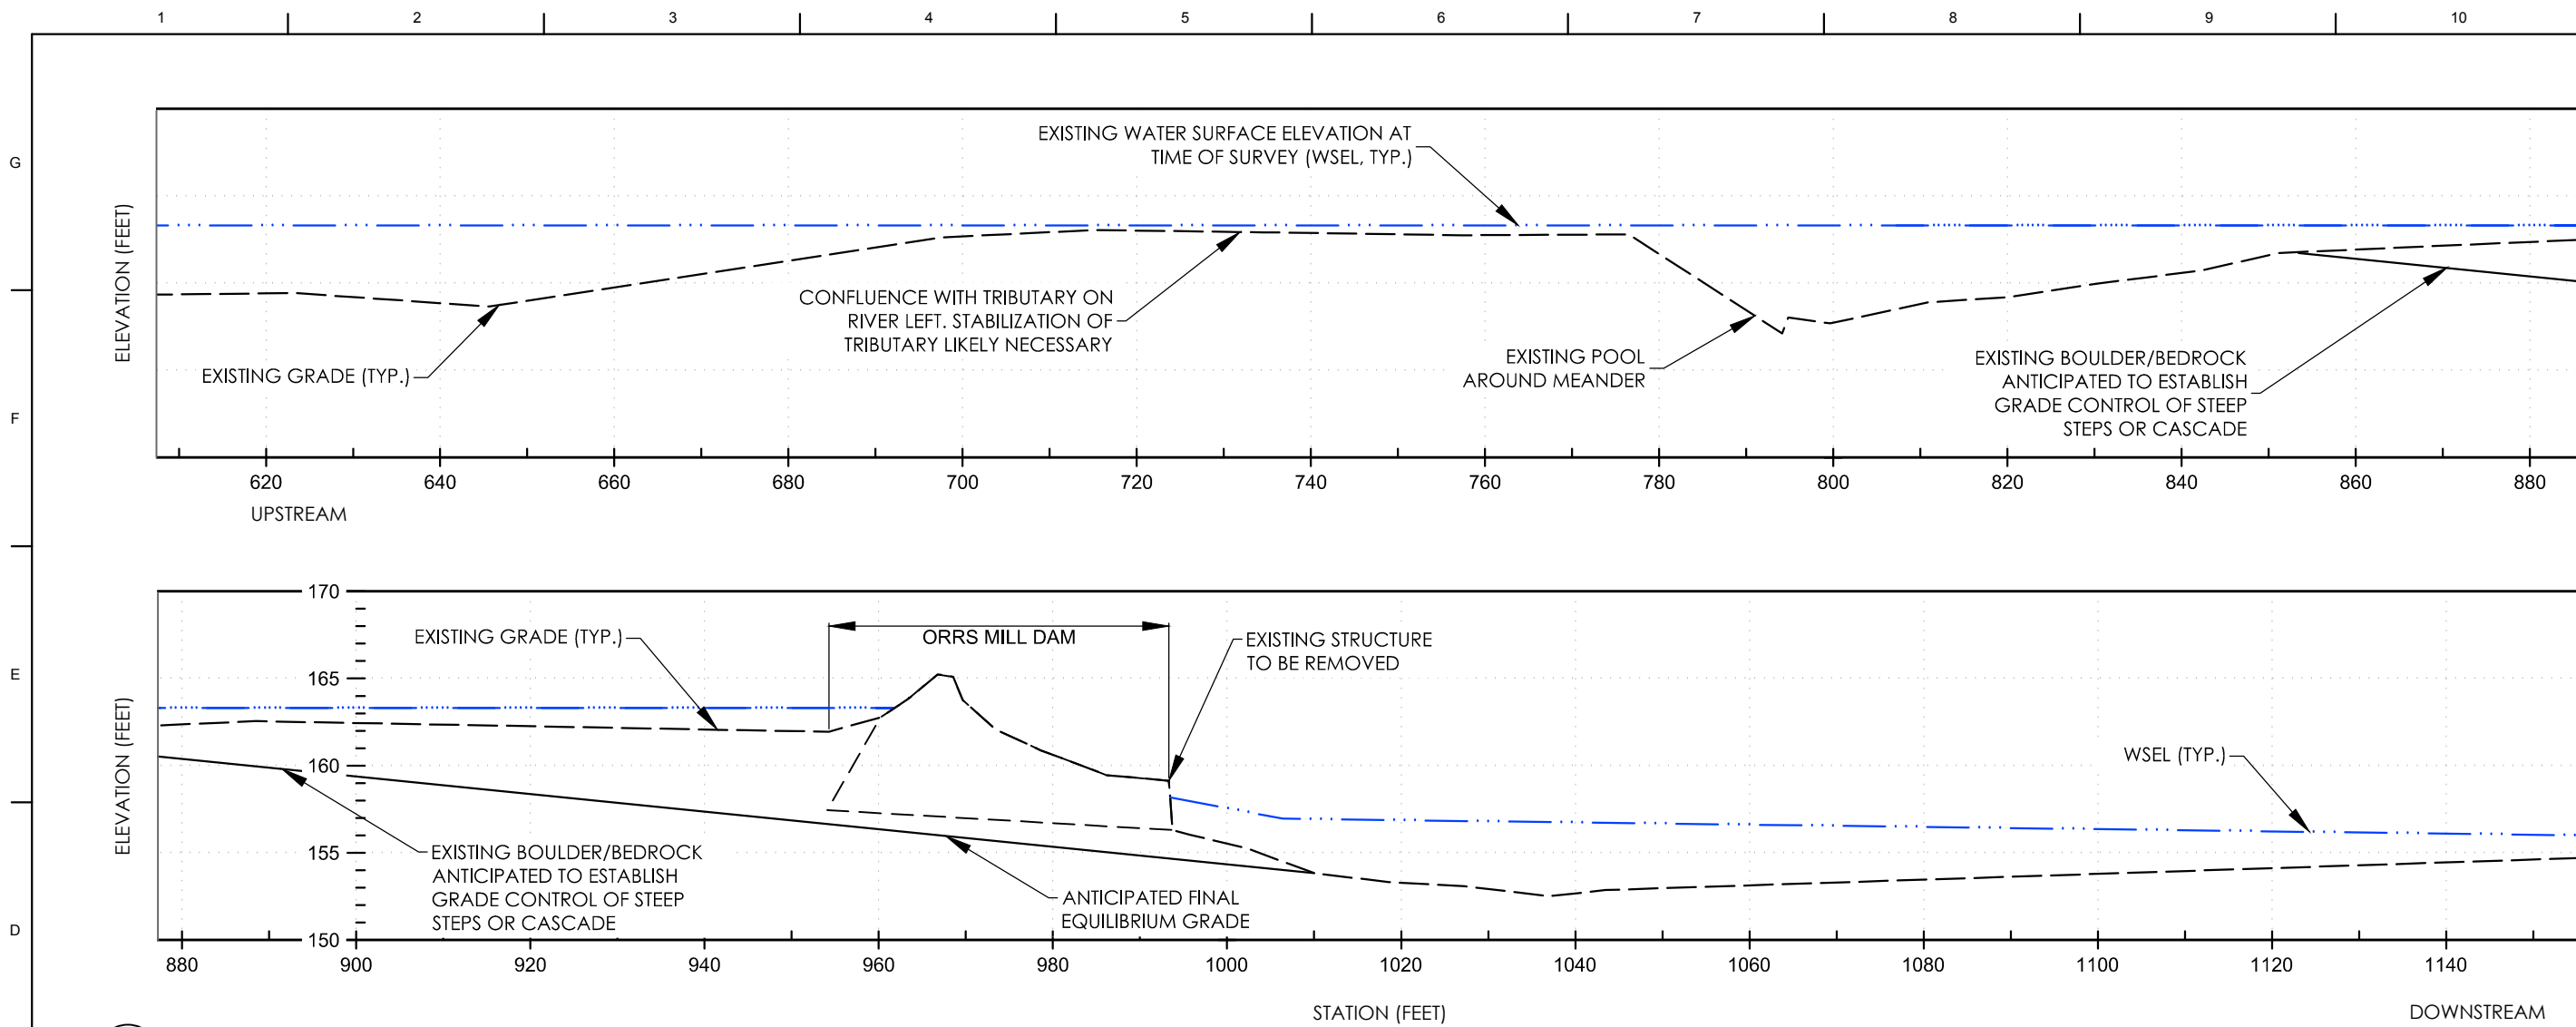
**A** AOP 3 - ORRS MILL DAM PROFILE  
ALTERNATIVE 1: DAM REMOVAL  
MOODNA CREEK

Dam or Barrier Removal is a type of AOP which restores free-flowing conditions to a reach of river, transport of sediment and organic material, movement of resident fish and other aquatic organisms, migration of diadromous species, and typically improves water quality including reduced maximum temperatures and increased dissolved oxygen content. Dam removal is often a preferred alternative because it often eliminates a threat to public safety and owner liability, and absolves the owner of further regulatory obligations. In addition, the upfront costs for dam removal are typically lower than for dam repair or rebuild, and there are no long-term costs for monitoring, maintenance, and repairs. Dam / Barrier removal was proposed as Alternative 1 for Orr's Mill Dam on Moodna Creek, Alternative 2 for Firth Cliff Dam on Moodna Creek, and Alternative 2 for Eddyville Dam on Rondout Creek.

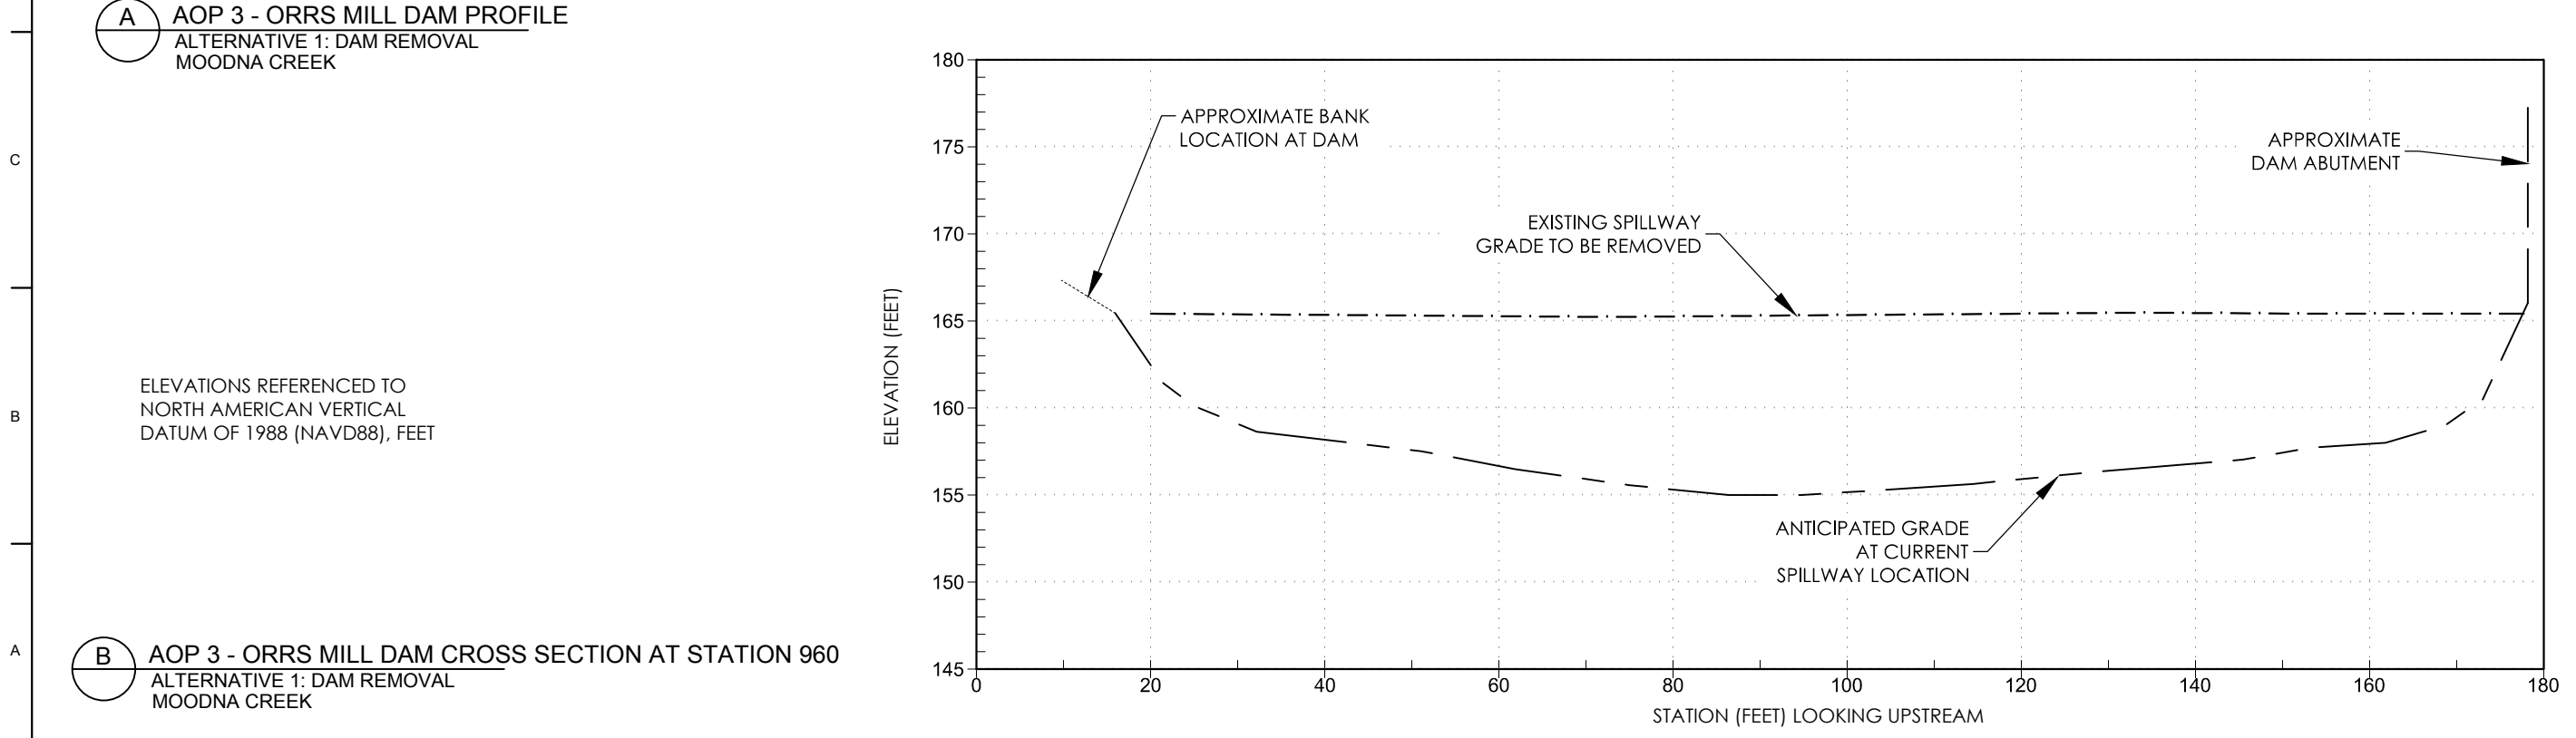
**B** AOP 3 - ORRS MILL DAM CROSS SECTION AT STATION 960  
ALTERNATIVE 1: DAM REMOVAL  
MOODNA CREEK
