APPENDIX H2 – QUALITATIVE ECOLOGICAL ASSESSMENT OF POND AT AOC 1

RE: Findings Letter – NYSDEC FWIA Step 1.B Schenectady Depot – Albany County, NY Flora & Fauna Project No. 0012

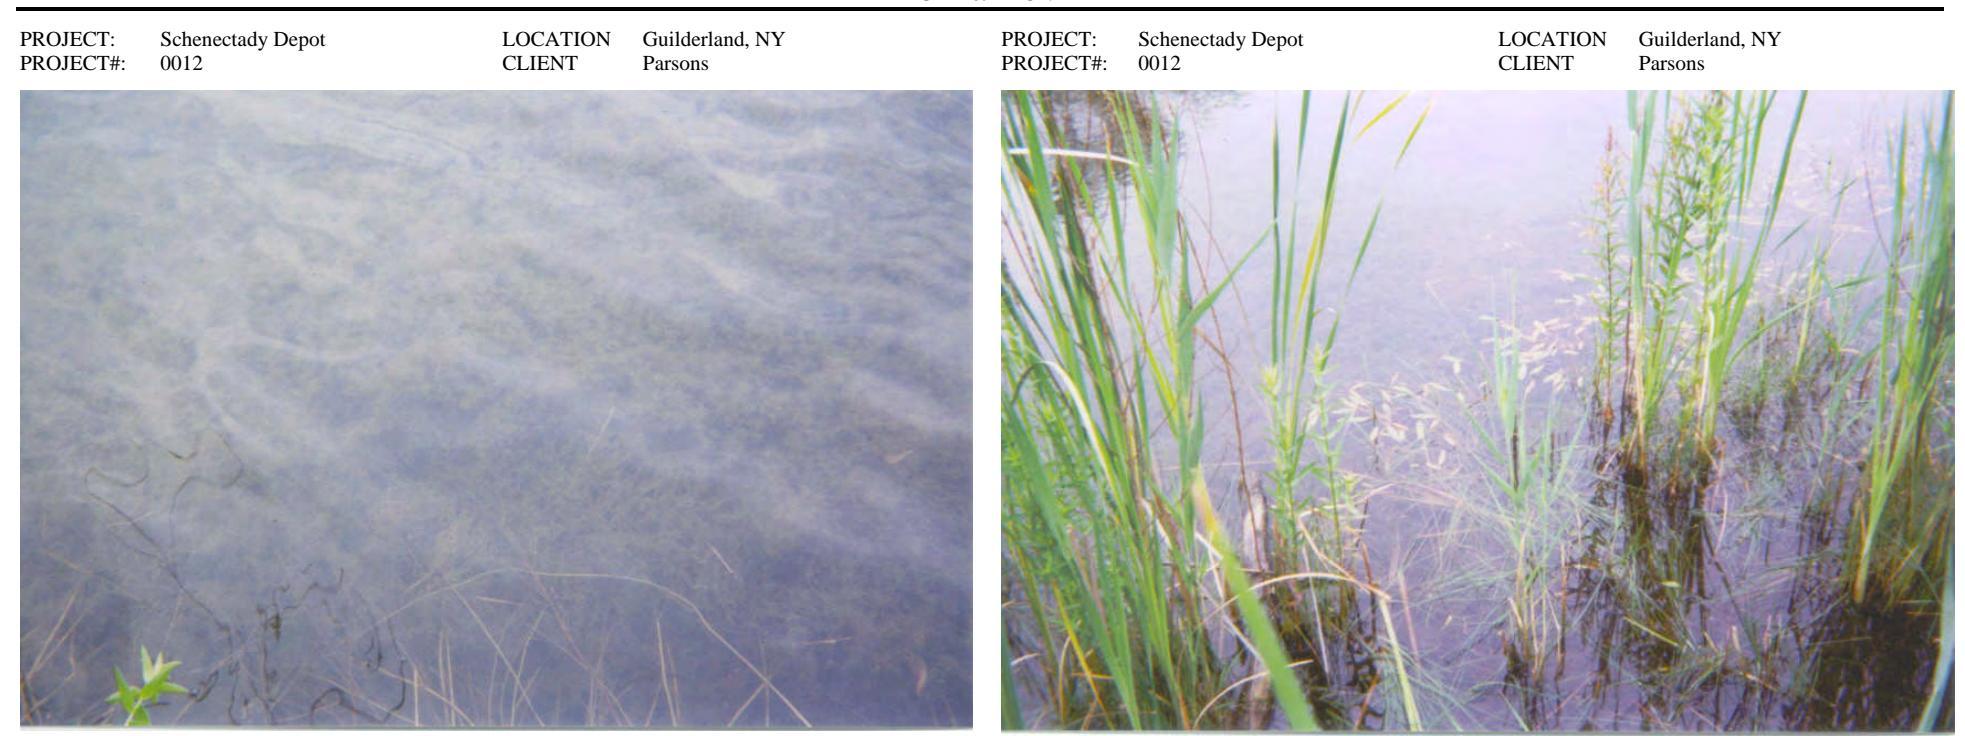
Submergent aquatic vegetation was found to consist almost exclusively of bladderwort (*Utricularia* spp.). This alga covered the bottom of the entire open aquatic area; and ranged in plant height from 6 inches to 1 foot (Photo 1). In addition, patches of a floating aquatic plant, variable leaf pondweed (*Potamogeton* spp.), were found present along the eastern shoreline (Photo 2).

Status as of:6/22/04Photo #1:Shows bladder wort covering of pond bottom.

Status as of:6/22/04Photo #2:Shows patches of variable pond weed present along the eastern edges of the pond..

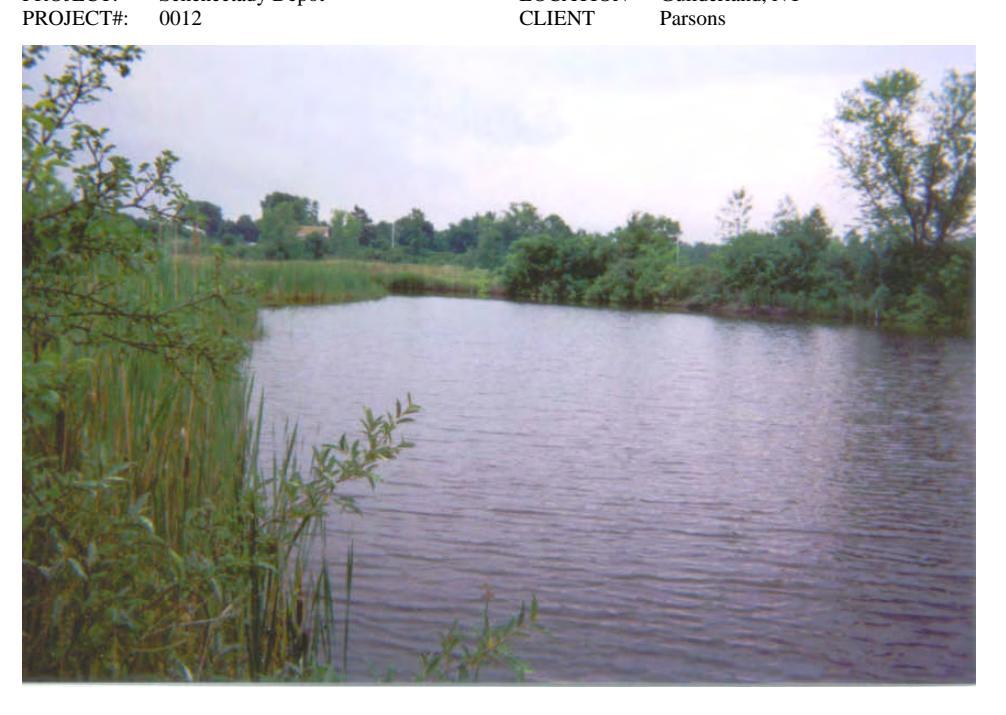
Photo #3:

Emergent aquatic vegetation around the pond was found to be dominated by narrow-leaved cattail (*Typha angustifolia*). The cattails formed large, dense stands along the eastern and southern shores (Photos 3 and 4). The cattails also thickly covered a small island located in the northern portion of the pond (Photo 5). Other species commonly present within the cattail marsh areas included purple loosestrife (*Lythrum salicaria*), spike rush (*Eleocharis acicularis*), twig rush (*Cladium mariscoides*), and common reed (*Phragmites australis*) - though the common reed was only prevalent at the southern end of the pond. Purple loosestrife formed narrow, moderately dense fringes along the eastern shoreline (Photo 6).

View is looking east across the pond. Photo shows the cattail dominated marsh along the eastern shore of the pond. Photo also shows the proximity of the active railway line that runs parallel to the eastern shore.

Photo #4: View is looking south across the pond. Photo shows the cattail and common reed dominated marsh present along the southern shore of the pond.

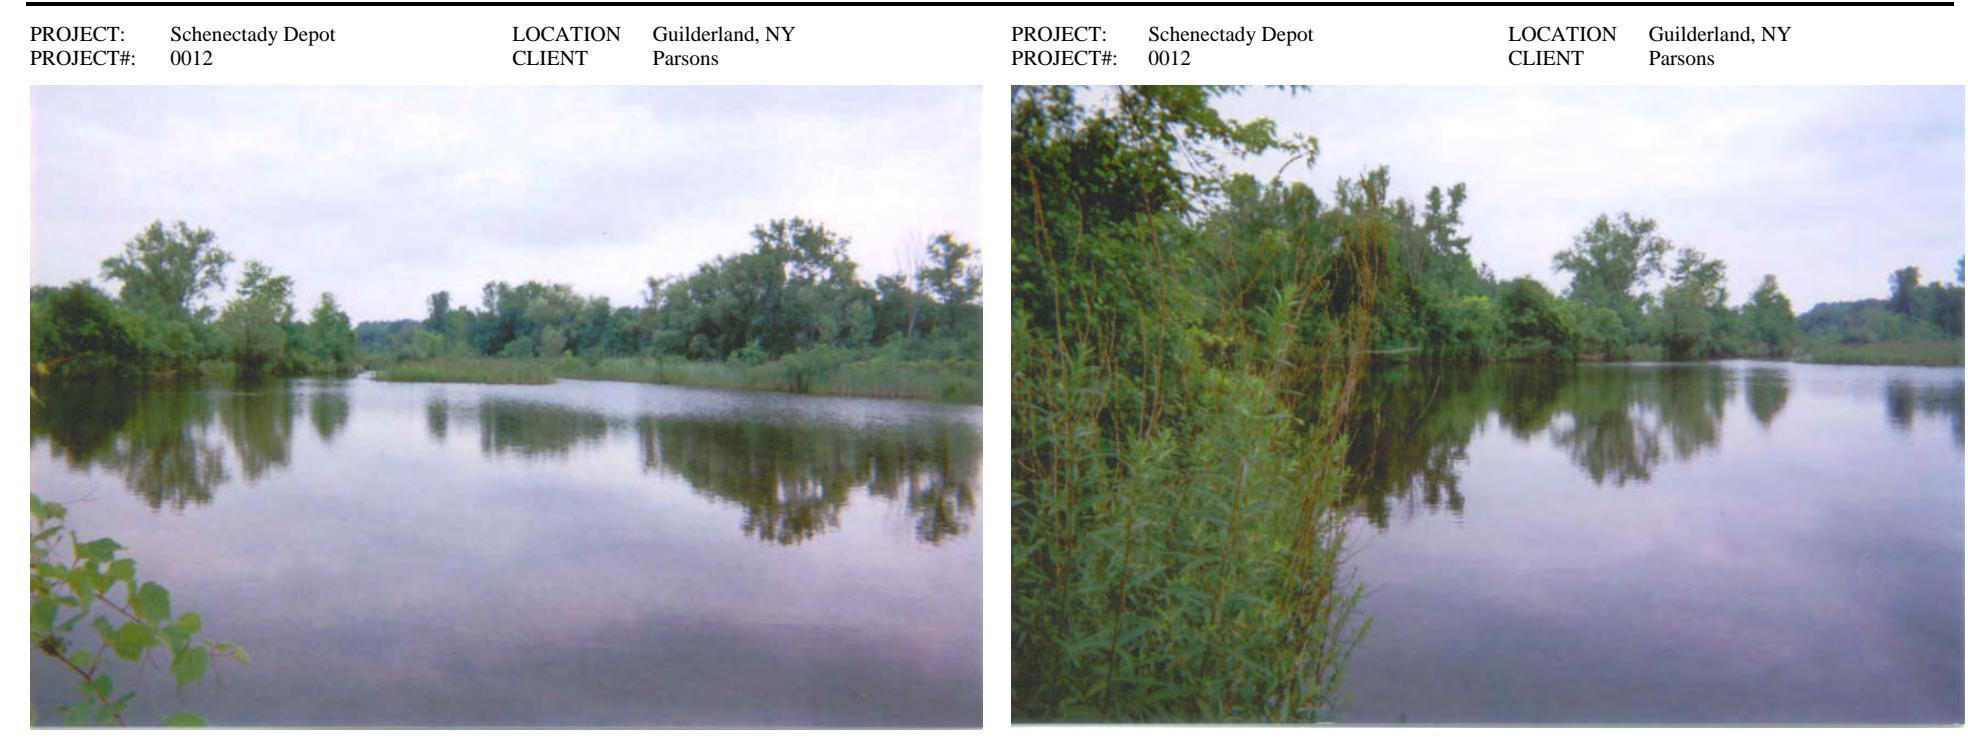
Photo #5: View is looking north across the pond. Photo shows the small cattail dominated island present in the northern section of the pond. Photo also shows the cattail fringe present along the eastern shore of the pond.

View is looking north along the western edge of the pond. Photo shows the narrow fringe of purple loosestrife present along the western shore of the pond.

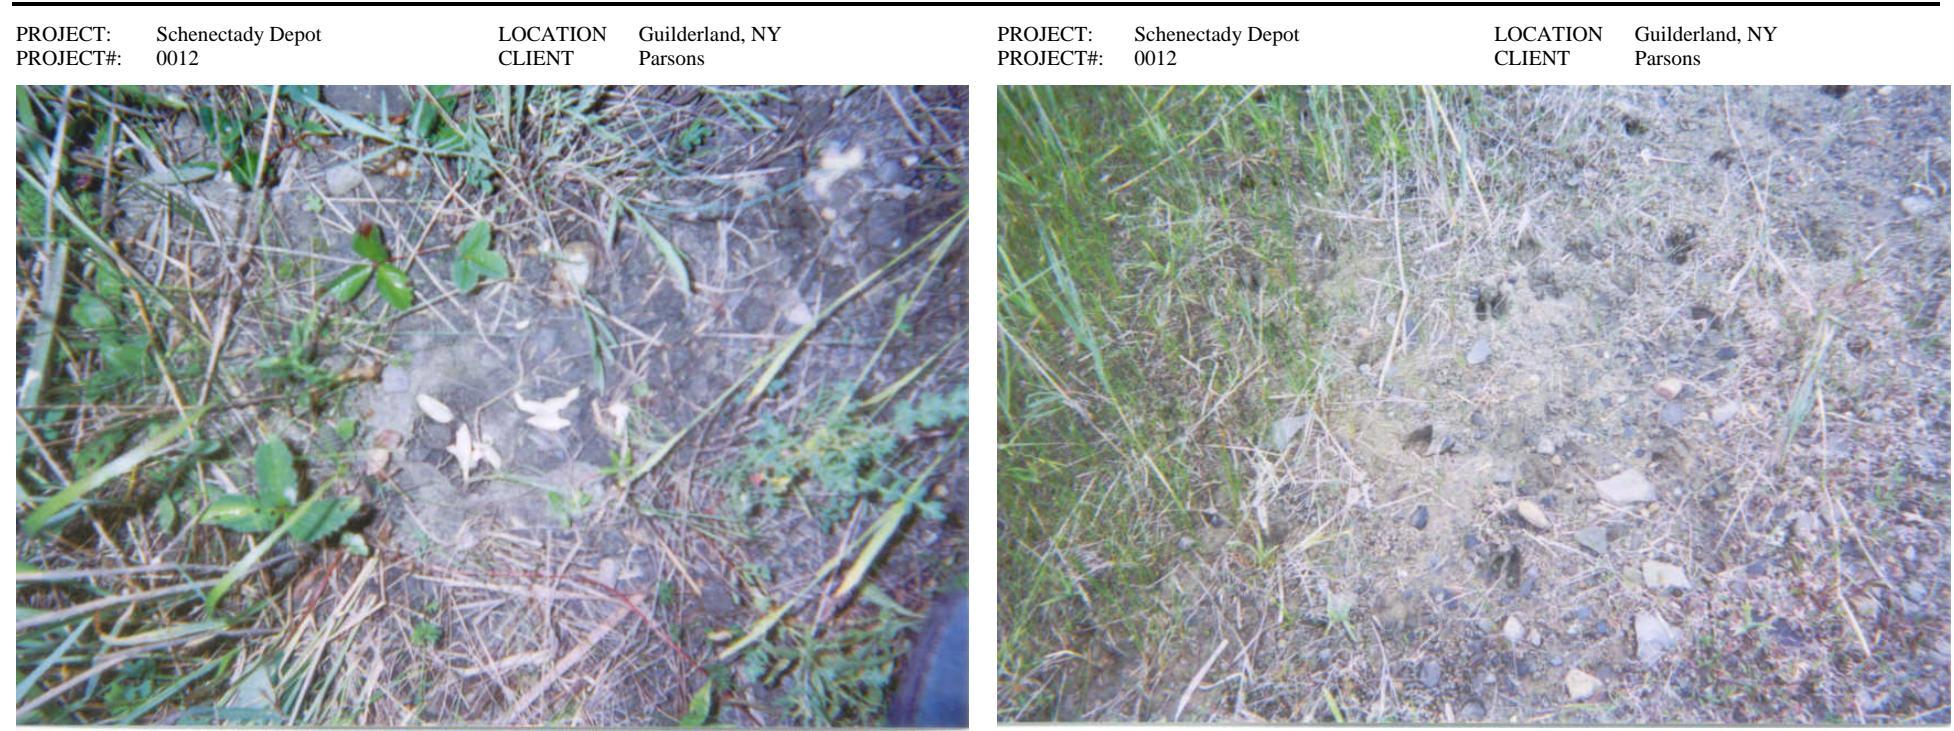
Three turtle nests with eggshell remains were found (Photo 7). The nest sites were investigated to find if any unhatched eggs remained in the nests. No unhatched eggs were found remaining within the nests. Also, no signs of claw marks and/or enlargement of the nest sites were observed that would suggest the

Deer trails and tracks were numerous around the shoreline of the pond (Photo 8), indicating that the area supports an active deer population. Raccoon tracks and scat (Photo 9) were also observed around the pond. The entire depot area is surrounded by high fences, so some restriction of the movement of animals to-and-from the pond is expected.

Photo #7: Photo shows a turtle nest site. The dug depression and the remnants of the shells are evident. No unhatched eggs were found remaining within the nests. No signs of claw marks and/or enlargement of the nest sites were observed that would suggest the eggs were dug up and eaten by predators. These circumstances suggest that the eggs were laid normally and the hatchlings emerged successfully.

Photo #8: Photos shows deer tracks present in the soft soils surrounding the pond; thus demonstrating the presence of deer in the area.

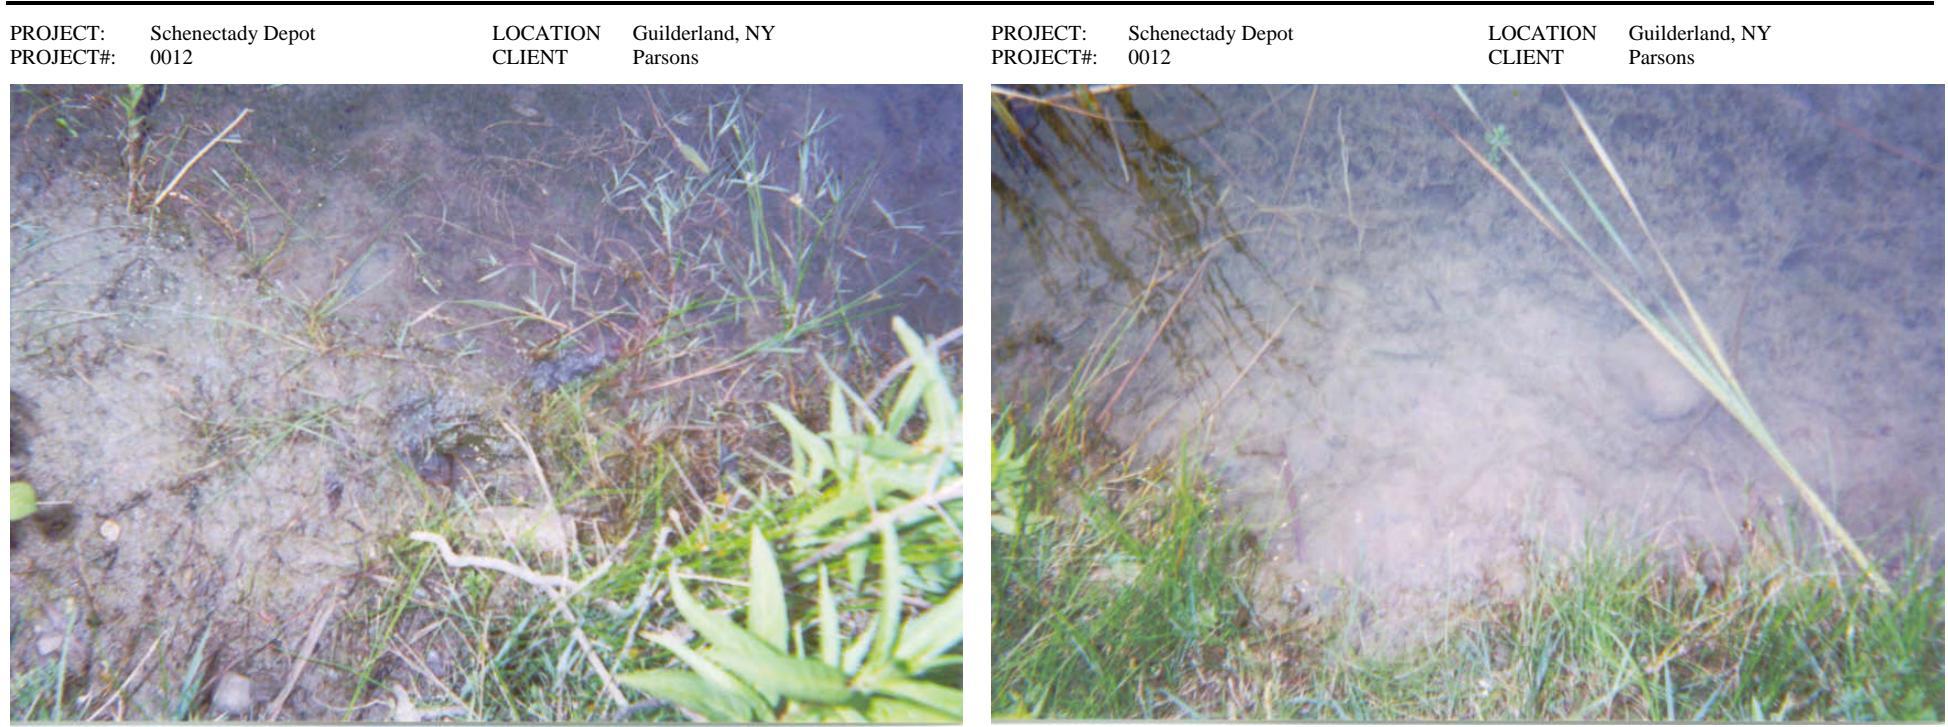
A grayish-white film was noted coating the pond floor (Photo 10). The 1983 USDA Soil Conservation Service *Soil Survey of Albany County, NY* (Figure 4) lists the pond as a wet spot situated within Udorthent soils (i.e., soils that have been manipulated through man's development activities and thus no longer possess a set geologic profile). Accordingly, it could not be determined from the site visit whether the film was from a natural source, such as fine clay silt present in the area, or an introduced source. Two small ditches leading into the pond from the east were found to possess a bluish hue and an oily sheen (Photo 11). The approximate locations of these ditches are shown in Figure 3. Water runoff toward the pond from the east comes from the direction of a well-used railroad track. However, it could not be determined from the site visit whether the blue coloring and sheen were coming from a natural source, the railroad track, or from some other introduced source.

Status as of:6/22/04Photo #9:Photos show raccoon scat present at the edge of the pond.

Status as of:6/22/04Photo #10:Photo shows the grayish-white film coating the pond bottom.

The grayish-white film coating the bottom of the pond and the reason for the bluish color and oily sheen observed in the feeder ditches may warrant further investigation. Otherwise, no further signs of stress other were observed at the pond. The water was clear and odorless. No fish or wildlife carcasses were found. The observed species composition seemed appropriate for the habitat conditions present. And, all species present appeared active and looked & behaved in a normal fashion.

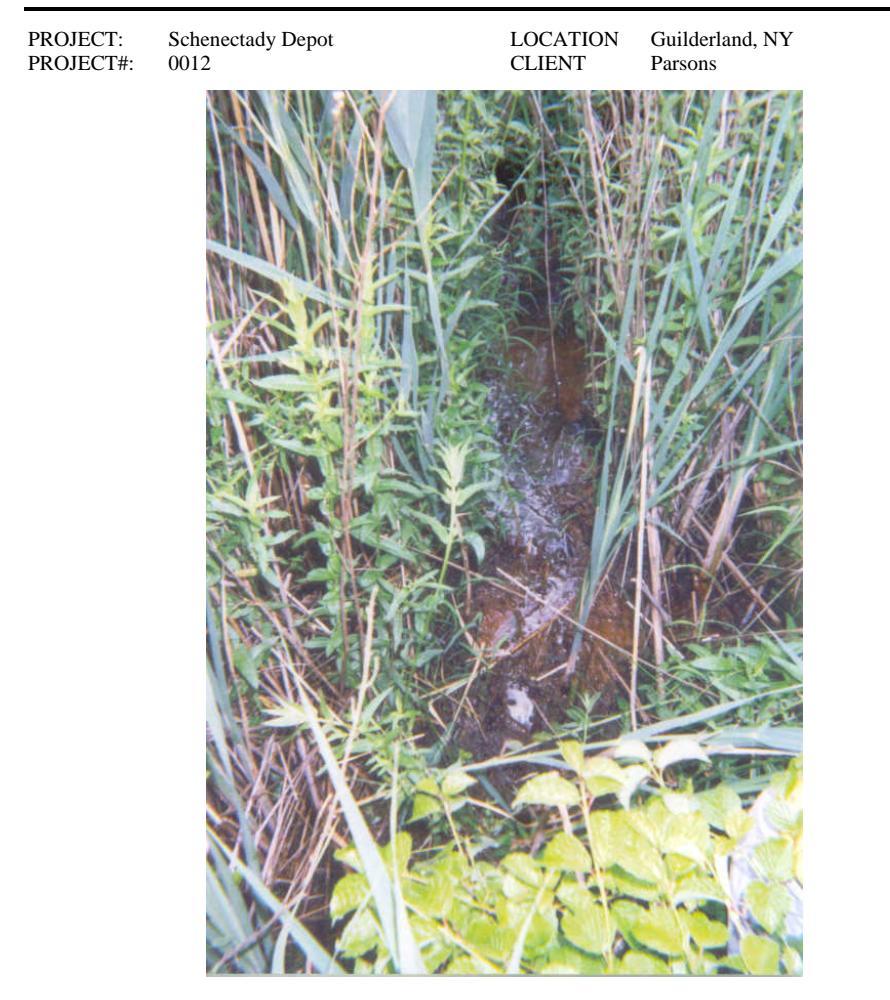
Photo #11: Photo shows one of the two small ditches present in the northeastern portion of pond that exhibited a bluish color and an oily sheen..
