Integrated Hurricane Sandy
General Reevaluation Report
and
Environmental Impact Statement

Atlantic Coast of New York

East Rockaway Inlet to Rockaway Inlet and Jamaica Bay Appendix B – Economic Benefits

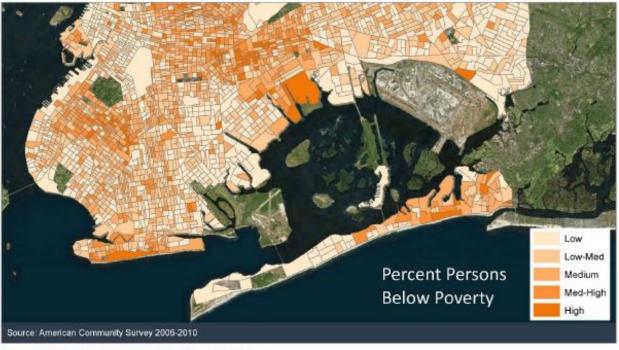
Figure 1-2: Persons below Poverty Level

NYSDEC publishes county maps identifying PEJAs, including Kings, Queens, and Nassau counties. **Figure 1-2** identifies the proportion of persons below the poverty level for census blocks within project area communities.

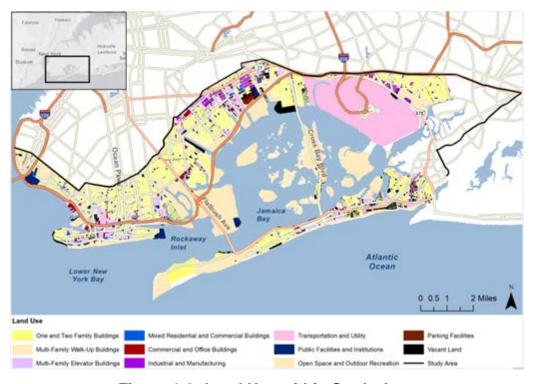
Figure 1-3: Land Use within Study Area

The majority of land in the immediate study area contains residential development with commercial development concentrated within residential areas and extensively in designated business zones. The majority of land development within the study area is more than 25 years old. **Figure 1-3** shows a map of land use within the study area, and **Table 1-3** shows land use in the

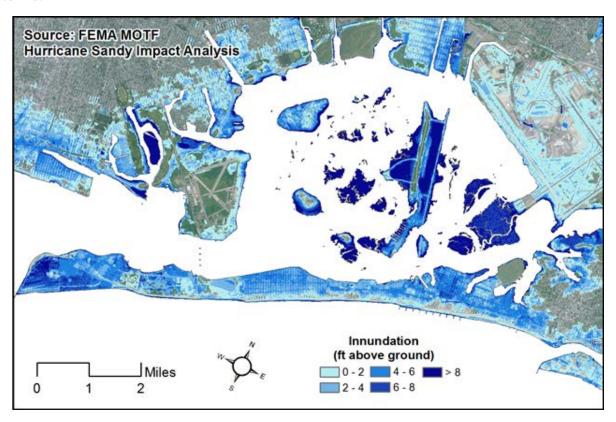
Figure 2-1: Hurricane Sandy Flood Inundation

The Rockaway Peninsula and Jamaica Bay were some of the hardest hit areas by Hurricane Sandy. An overview of the extent of flooding in the project area is shown in **Figure 2-1**. As the storm surge rose, the peninsula and bay side communities were flooded with water from the ocean and from the bay. Along the shorefront, strong ocean waves and currents carried water, sediment, and debris across the peninsula leaving behind a wake of destruction (**Figure 2-2**). Many homes and other buildings, including the boardwalk, were destroyed by waves or flooding and many more were severely damaged (**Figure 2-3** and **Figure 2-4**). At least four people are known to have died in this area. In addition to the direct effects of flooding, the storm caused the outbreak of multiple fires in Rockaway caused by the interaction of electricity and sea water, including one in Breezy Point that destroyed over 100 homes. Critical services like electricity and water were knocked out leading to dangerous conditions, particularly in high-rise structures. Every community along the bayfront suffered extensive flooding, damaging homes and infrastructure.

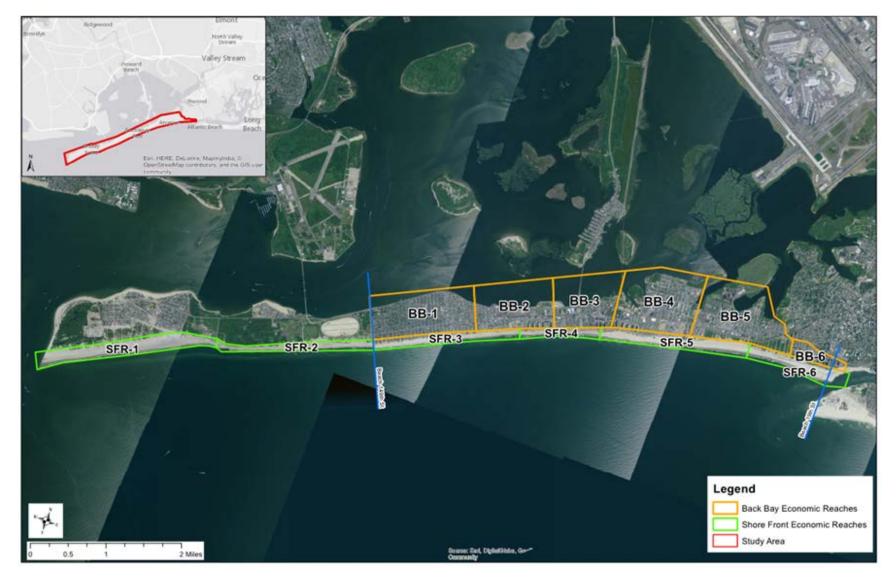
Figure 4-1: Study Area Primary Economic Reaches

In order to evaluate damages from these three main flood sources and develop appropriate stage versus damage relationships, the Rockaway Peninsula portion of the study area was divided into a total of twelve primary economic reaches (**Figure 4-1**): six reaches SFR-1 through SFR-6 to evaluate shorefront flooding conditions, and six reaches BB-1 through BB-6 to evaluate non-shorefront (backbay and cross-shore) flooding conditions. Reaches SFR-1 through SFR-6 were further subdivided for purposes of improving economic assessments. The alternative plans provide risk management up to the easternmost project limit at Beach 19th Street. The study area includes a handful of structures in an area immediately to the east of Beach 19th Street that would also be affected by the project. Information detailing the value and flood vulnerability of development in each subreach is provided in Sub-Appendix A.

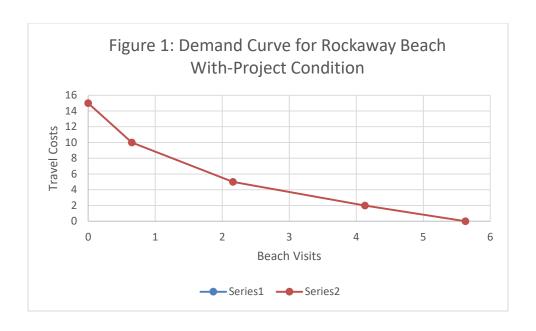
The use value for the existing condition at Rockaway Beach is calculated by measuring the area under the demand curve represented by regression equation 1. The estimated demand curve is displayed in Figure 1. A demand curve is shown by varying Travel Cost and calculating how annual visits change (Table V-A).

Change in Travel Costs	Estimated Number of Visits	Area Under Demand Curve
\$20.00	0	0
\$15.00	0	0
\$10.00	.65	8.125
\$5.00	2.16	11.325
\$2.00	4.13	6.895
\$0.00	5.63	1.5
	Consumer Surplus	\$27.845
	Consumer Surplus per Visit	\$4.94

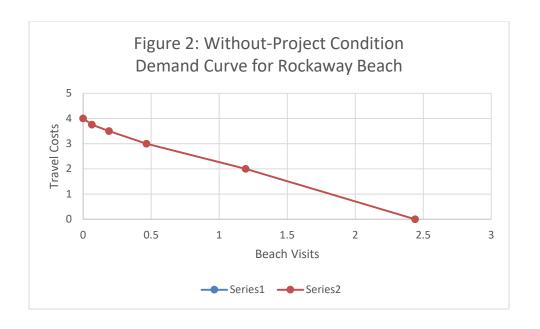
The without-project condition use value is estimated using a travel cost regression model similar to Equation 1, substituting visits under the without-project condition for existing visits as the dependent variable. Only respondents that had positive without-project visits can be used; reducing the number of observations to 38.

Change in Travel Costs	Estimated Number of Visits	Area Under Demand Curve
\$4.00	0.00	0.00
\$3.75	0.07	0.25
\$3.50	0.19	0.45
\$3.00	0.47	0.90
\$2.00	1.20	1.82
\$0.00	2.44	1.25
	Consumer Surplus	\$4.67
	Consumer Surplus per Visit	\$1.91
