**SOUTH SHORE OF STATEN ISLAND
COASTAL STORM RISK MANAGEMENT**

**INTERIM FEASIBILITY STUDY
FOR
FORT WADSWORTH TO OAKWOOD
BEACH**

ENGINEERING & DESIGN APPENDIX

**U.S. Army Corps of Engineers
New York District**

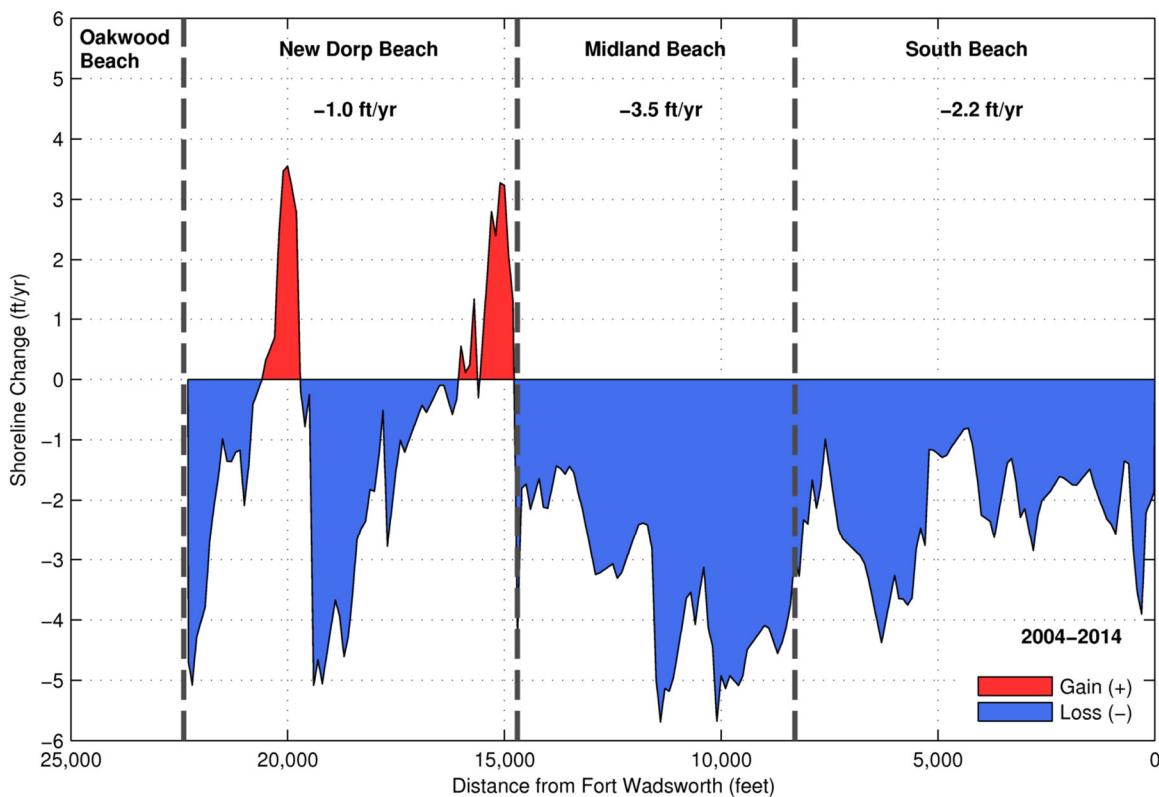
Figure 2-3: Recent Shoreline Changes

The observed shoreline changes are shown in Figure 2-3. Reach average shoreline change rates along South Beach, Midland Beach, and New Dorp range between -1 ft/yr to -3.5 ft/yr. These shoreline change rates are similar to the historical sediment budget described below.

Recent shoreline changes were analyzed by comparing aerial imagery from the spring of 2004 and spring of 2014 that were published by Google Earth. This analysis was performed to reaffirm the historical shoreline trends described above and sediment budget described below. The wet/dry line on the aerial photography was selected as the baseline shoreline for 2004 and 2014. During this 10-year period the City of New York City Department of Parks and Recreation (NYC Parks) has performed miscellaneous beach management activities that include beach scraping and construction of artificial dunes. An exact accounting of sediment added to the active littoral system from these activities is not available but the assumption is that these activities did not provide a significant contribution to the sediment budget or shoreline change.

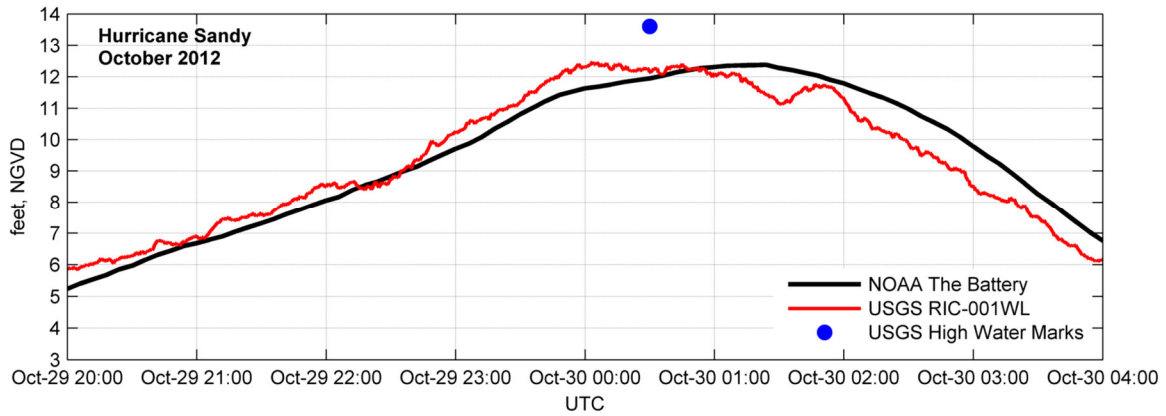
Figure 2-7: Hurricane Sandy Storm Tide and High Water Marks

The south shore of Staten Island was one of the hardest hit areas by Hurricane Sandy. USGS deployed storm tide sensors and surveyed high water marks after the storm that indicated the maximum water levels during Sandy were likely between 12.5 and 13.6 ft, NGVD within the project area (USGS, 2013). Figure 2-7 shows a time series of the recorded water levels at Fort Wadsworth (RIC-001WL), The Battery, and surveyed USGS high water marks. It is noted that high water marks may be higher than still water levels just offshore of the shoreline since they may include an additional increase in the water level from wave setup or wave runup.

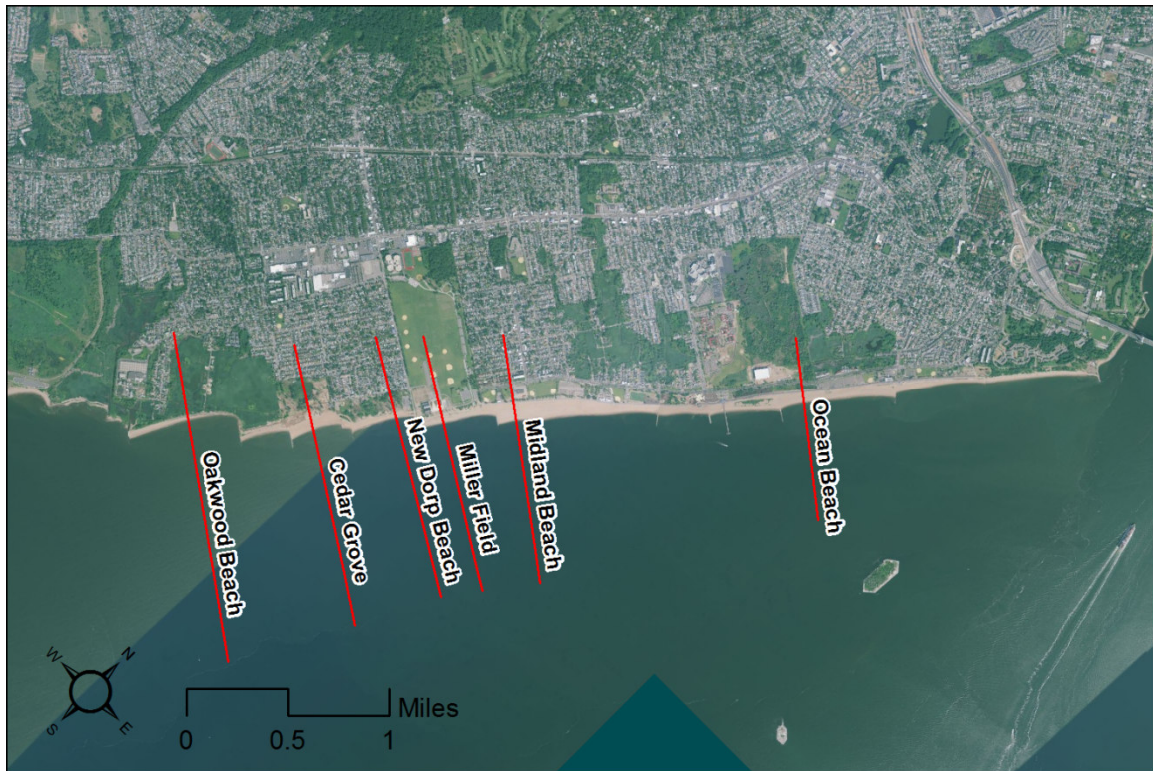
Figure 3-1: SBEACH Profile Locations

Six profile transects were selected to capture the variability in the beach conditions. The profile topography (above MHW) was obtained from the Post-Sandy 2012 LIDAR data. The submerged portion of the profile was based on the February 2000 beach profile surveys. Figure 3-1 shows the six SBEACH profile transects. The alongshore spacing of the SBEACH profile transects was selected based on the alongshore variability in the beach conditions and availability of submerged profile data. The beach conditions from Fort Wadsworth to Midland Beach are fairly uniform and two profiles are adequate to capture the range in beach conditions. More detail about the uniformity of the beach conditions in the study area is provided in (Figure 5-2, Section 5.3).

With Project SBEACH simulations were performed at the same six profiles as in the Without Project modeling (Figure 3-1). Seawalls were added to the profiles based on the preliminary location of the toe of the structure. A failure threshold for the seawalls was not added to SBEACH since the primary goal is to evaluate how the structure impacts profile change during storm events. Therefore the structure is treated as an infinitely high vertical wall. SBEACH does not model the detailed physics at the structure: wave runup, wave reflection, and local scour. However, SBEACH does capture the larger scale effect of the structures on the profile change such as preventing wave overwash and starving the area immediately seaward of the structure of sand.

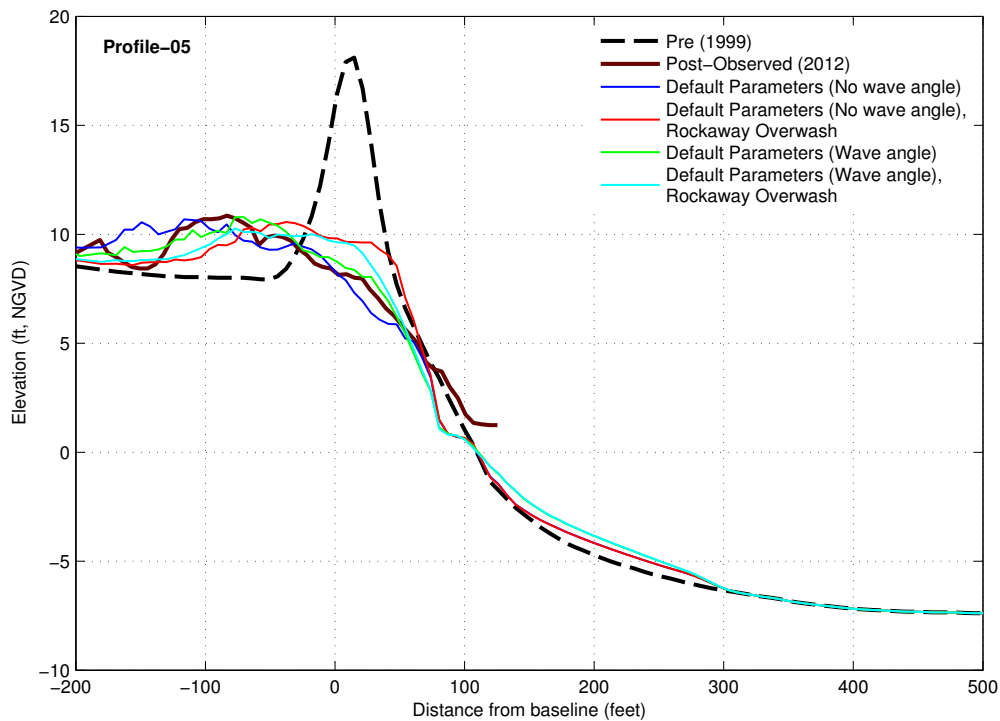
Figure 3-2: SBEACH results from Hurricane Sandy simulation (New Dorp Beach)

The model has been verified based on field measurements at Duck, NC; Manasquan, NJ; Point Pleasant, NJ; and Torrey Pines, CA (Larson and Kraus 1989a, Larson et al. 1989b). However, it is still recommended that site specific model calibration be performed. No suitable data was available in the Project Area to calibrate the model. The available topographic data, 2001 and 2012, is too far apart to be used for model calibration. A sensitivity analysis and qualitative model validation was performed for Hurricane Sandy based on the available topographic data. Figure 3-2 presents the results of the SBEACH simulations at New Dorp Beach, capturing the erosion of sandy dune that occurred during Hurricane Sandy (Figure 3-3). The model sensitivity analysis shows that model is able predict the erosion of the sandy dune.

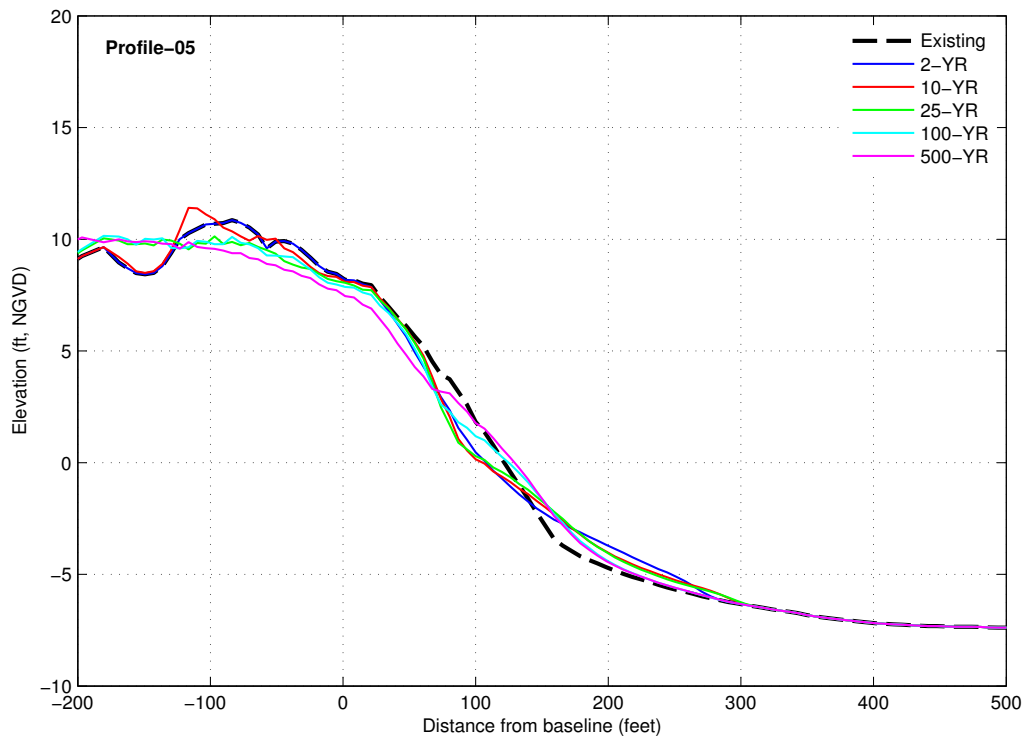
Figure 3-5: SBEACH Without-Project Results for New Dorp Beach

Return Period (Years)	Oakwood Beach	Cedar Grove	New Dorp Beach	Miller Field	Midland Beach	South Beach
2	2	0	1	1	0	2
10	5	0	2	0	1	38
25	104	0	21	0	13	41
100	BC	1	23	5	16	45
500	BC	22	37	12	33	59

Notes: BC - Below contour. Entire profile was below the 8 ft contour at some point in the simulation.

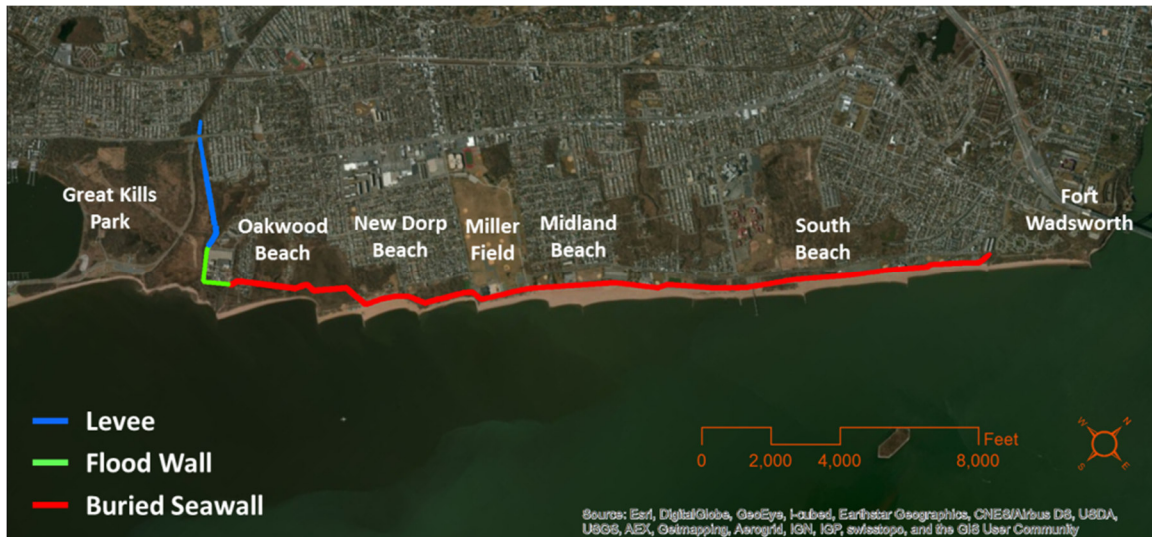
Figure 4-1: Overview of Line of Protection

An overview of the alignment is provided in Figure 4-1.

Starting in Oakwood Beach in Shoreline Reach A-1, the earthen levee with a 10-ft wide crest ties into high ground on the northwest side of Hylan Boulevard. A closure structure, consisting of H-shaped posts that accommodate the stacking of metal panels, is proposed at Hylan Boulevard to prevent floodwaters from flanking the levees during rare high water events. The earthen levee continues southeast through Oakwood Beach parallel to Oakwood Creek and Buffalo Street until the levee crosses over Oakwood Creek. A tide gate structure is proposed at this location. The total length of Shoreline Reach A-1 is 2,800 ft.

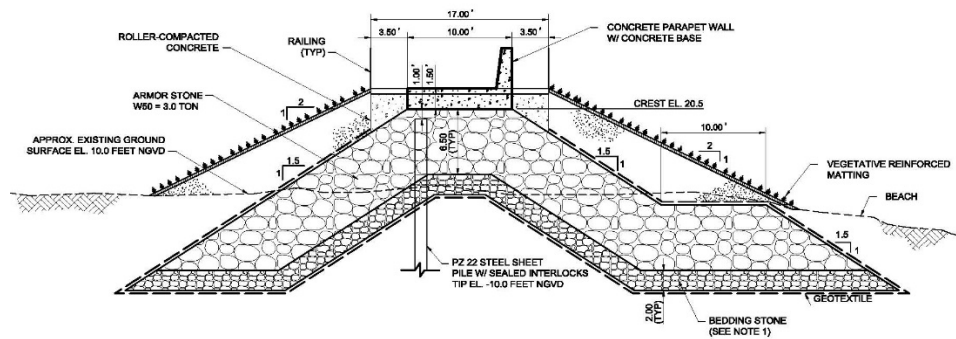
A reinforced concrete parapet wall and base constructed atop the crest of the buried seawall would raise the crest height of the structure by up to 3 feet to provide overtopping protection as shown in Figure 4-2. The parapet wall and base may be aligned with the landward or seaward crest edge of the buried seawall (Figure 4-2 shows the latter alignment). A concrete base integrated with the armor layer of the buried seawall is designed to prevent overtopping and sliding of the parapet wall due to wave-induced horizontal and vertical forces.

The concrete vertical floodwall may accommodate sea level change by raising the top of wall height. By designing the foundation of the concrete floodwall during the initial construction to counteract future hydrostatic and wave forces, the reinforcing steel matrix is arranged to accept doweling of the future cast-in-place concrete wall addition as shown in Figure 4-3.

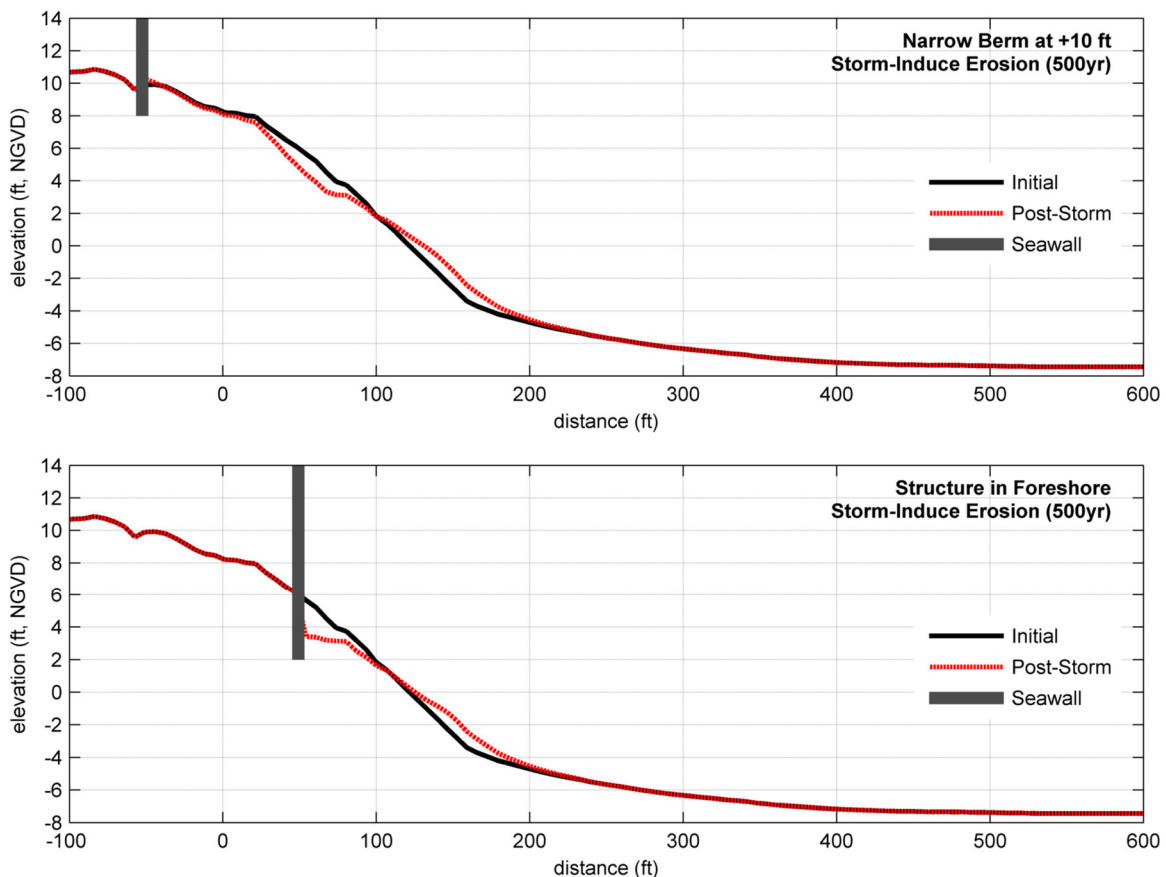
Figure 5-1: Sensitivity of Storm Induced Erosion to Structure Alignment

The effect of the structures storm induced profile change to the location of the structure is presented in Figure 5-1. The top panel shows an example of storm-induced erosion if the structure is located on the berm. In this example the structure does not have a significant impact on the profile erosion. The bottom panel of Figure 5-1 shows an example of storm induced erosion when the structure is located in the foreshore. In this example (bottom panel) the structure has an impact on the profile change and causes an increase in erosion immediately seaward of the structure.

The line of protection was selected to minimize the risk of storm-induced profile lowering at the toe of the structure, which could lead to structural instability. Local scour may occur at the structures due to wave breaking, turbulence, and wave reflection, which is not accounted for in SBEACH.

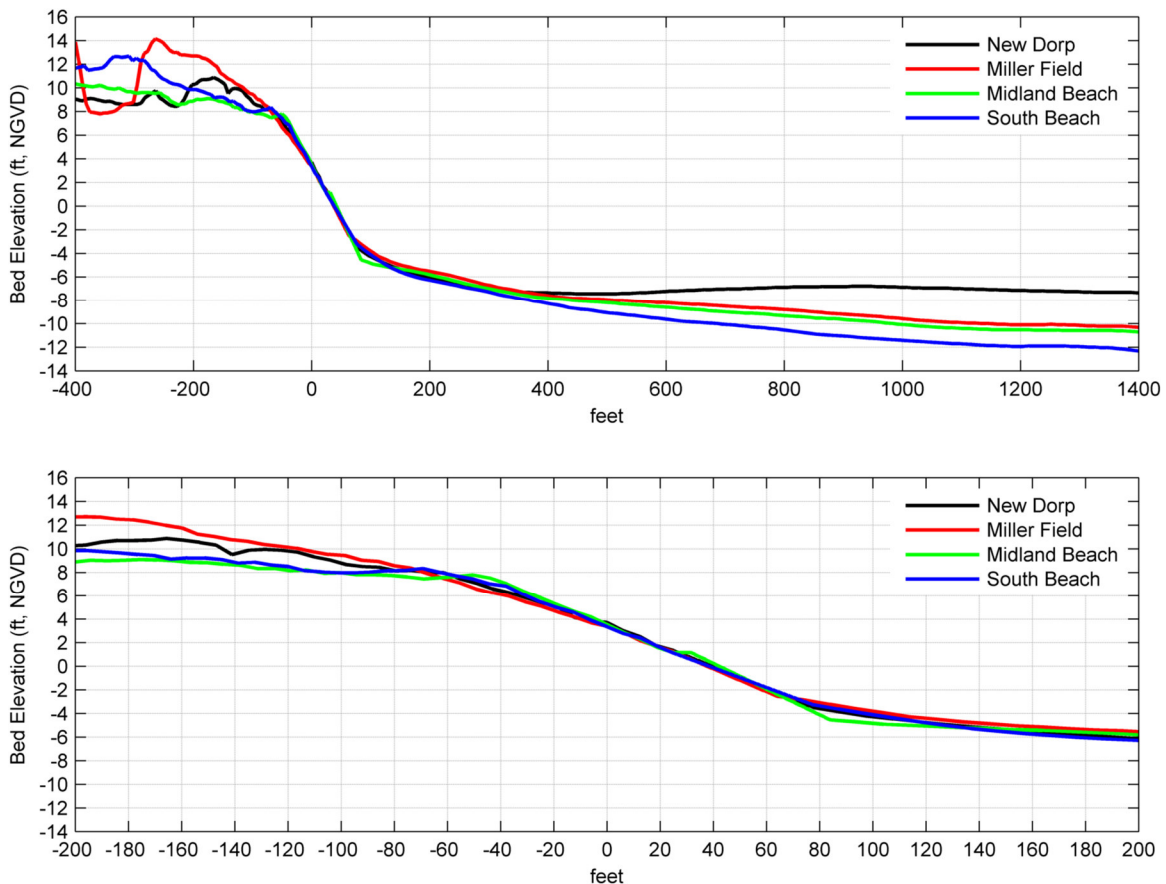
Figure 5-2: Aligned Beach Profiles in Project Area

An analysis of the beach profile characteristics in the study area (Section 2.1.2) indicates that the nearshore and onshore beach slope is fairly consistent throughout the project area. The shoreline may generally be characterized by a gentle offshore slope (e.g. 1:100) and steep nearshore and onshore beach slope (e.g. 1:10). Most of the shoreline is characterized by a gently sloping beach berm between 8 and 10 ft NGVD. Figure 5-2 shows the beach profiles at four locations along the Project Area aligned at MHW, highlighting the similarity in the offshore, nearshore, and onshore beach slopes.
