# Back Bay Flooding Through Inlets

# Back Bay Flooding with a Barrier Island Breach in Great South Bay

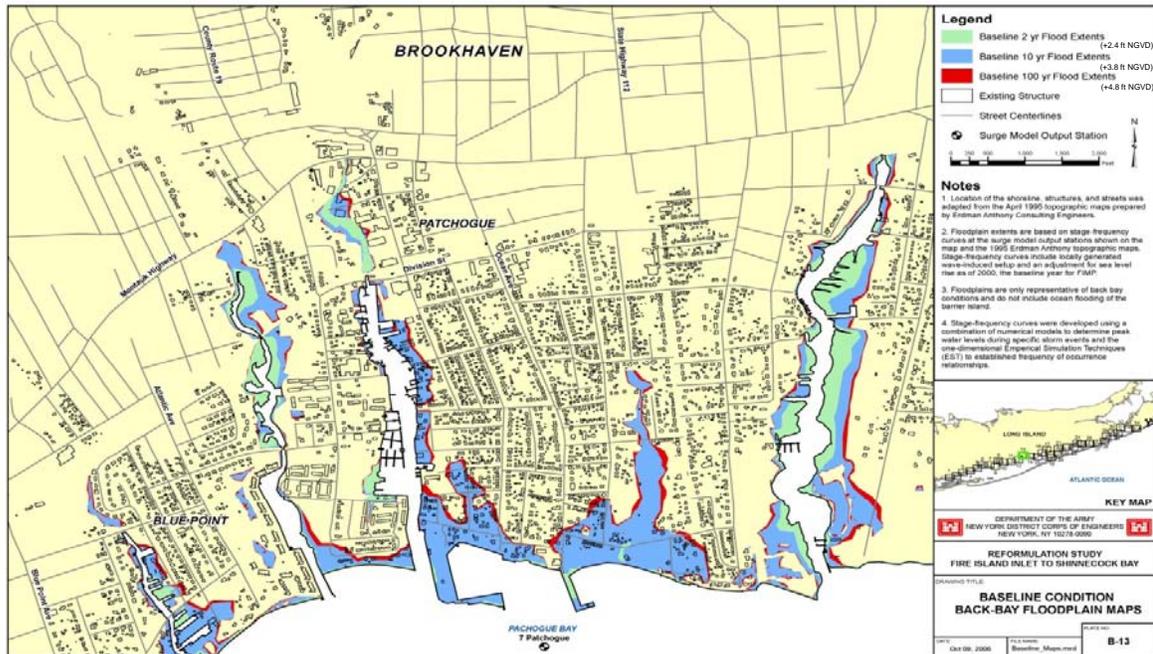
Below is a representative image showing Potential impacts to communities in the 2, 10, and 100 year floodplain with barrier islands in their current configuration. This shows flooding due to water that enters through the inlets, and setup in the bays. Approximately 11,700 buildings are impacted in the 100-yr floodplain scenario.

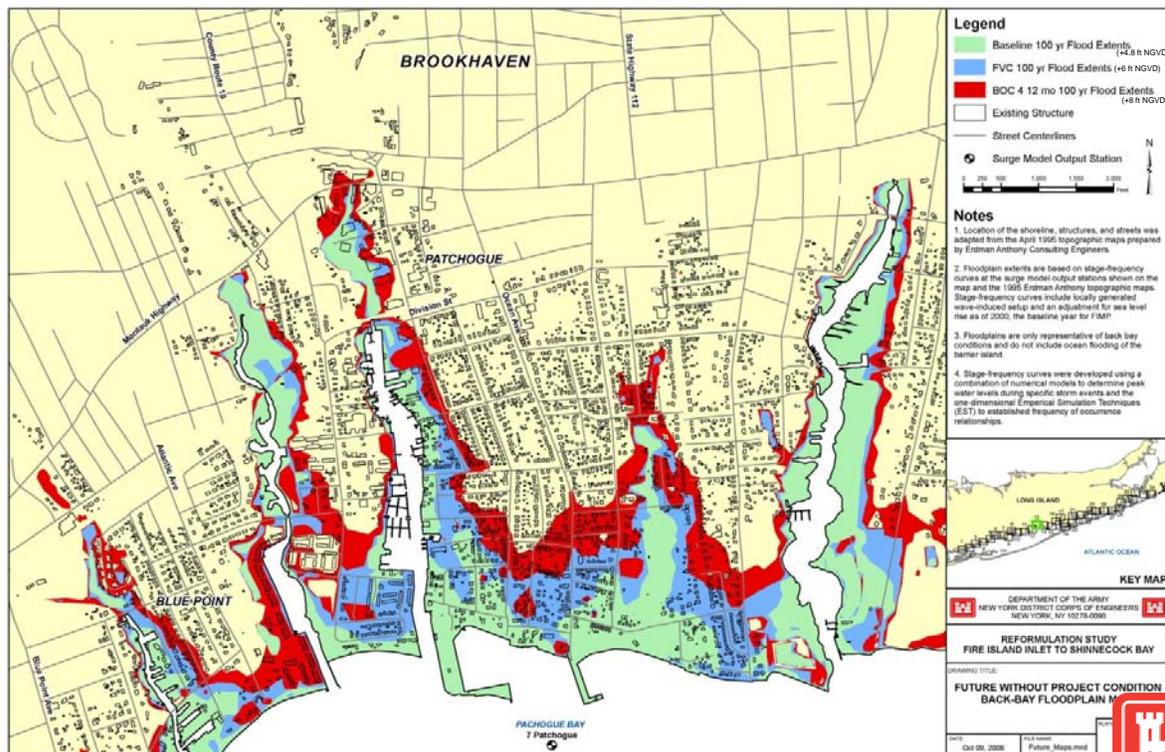
Below is a representative image showing potential impacts to communities due to varying barrier island conditions. The largest area shows the 100 year floodplain with a breach open.

Note: The figure above shows the median for flooding into the bay due to a breach in proximity to this location. There are uncertainties regarding the flooding values. The amount of flooding that would occur also depends upon the location and size of the breach.
