HUDSON-RARITAN ESTUARY COMPREHENSIVE RESTORATION PLAN
POTENTIAL RESTORATION OPPORTUNITIES
PROJECT SUMMARY SHEETS
Jamaica Bay

Restoration Opportunities
CRP Identification #: Site Name

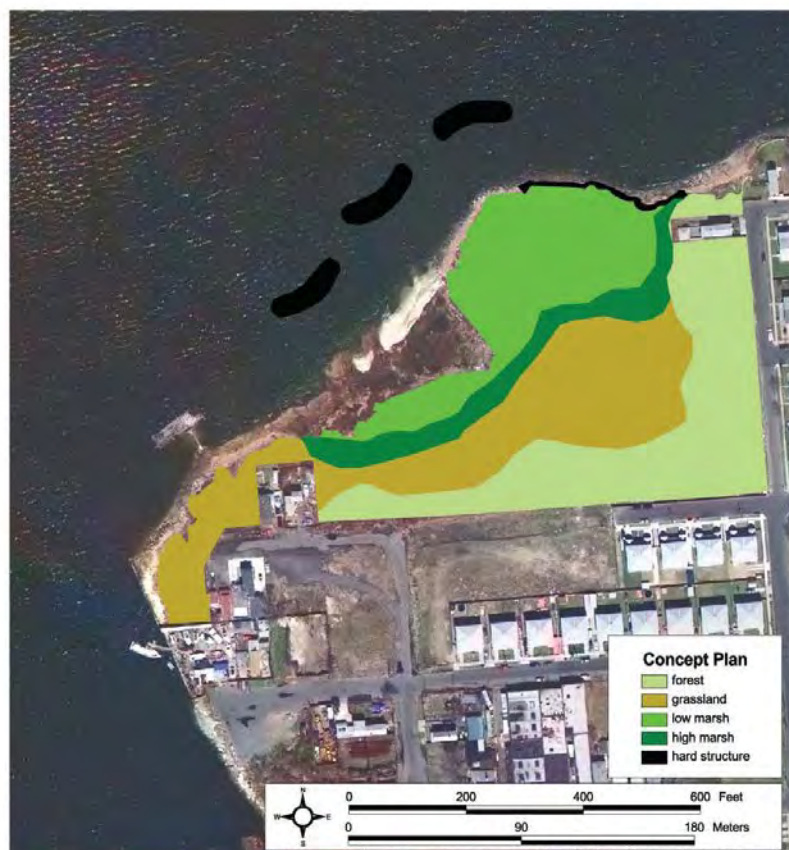
BRANT POINT RECOMMENDED ALTERNATIVE (from Pre-Draft Interim Feasibility Study Report)

Creates macroinvertebrate habitat by creating three offshore rubble mounds with a footprint of approximately 0.36 acres total. These structures will be placed randomly within a trapezoidal shape which incorporate interstitial spaces of various sizes that can be used as refugia by various species and also provide wave attenuation to the area. Additionally, approximately 6 acres of existing benthic habitat should be assessed for composition, level of degradation and potential enhancements to increase habitat connectivity.

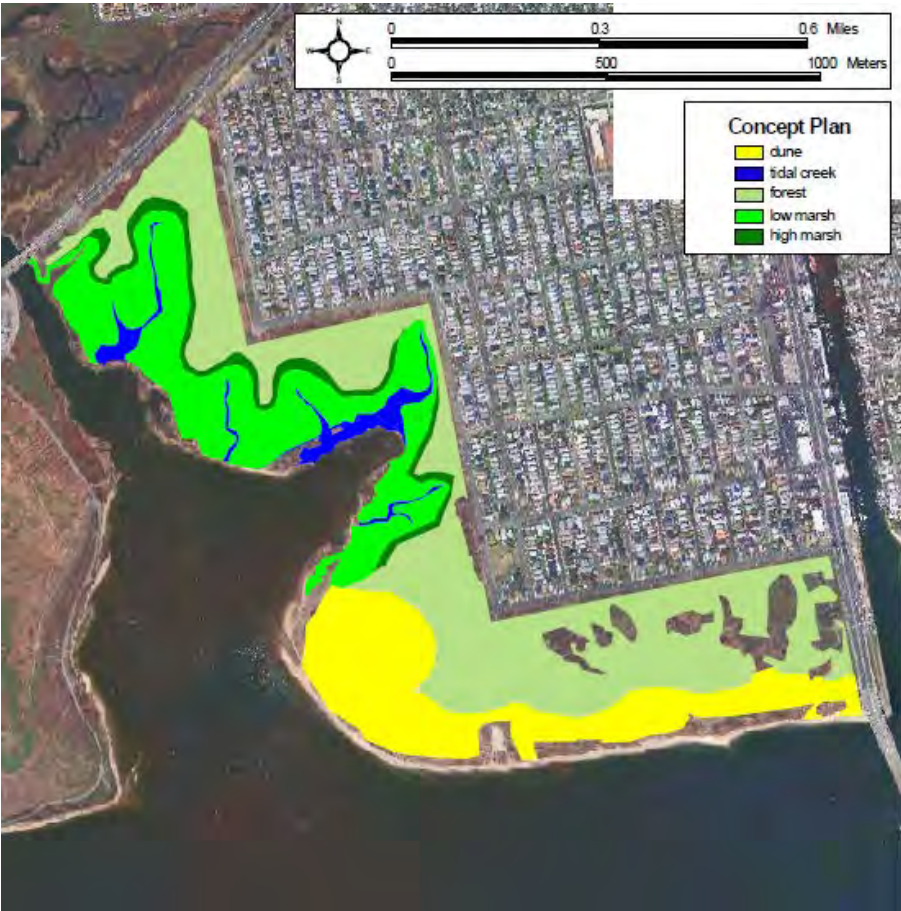
SPRING CREEK RECOMMENDED ALTERNATIVE (from Pre-Draft Interim Feasibility Study Report)

Spring Creek South (Feasibility Study) seeks to improve the habitat in Spring Creek Park, located in northern Jamaica Bay, and bounding the counties of Kings and Queens. The construction, maintenance, and improvement of the network of channels in Jamaica Bay required the dredging of millions of cubic yards of material. Most of this material was deposited in nearby wetland areas, profoundly degrading the salt marsh community at Spring Creek. The proposed project would restore a total of 151.6 acres of habitat including 49 acres of low marsh, 10 acres of high marsh and 6 acres of tidal creek.

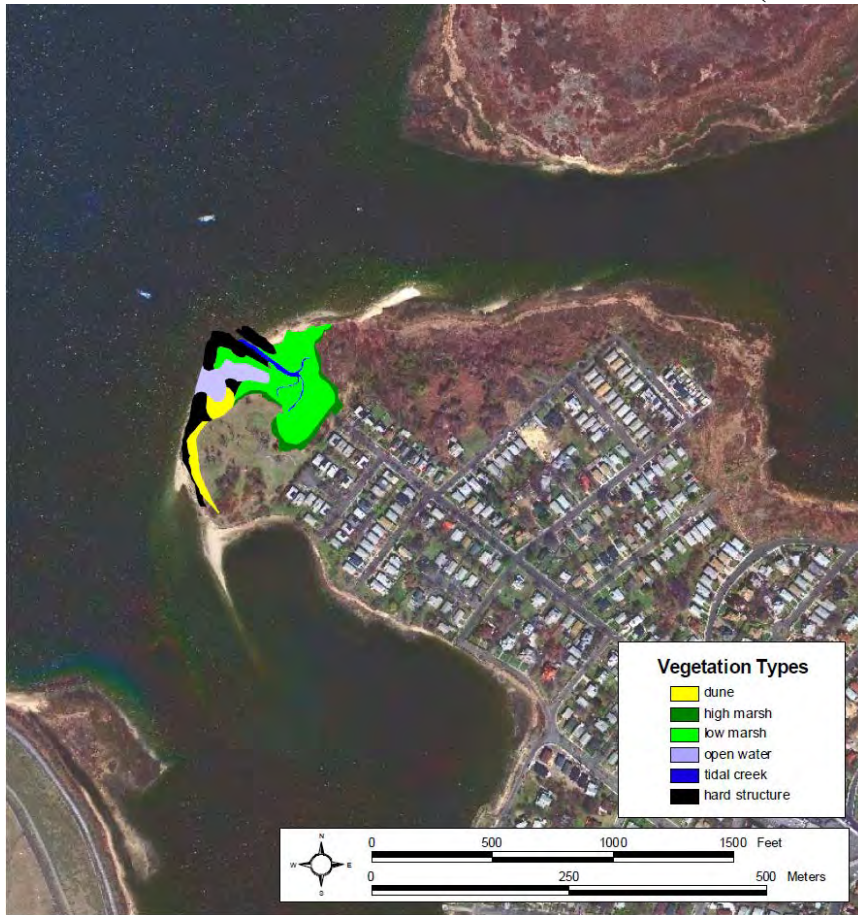
BAYSWATER STATE PARK RECOMMENDED ALTERNATIVE (from Pre-Draft Interim Feasibility Study Report)

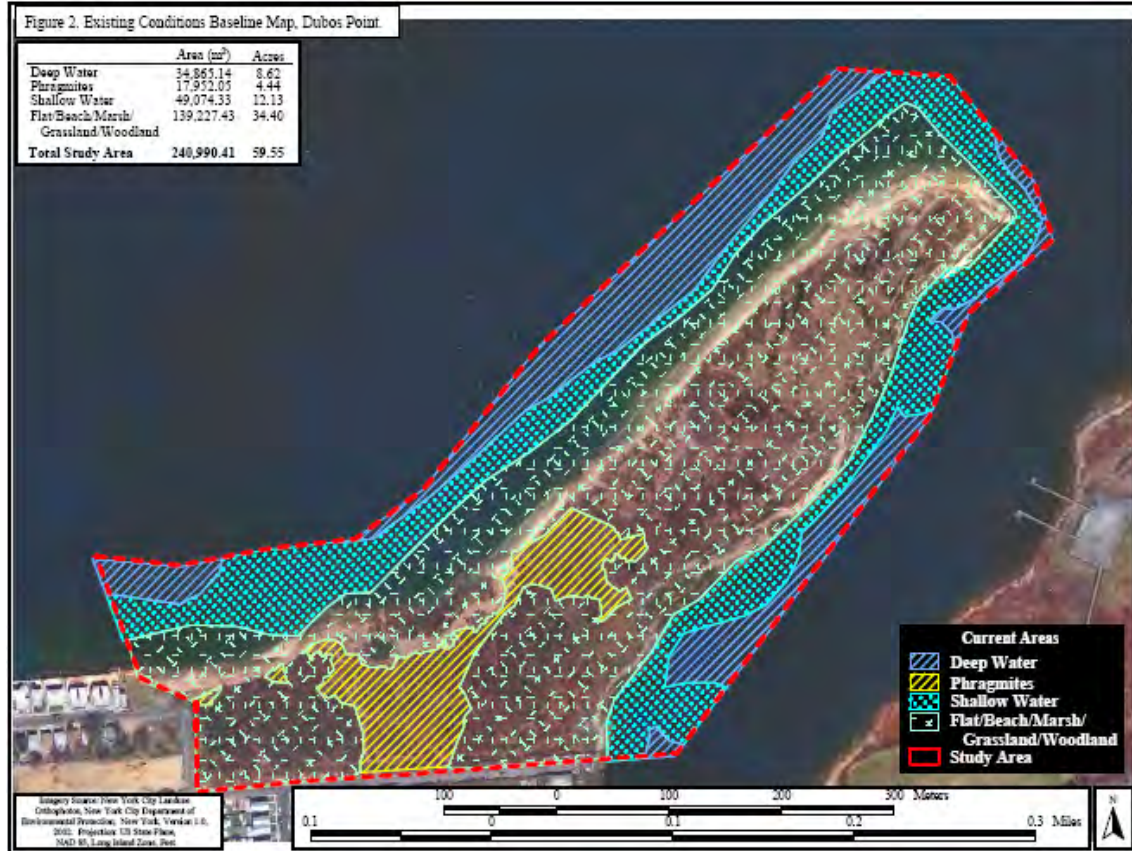
DUBOS POINT EXISTING CONDITIONS (from Pre-Draft Interim Feasibility Study Report)

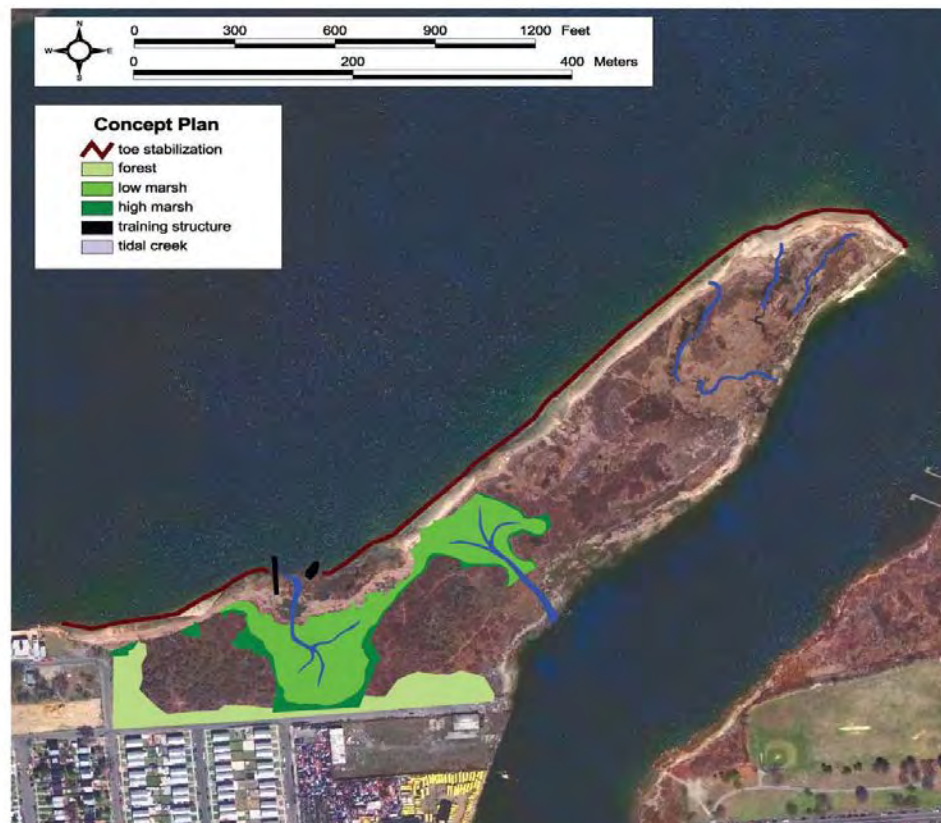
DUBOS POINT RECOMMENDED ALTERNATIVE (from Pre-Draft Interim Feasibility Study Report)

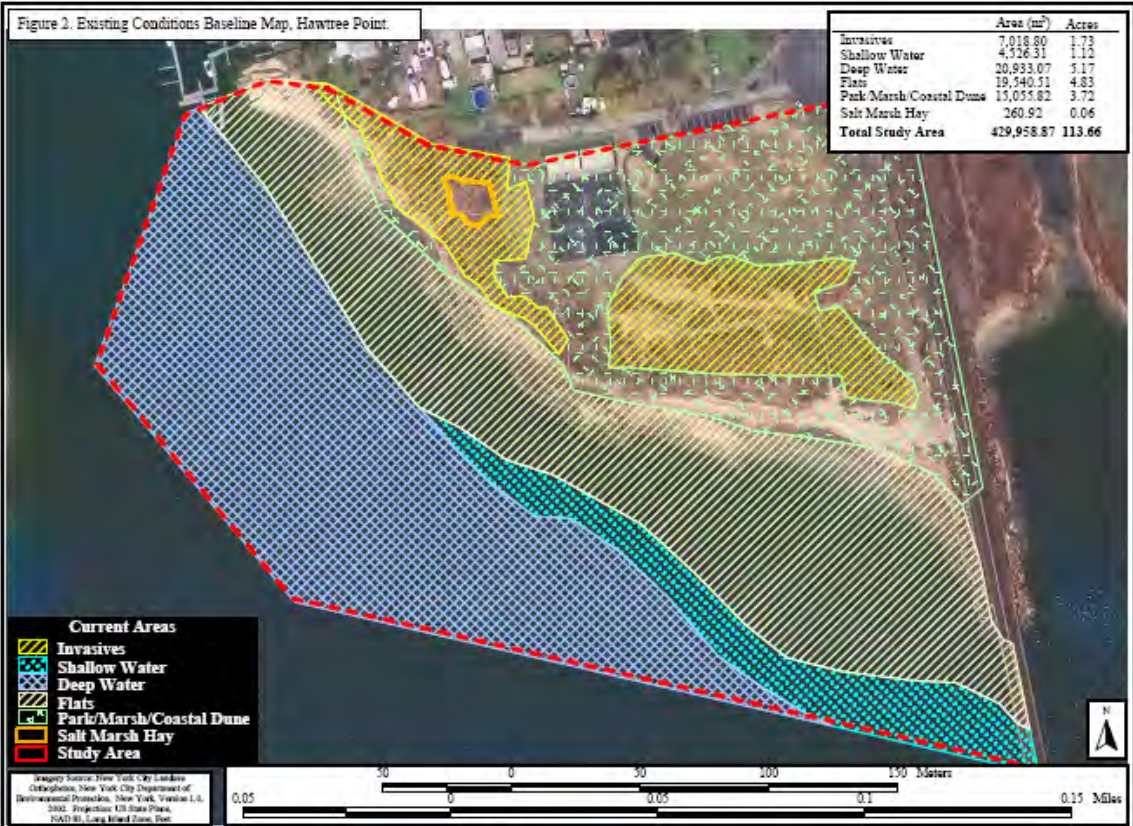
HAWTREE POINT EXISTING CONDITIONS (from Pre-Draft Interim Feasibility Study Report)

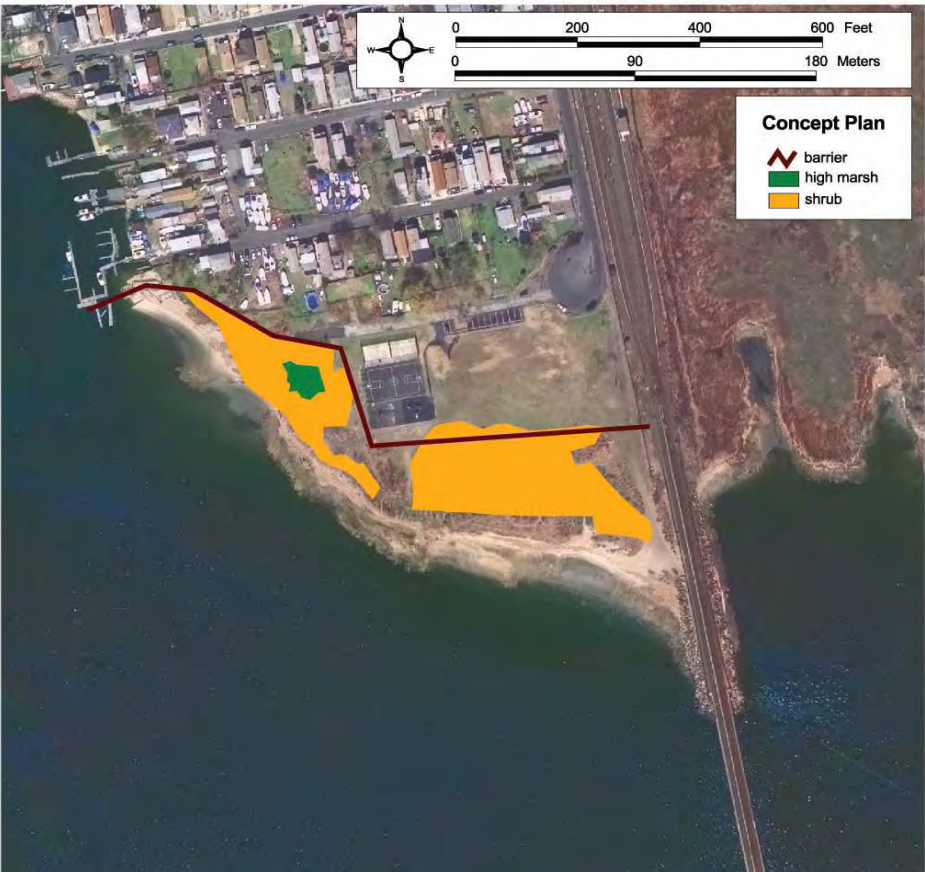
HAWTREE POINT RECOMMENDED ALTERNATIVE (from Pre-Draft Interim Feasibility Study Report)

Proposed Project: [HEP nomination: recommended Salt marsh restoration.]. Protection of remaining marshes by replacing invasive dominated area with 1.7 acres of coastal scrub and grassland habitat and creation of barrier to motorized vehicles by placing boulders along the boundary of the restoration area.

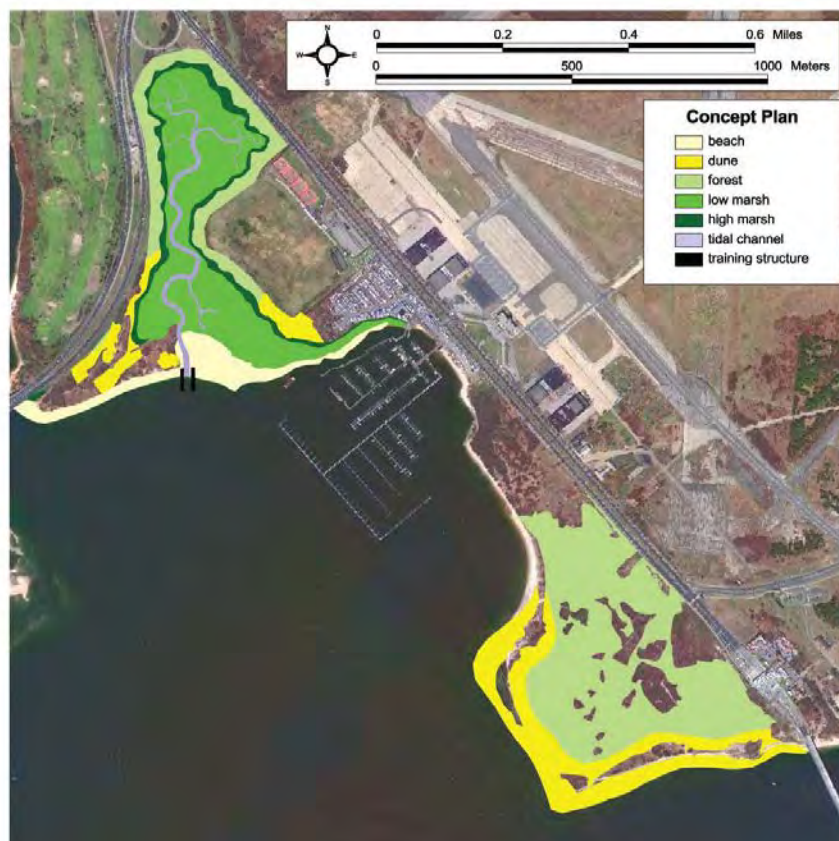
DEAD HORSE BAY RECOMMENDED ALTERNATIVE (from Pre-Draft Interim Feasibility Study Report)

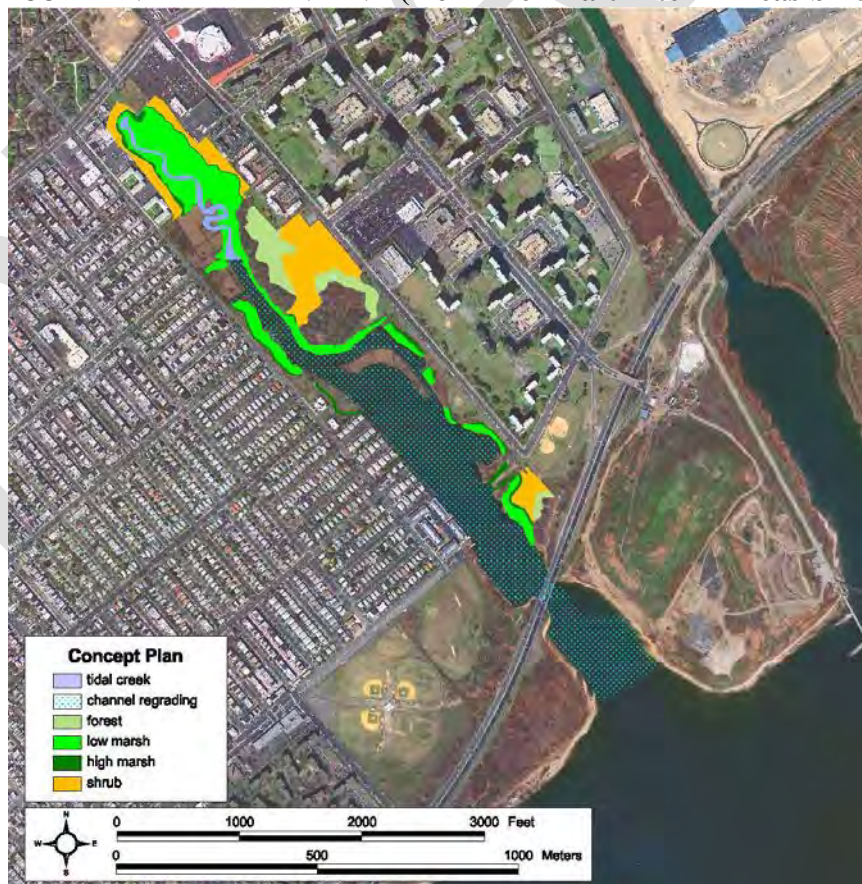
FRESH CREEK RECOMMENDED ALTERNATIVE (from Pre-Draft Interim Feasibility Study Report)

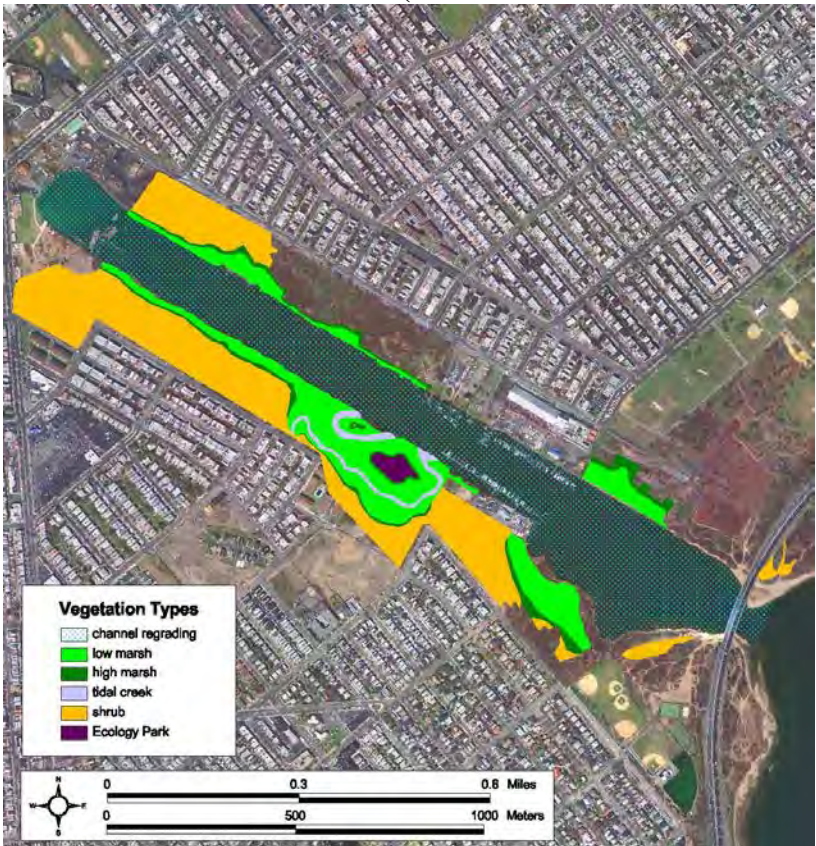
PAERDEGAT BASIN RECOMMENDED ALTERNATIVE (from Pre-Draft Interim Feasibility Study Report)
