Hudson-Raritan Estuary Ecosystem Restoration Feasibility Study

Appendix H Hazardous Toxic Radioactive Waste

**Draft Integrated Feasibility Report &
Environmental Assessment
February 2017**

**Prepared by the New York District, North Atlantic Division,
U.S. Army Corps of Engineers**

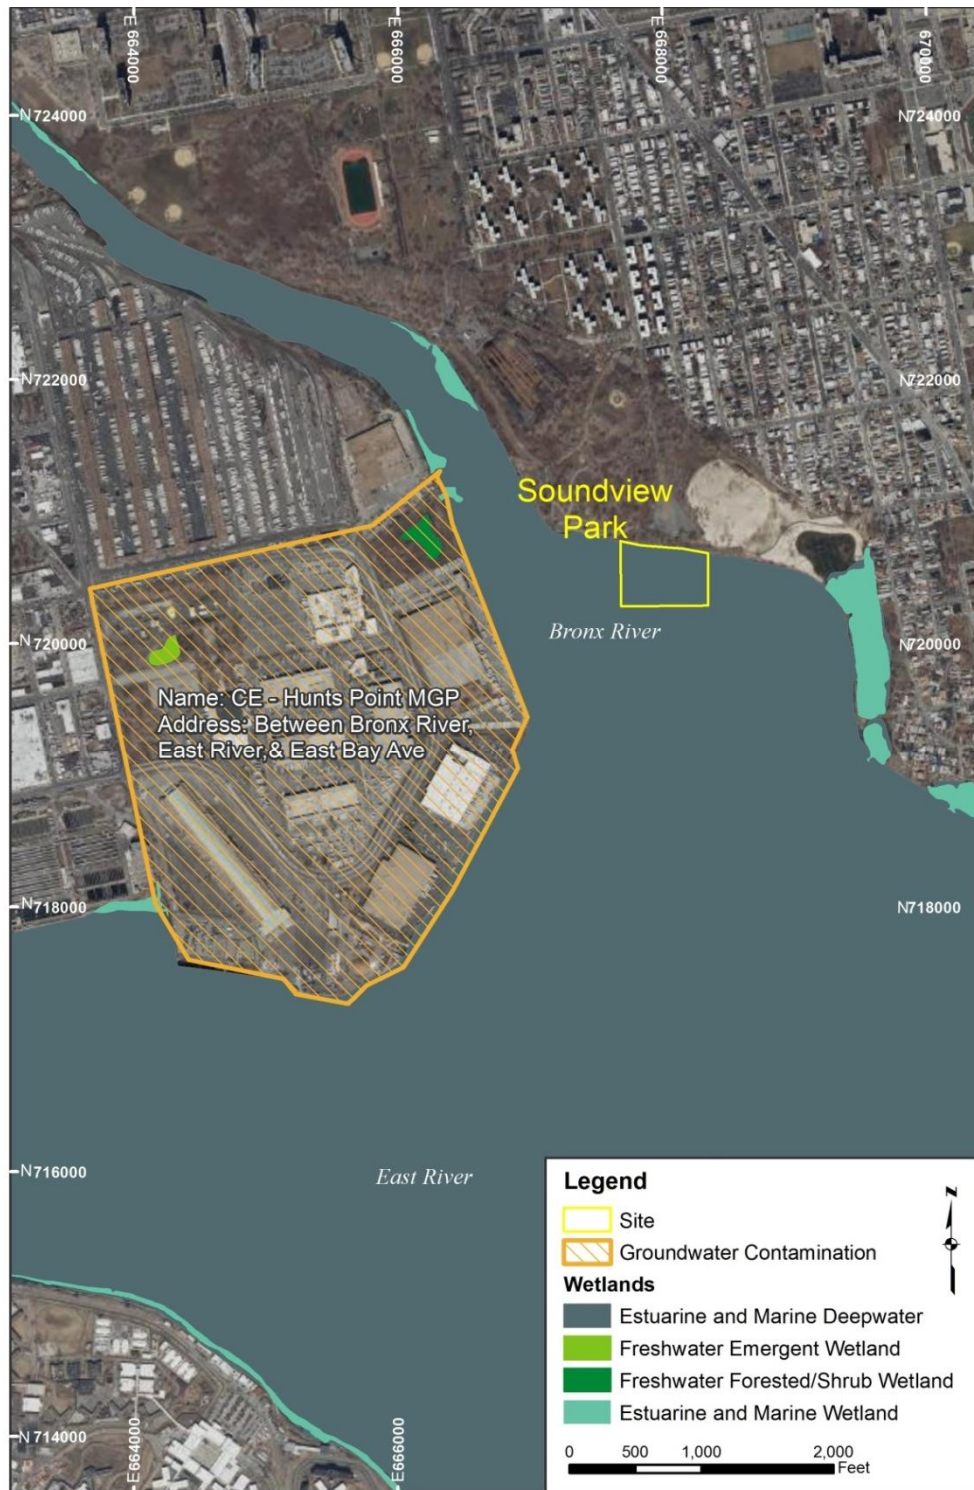
Figure 2-2: Wetland areas and the one Known Contaminated Site near the Soundview Park site.

Base map images are 2014 orthorectified aerial images (NYS DOP, 2014), as well as images from USGS EROS (2014). Wetland data is from U.S. Fish and Wildlife Service, National Wetlands Inventory (2004, 2011). Groundwater contamination data is from NYSDEC Environmental Site Database Search (Remediation Site Boundaries, 2013).

Figure 2-2 shows the locations of known contamination sites in or near the Soundview Park site.

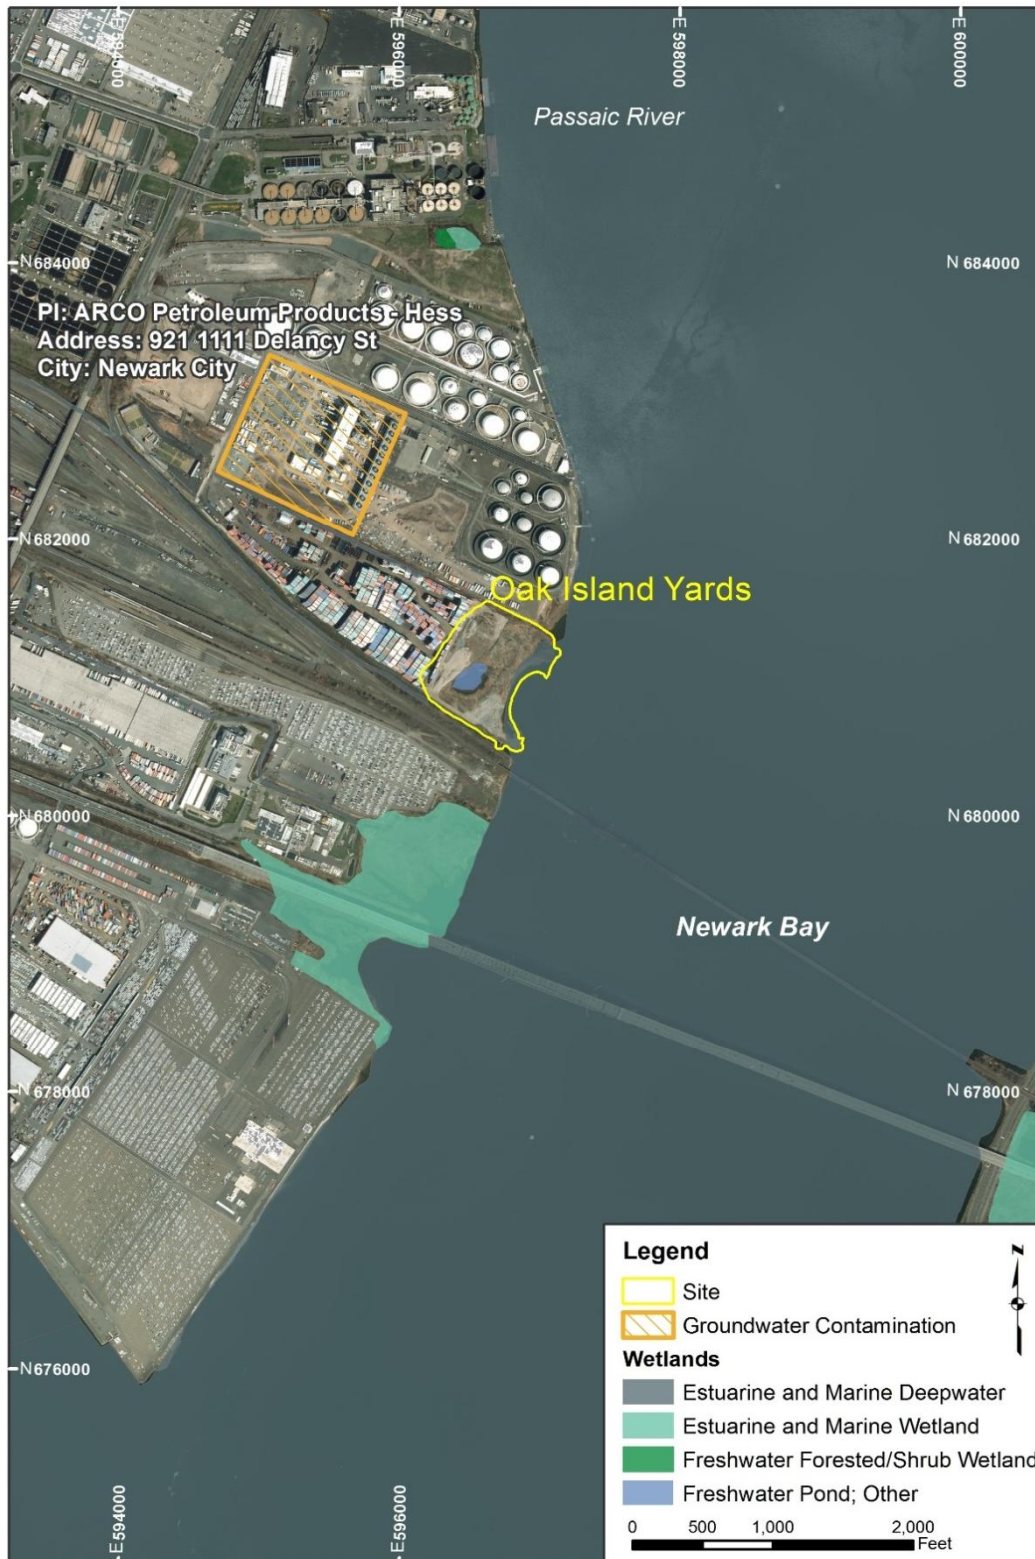
Figure 2-4: Wetland areas and NJDEP Known Contaminated Sites in the area of the Oak Island Yards site.

Orthophoto obtained from NJGIN Clearinghouse Web Map Services, 2015. Wetland information obtained from U.S. Fish and Wildlife Service, National Wetlands Inventory, 2010

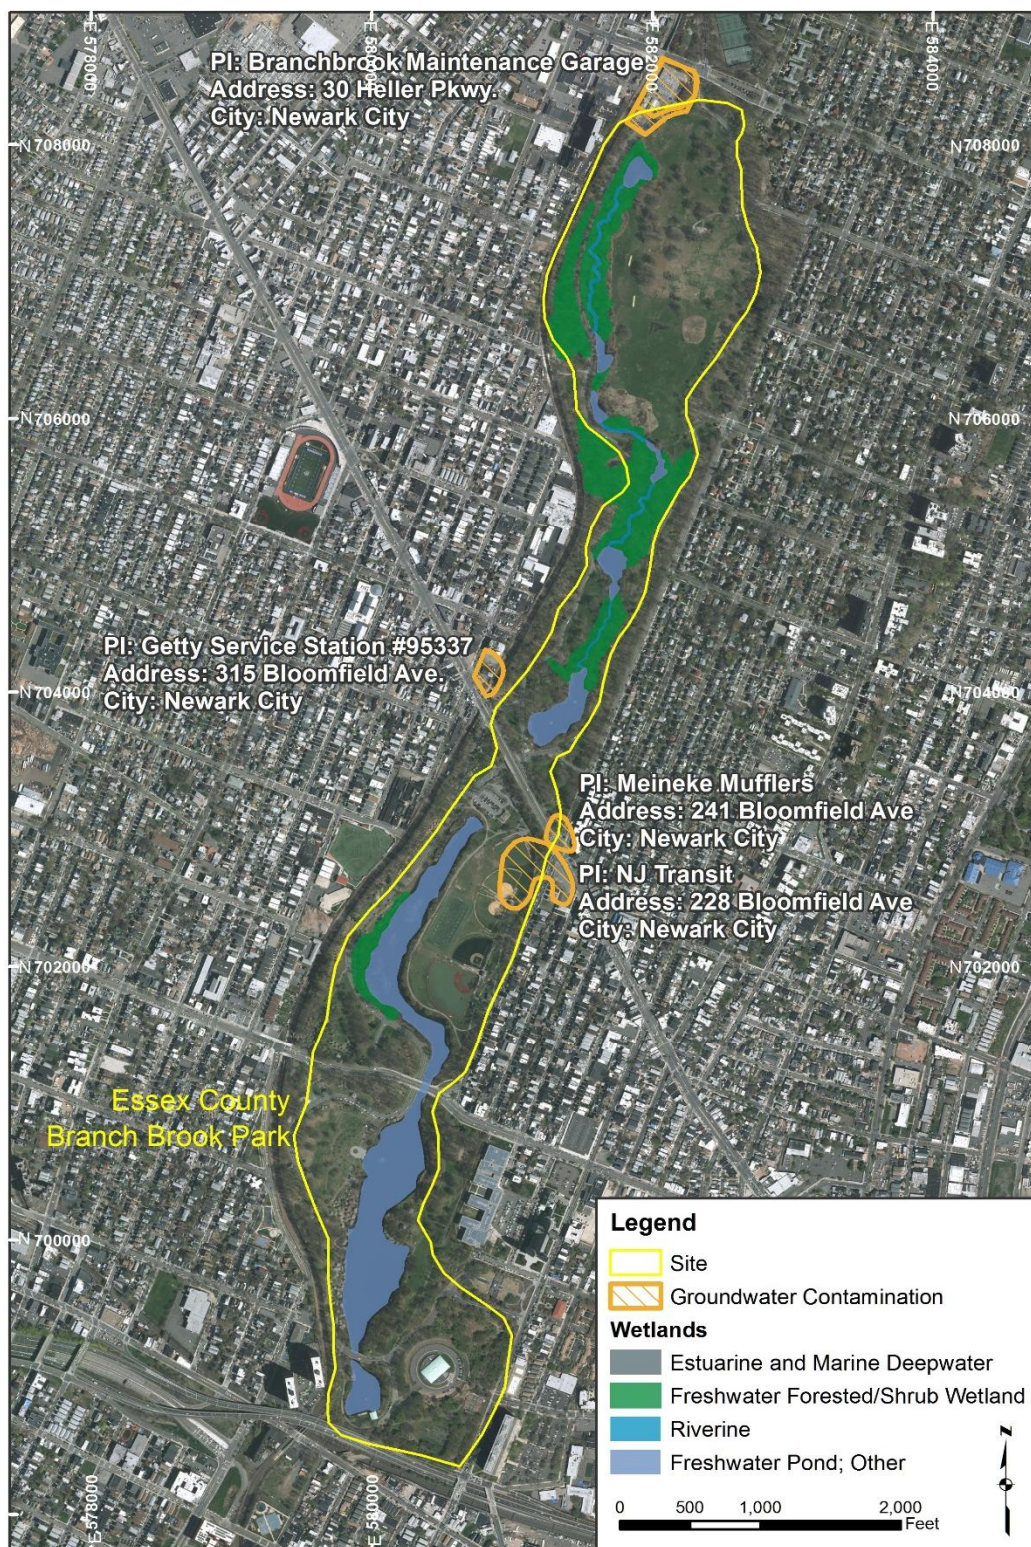
Figure 2-5: Wetlands and NJDEP recognized Known Contamination Sites in the area of the Essex County Branch Brook Park site.

Figure 2-5 shows the locations of known contamination sites in or near the Essex County Branch Brook Park site.

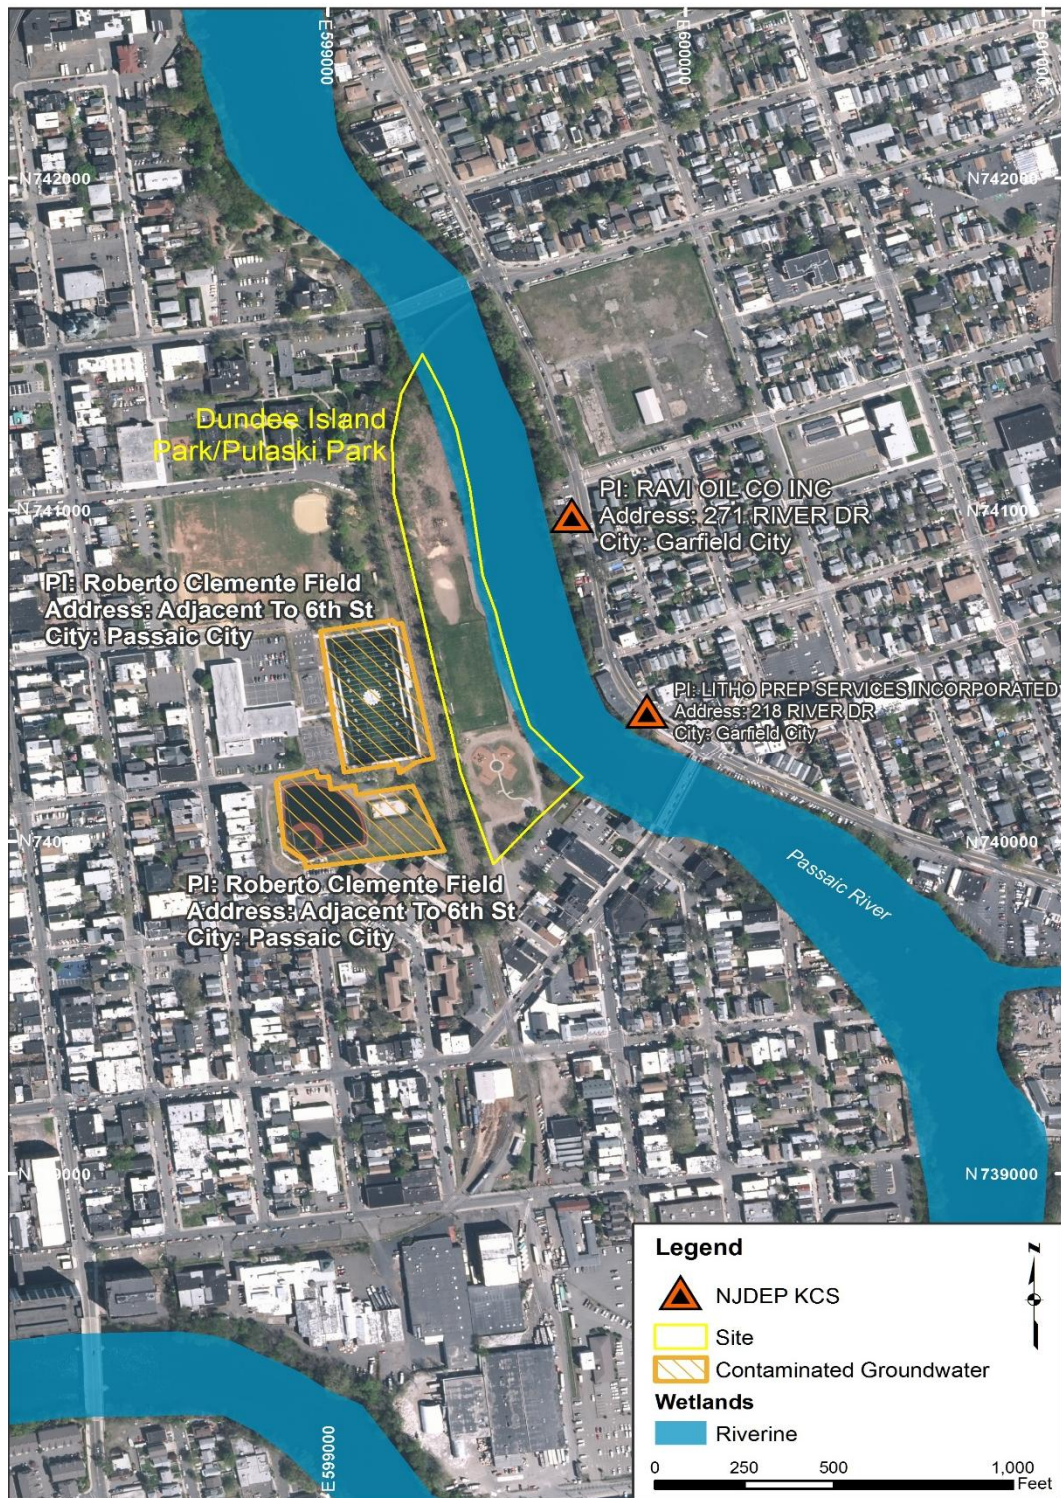
Figure 2-6: Wetlands and NJDEP recognized Known Contamination Sites in the area of the Dundee Island Park/Pulaski Park site.

There are no Known Contaminated Site (KCS) within the boundaries of the Dundee Island Park/Pulaski Park site. Figure 2-6 shows the locations of known contamination sites near the Dundee Island Park/Pulaski Park site.

While the Dundee Island Park/Pulaski Park site is adjacent to the Passaic River, the site itself does not contain any wetland areas, as shown in Figure 2-6.

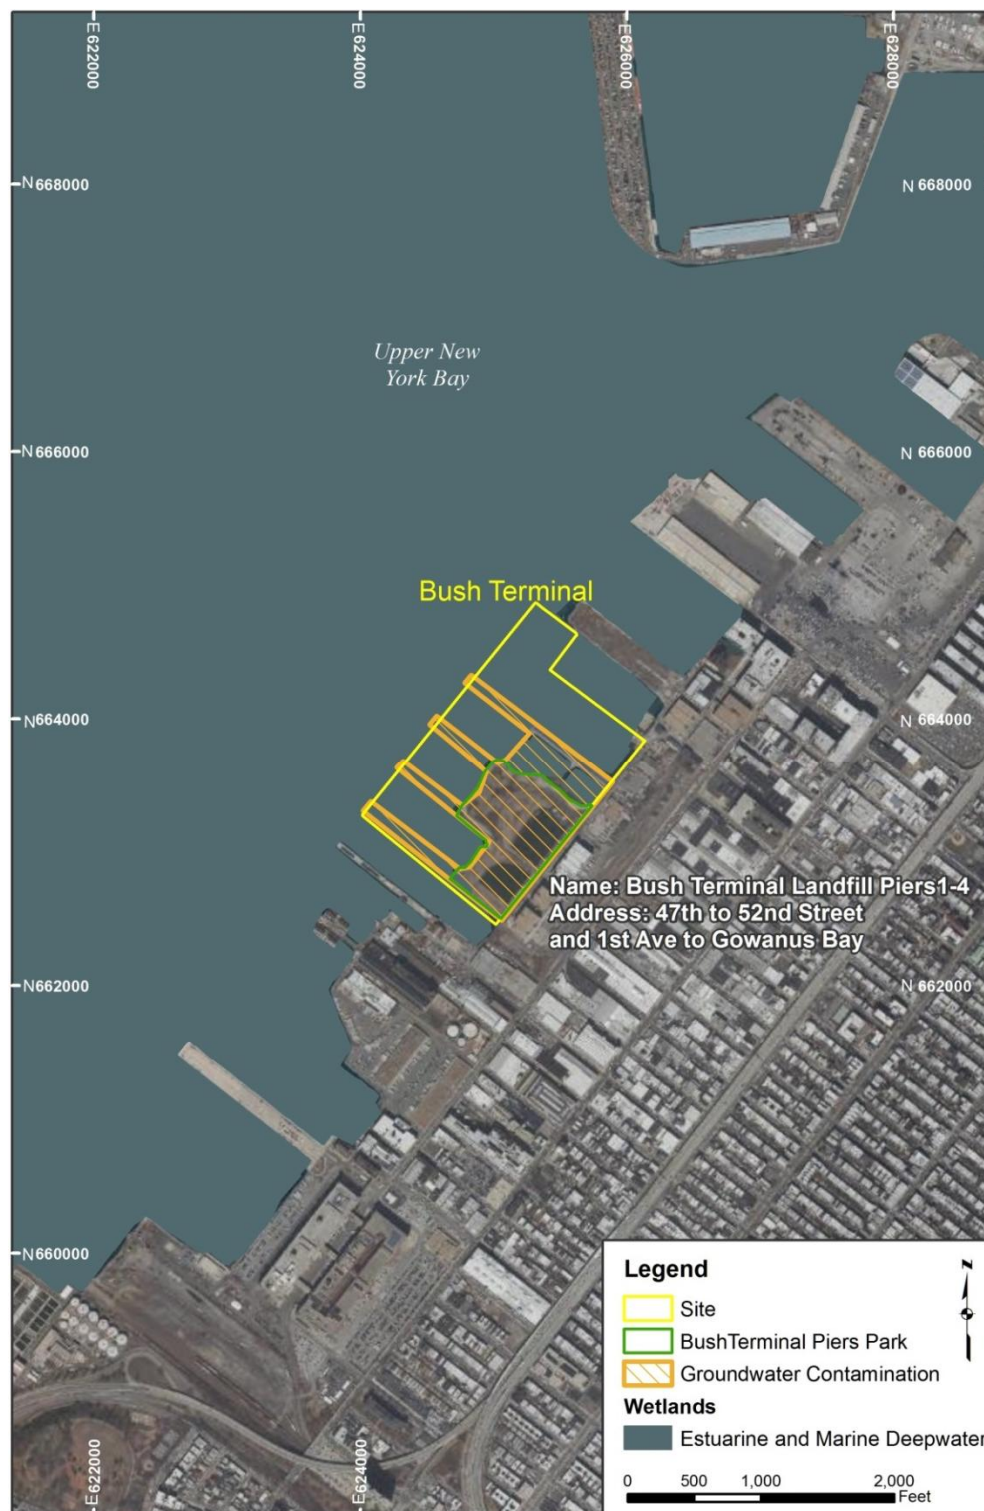
Figure 2-11: Wetland areas and the Known Contaminated Site at the Bush Terminal site.

Figure 2-11 shows the locations of known contamination sites in or near the Bush Terminal site. Bush Terminal is listed as an Environmental Restoration Program site. The address of the restoration site is 47th to 52nd Street and 1st Ave to Gowanus Bay, Kings County New York. The site code is B00031. The site name is Bush Terminal Landfill Piers 1-4. This report did not identify the exact nature and extent of the contamination. Remediation activities are ongoing.

There is also a NYS Open Petroleum Spill Location noted at the Bush Terminal site. The spill name is Brooklyn West 07 DOS-DDC, the spill number is 9614638, and the spill address is 5100 1st Avenue. The spill occurred on 03/19/1997 and involved an unknown amount of gasoline and diesel fuel. The record was closed on 03/04/2014 after sufficient remediation activities had occurred.

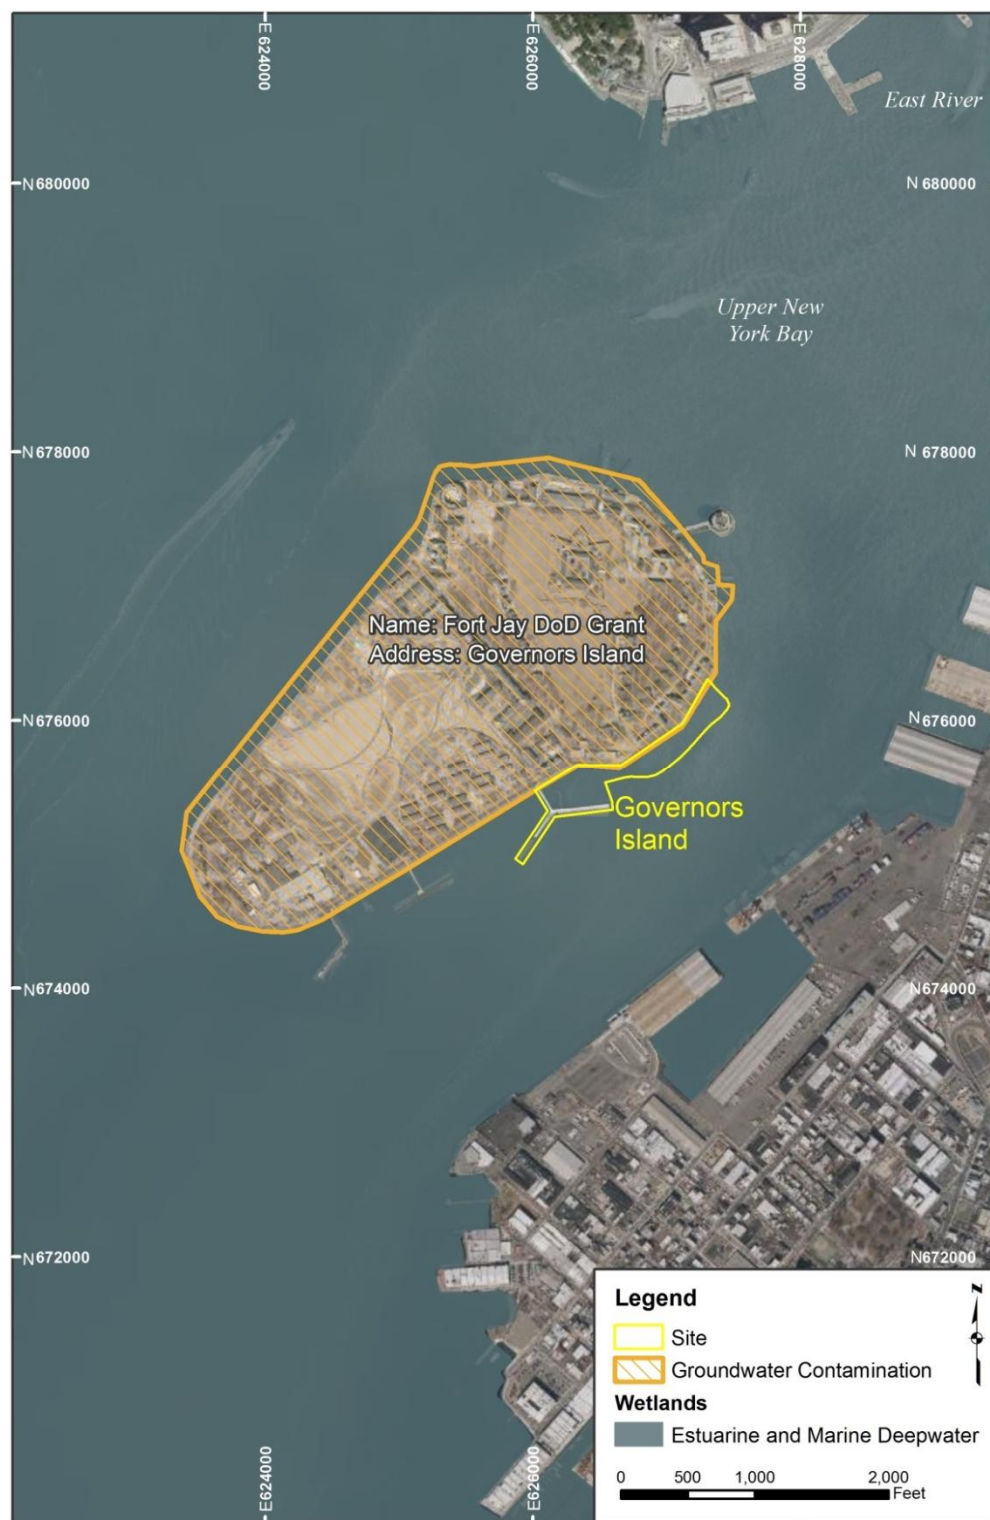
Figure 2-12: Wetland areas and the NYSDEC recognized Known Contaminated Site at Governors Island site.

Figure 2-12 shows the locations of known contamination sites in or near the Governors Island site (NYC Mayor's Office of Sustainability, 2011). Governors Island (more specifically Fort Jay) is listed as a state superfund site. Governors Island was used as an active military base for over 200 years, which included a variety of activities of environmental concern (fuel storage, maintenance, etc.). A subsurface investigation conducted in 2011 identified heavy metals, semi-volatile organic compounds (SVOC's), pesticides, PCBs and residual petroleum. In addition, there remains the possibility of unexploded ordnance (UXO) both on land and in the waters surrounding Governors Island, which is described in the "Proposed Phased Redevelopment of Governors Island" (2011). However, this study does not mention specific environmental testing performed on the study area.

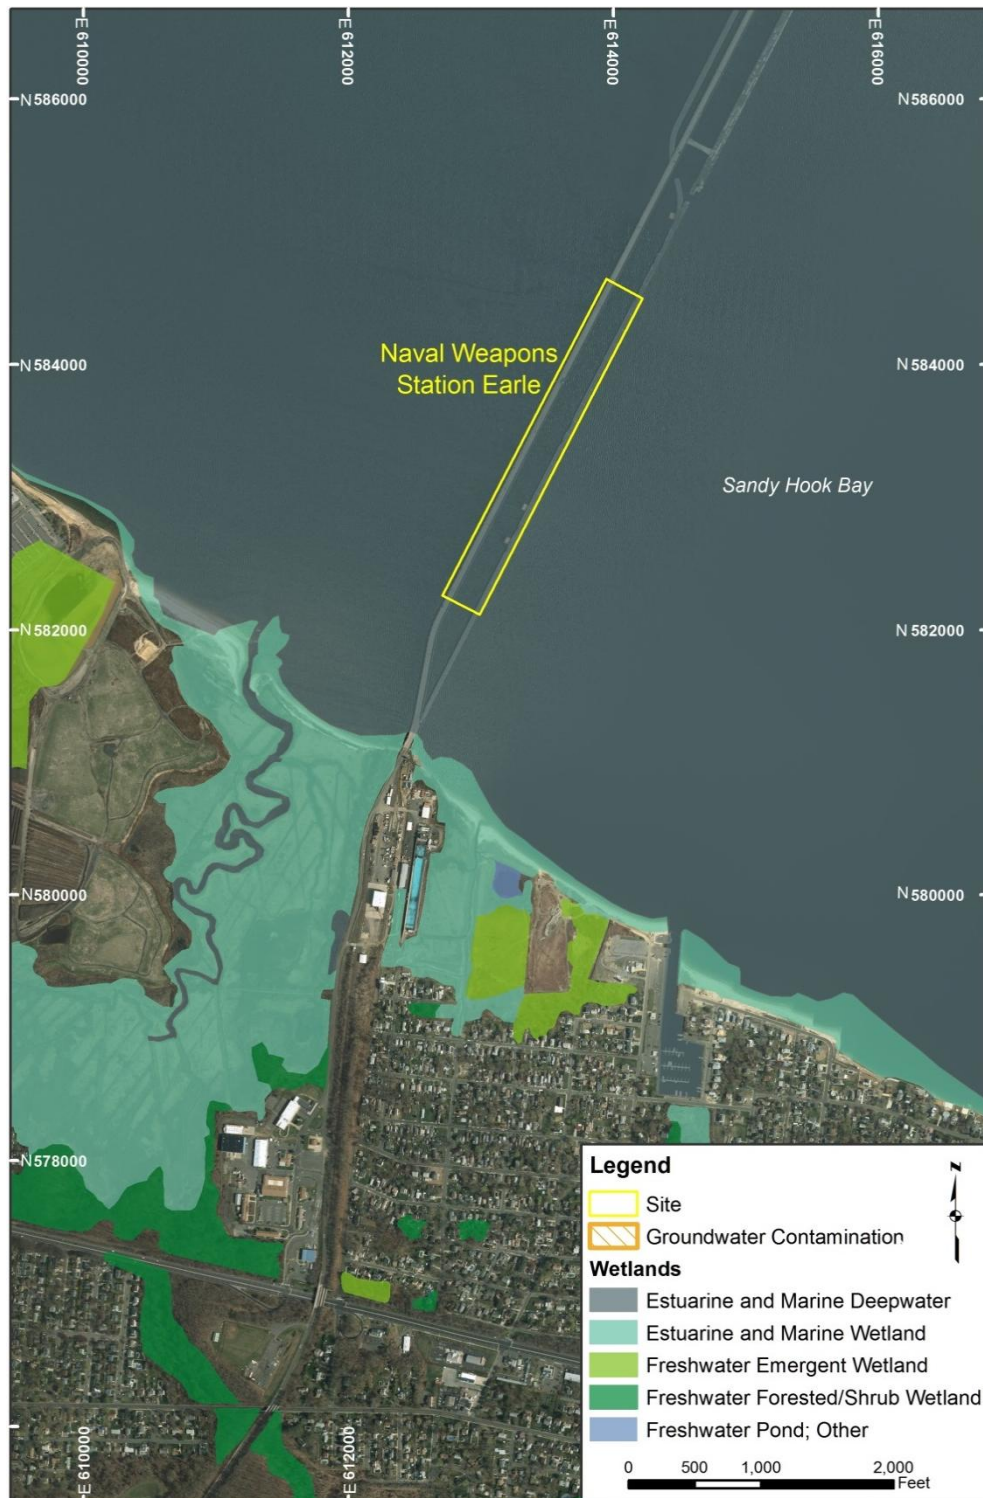
Figure 2-13: Wetland areas and NJDEP-recognized Known Contaminated Sites near the Naval Weapons Station Earle site.

Figure 2-13 shows the locations of wetland areas in or near the NWS Earle site. NWS Earle is a New Jersey Superfund site, due to toxic materials that have been buried in landfills as a result of military activities. The site name is Naval Weapons Station Earle (Site A). The site address is Tyler Lane and Texas Road in the city of Colts Neck, New Jersey. The site ID is NJ0170022172. The superfund site was established in 1984. The known contaminants include chromium, cobalt, lead, manganese, pentachlorophenol, titanium, zinc and others, but the scope and magnitude of the contamination is unknown. At least three areas are currently undergoing remediation under the Resource Conservation and Recovery Act (RCRA). The status of the cleanup operations is unknown.

The NWS Earle oyster site is part of the estuarine and marine deepwater wetland, as shown in Figure 2-13.

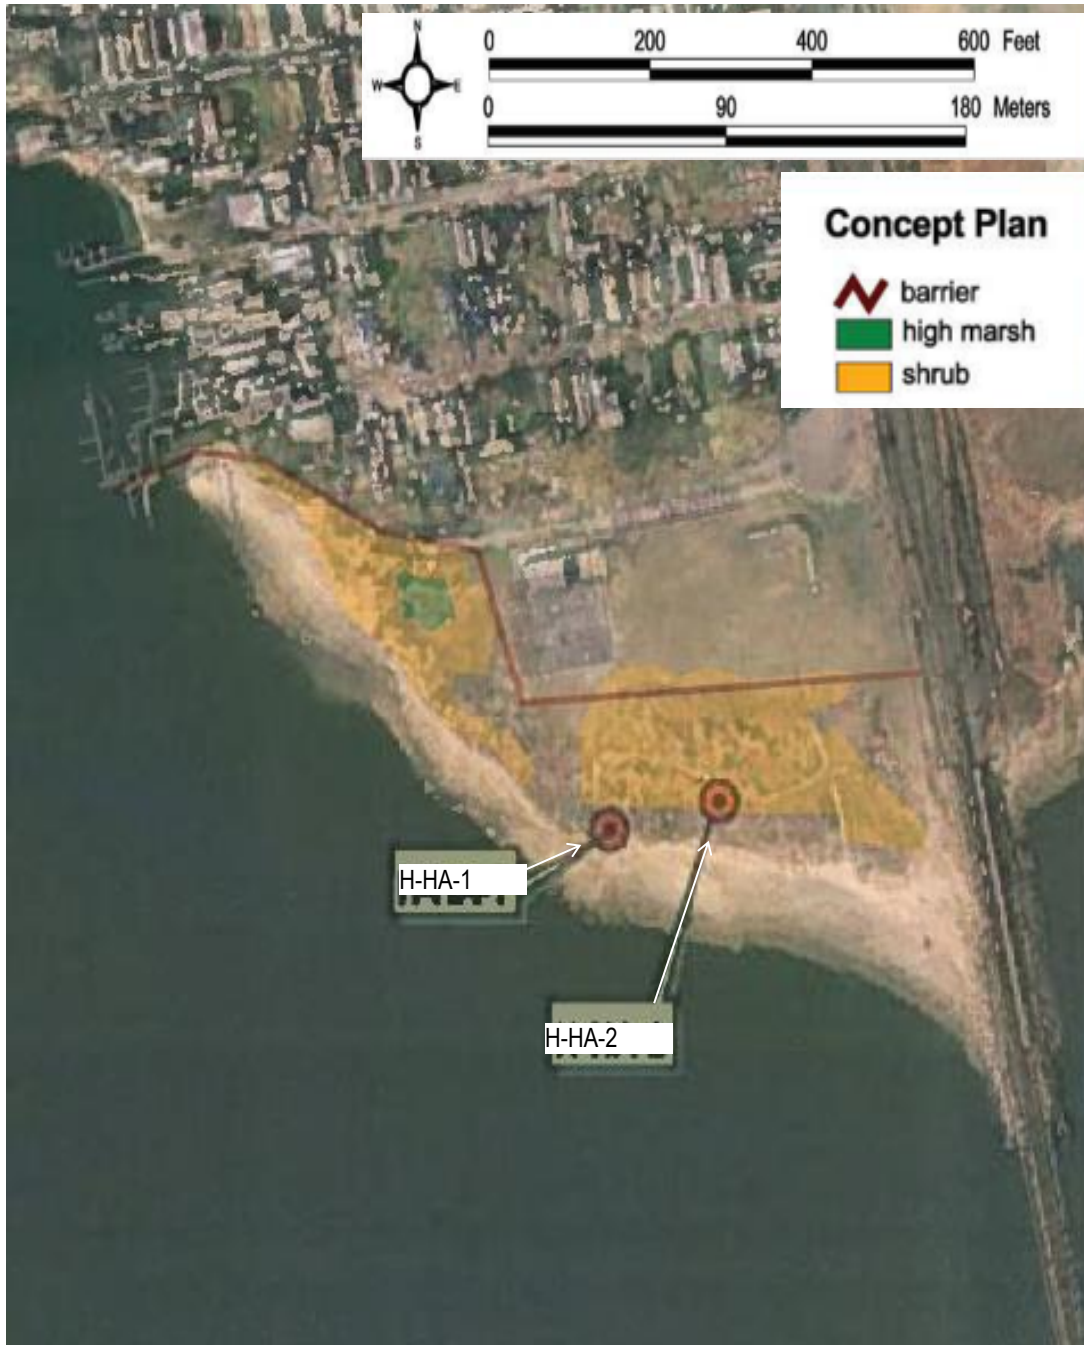
Figure 3: Sample Locations and Recommended Plan for Hawtree Point (Alternative 1)

- COPCs (HQ) exceeding NYSDEC Unrestricted Use and Protection of Ecological Resources SCO include:
 - Hexavalent chromium (20.7, assuming 100% Cr Hex; trivalent chromium (0.7) is more likely present), copper (1.3), lead (5.3), mercury (1.3), zinc (1.4) and DDT (3.3).
- DDT (1.6) exceeded the sediment ER-M for 1 sample (H-HA-2) (Figure 3).
- Potential exposure to COPCs is minimal and the proposed recommended alternative would not result in increased risk.
- Recommended alternative protects remaining marshes by replacing invasive dominated areas with 1.7 acres of coastal shrub and grassland habitat.
- Creation of a barrier to motorized vehicles by placing boulders along the boundary of the restoration area.
- The newly created habitats as well as the preserved existing marshes will be protected from vehicle access, but will still be accessible to pedestrians.

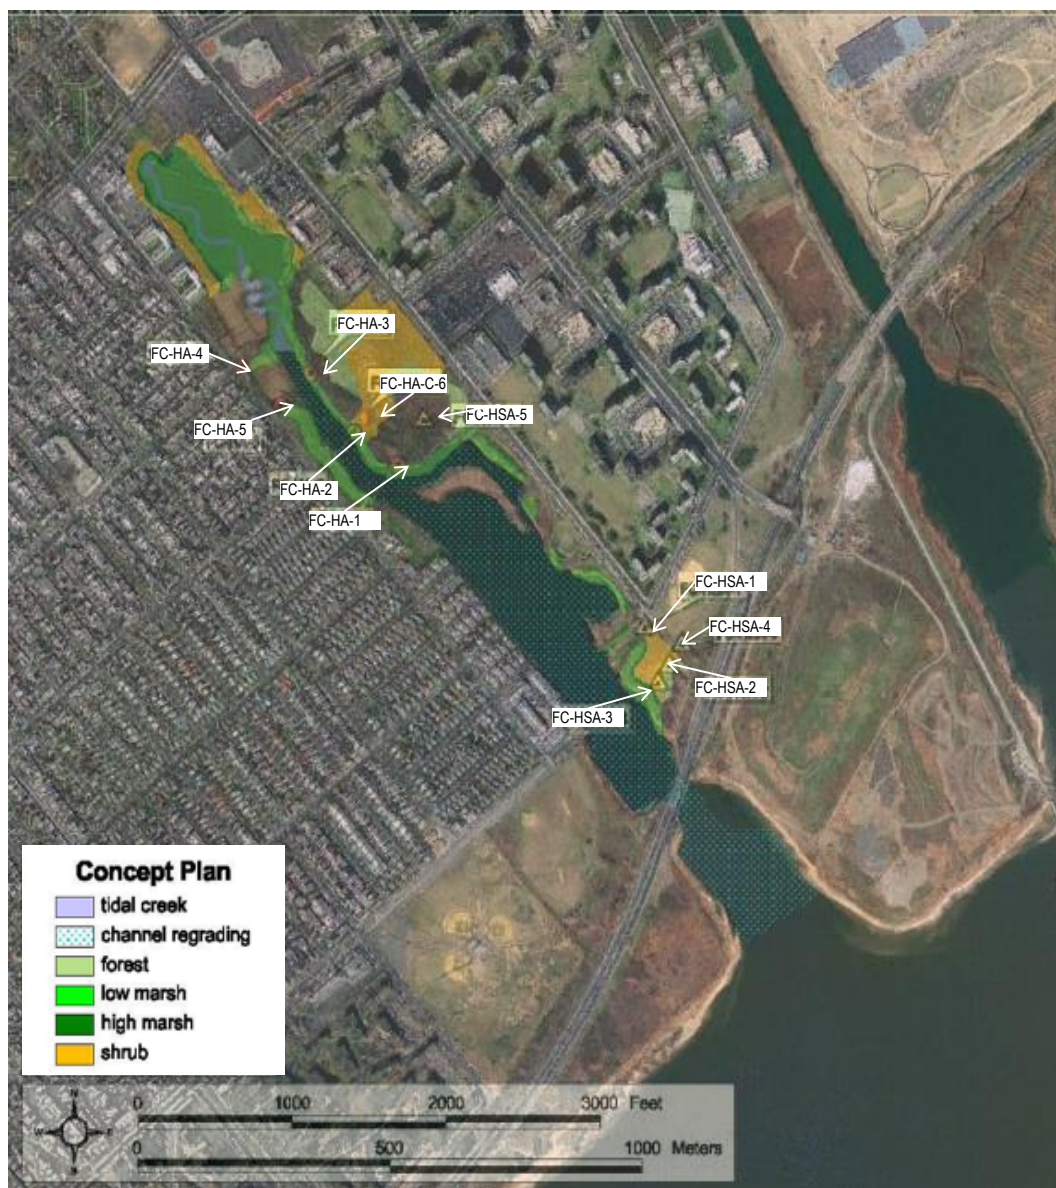
Figure 4: Sample Locations and Recommendation for Fresh Creek (Alternative 5)

- Exceeding only the Unrestricted Use and Protection of Ecological Resources SCOs, DDD (176), DDE (186) and DDT (1260) were significantly elevated at a single location at FC-HA-4 (Figure 4).
- Assuming sediment concentrations are similar to adjacent soils, 95% UCL concentrations exceeded sediment ER-Ms for copper (8.6), lead (3.4), mercury (3.5), zinc (5.2), phenanthrene (2), flouranthene (1.1), pyrene (2.3), benzo(a)anthracene (1.7), chrysene (1.1), benzo(a)pyrene (1.7), dibenzo(a,h)anthracene (1.2), total LMW PAHs (1.5), total HMW PAHs (2.8), DDD (29), DDE (22.7), DDT (593), DDT Total (111) and Total PCBs (1.1).

- Exceeding only Unrestricted Use and Protection of Ecological Resources SCOs, DDD (3.5) and DDE (2.2) and DDT (1.7) were detected in only 1/11 samples (FC-HA-C-6 for DDD and DDE/FC-HAS-T-1 for DDT) (Figure 4).

- Recontouring the basin will decrease residence time of water, thus improving the dissolved oxygen levels and water quality throughout the basin.
- 33 acre tidal marsh system with protective buffers will be created, which includes 13 acres of low marsh, 2.4 acres of high marsh, 2.1 acres of creek/pool, 4.5 acres of maritime forest and 11 acres of coastal shrub, as well as 60.1 acres of shallow water will be restored at this site.
