# **Hudson-Raritan Estuary Ecosystem Restoration Feasibility Study**

**Appendix G  
Hazardous, Toxic and Radioactive Waste**

**Final Integrated Feasibility Report &  
Environmental Assessment  
March 2020**

**Prepared by the New York District  
U.S. Army Corps of Engineers**

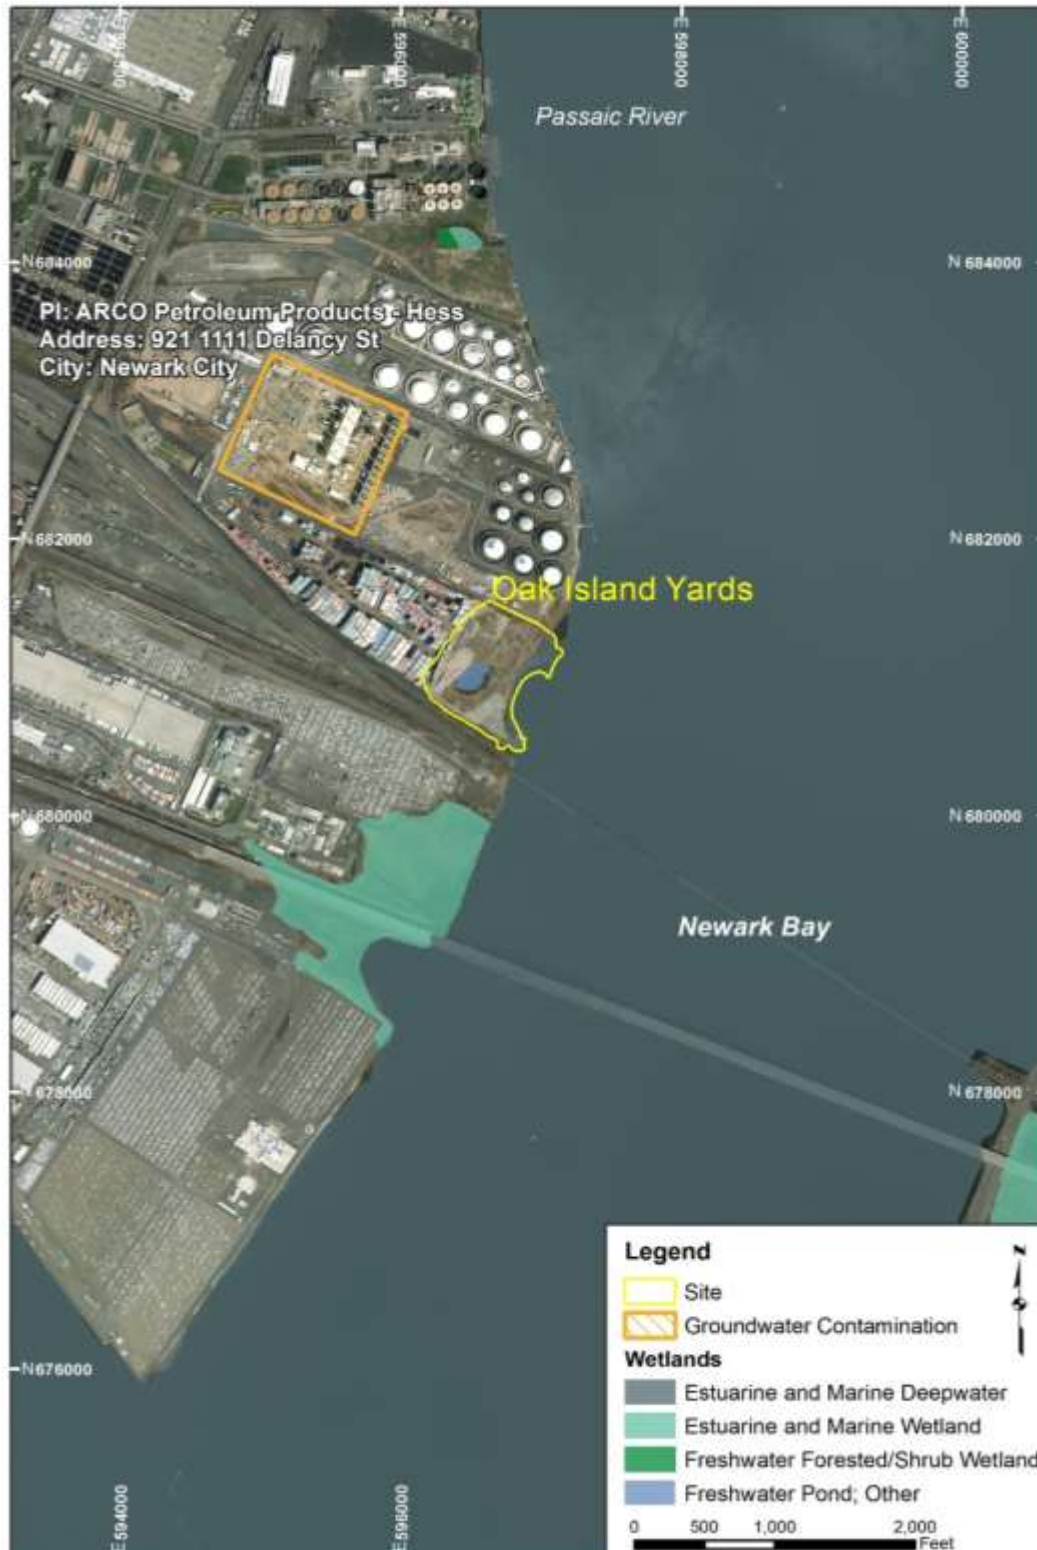
**Figure G-3. Wetland areas and NJDEP Known Contaminated Sites in the area of the Oak Island Yards site.**

There are no Known Contaminated Sites (KCS) within the Oak Island Yards site. Figure G-3 shows the locations of known contamination sites near the Oak Island Yards site. Less than 1,000ft northwest of the site there is a KCS with groundwater contamination associated with the Newark Energy Center constructed between 2012 and 2014. The address of the site is 921 1111 Delancy St, in the city of Newark, New Jersey. The PI name is ARCO Petroleum Products – Hess. The known contaminants include are listed in Table G-7. The contamination values were the greatest measured at the site described above at the time of Groundwater CEA establishment on 8/22/2012. The KCS encompasses 22.8 acres.

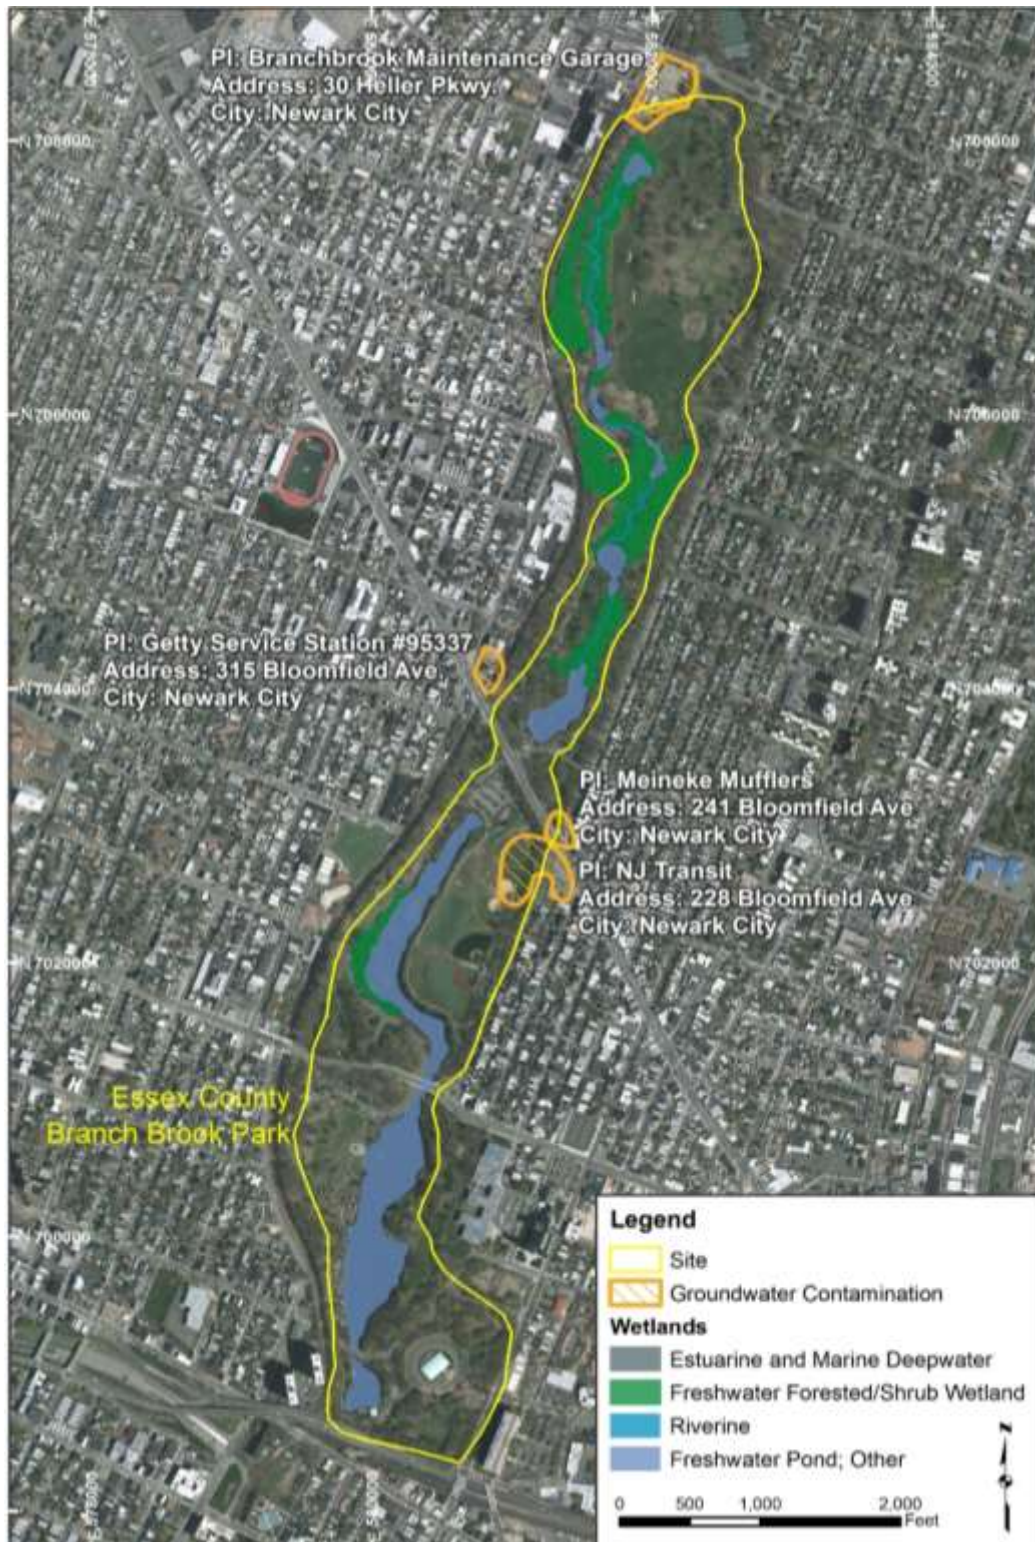
**Figure G-4. Wetlands and NJDEP recognized Known Contamination Sites in the area of the Essex County Branch Brook Park site.**

Figure G-4 shows the locations of known contamination sites in or near the Essex County Branch Brook Park site.

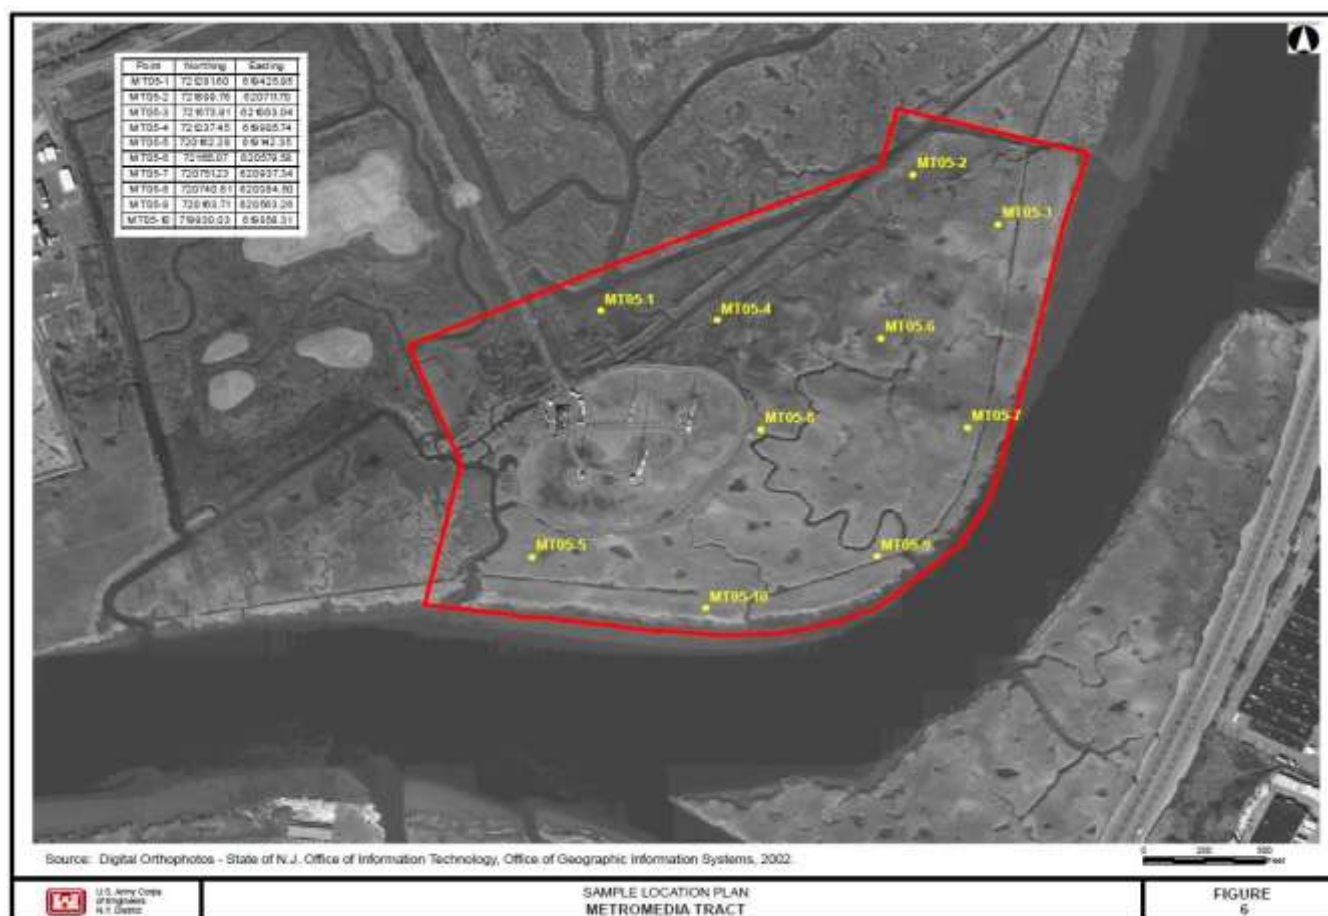
**Figure G-6.HTRW Sampling Locations at Metromedia Tract**

Figure G-6 shows the locations of the HTRW samples, while Table G-15 shows a summary of the sampling results.

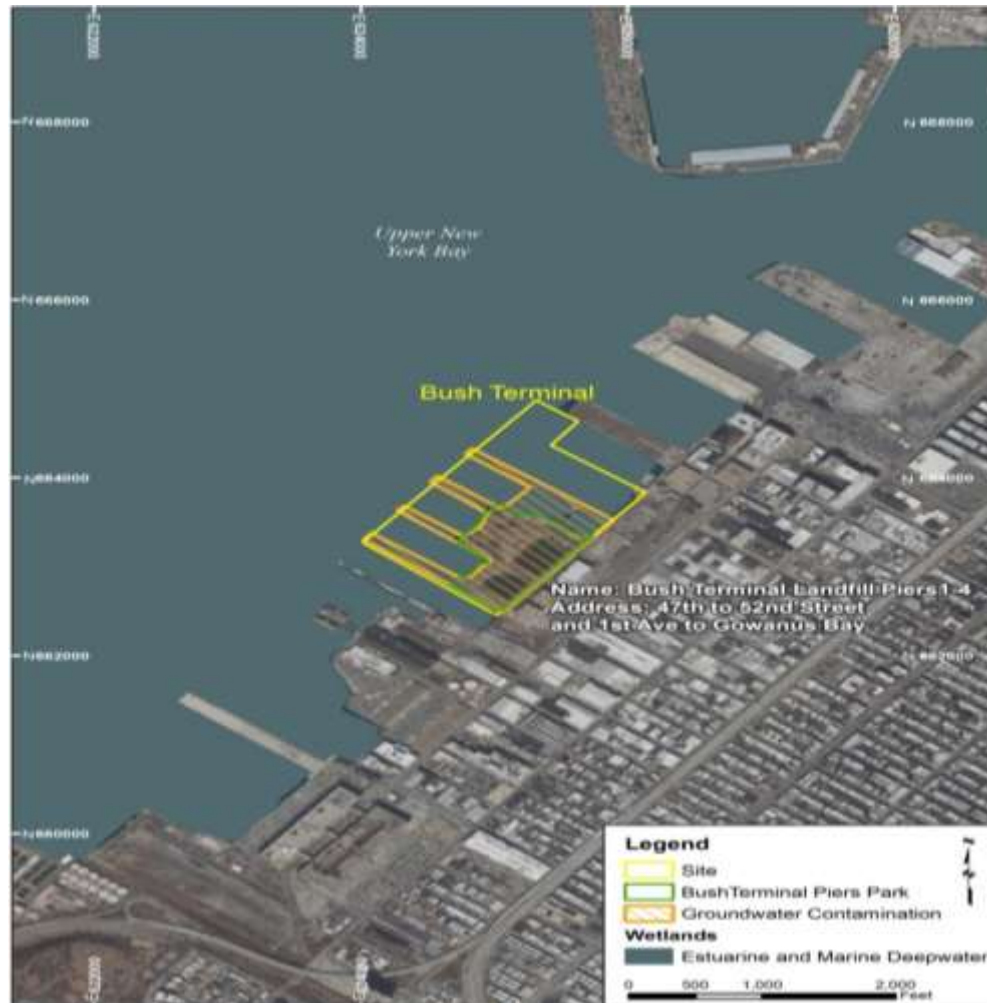
**Figure G-8. Wetland areas and the Known Contaminated Site at the Bush Terminal site.**

The same site is also listed as a State Superfund Program. The site code is 224011. The site name is Rear of Bush Terminal Building. The known contaminants include 2,4,-Dimethylphenol, Napthalene, Phenol, 4-Methylphenol, and heavy metals.

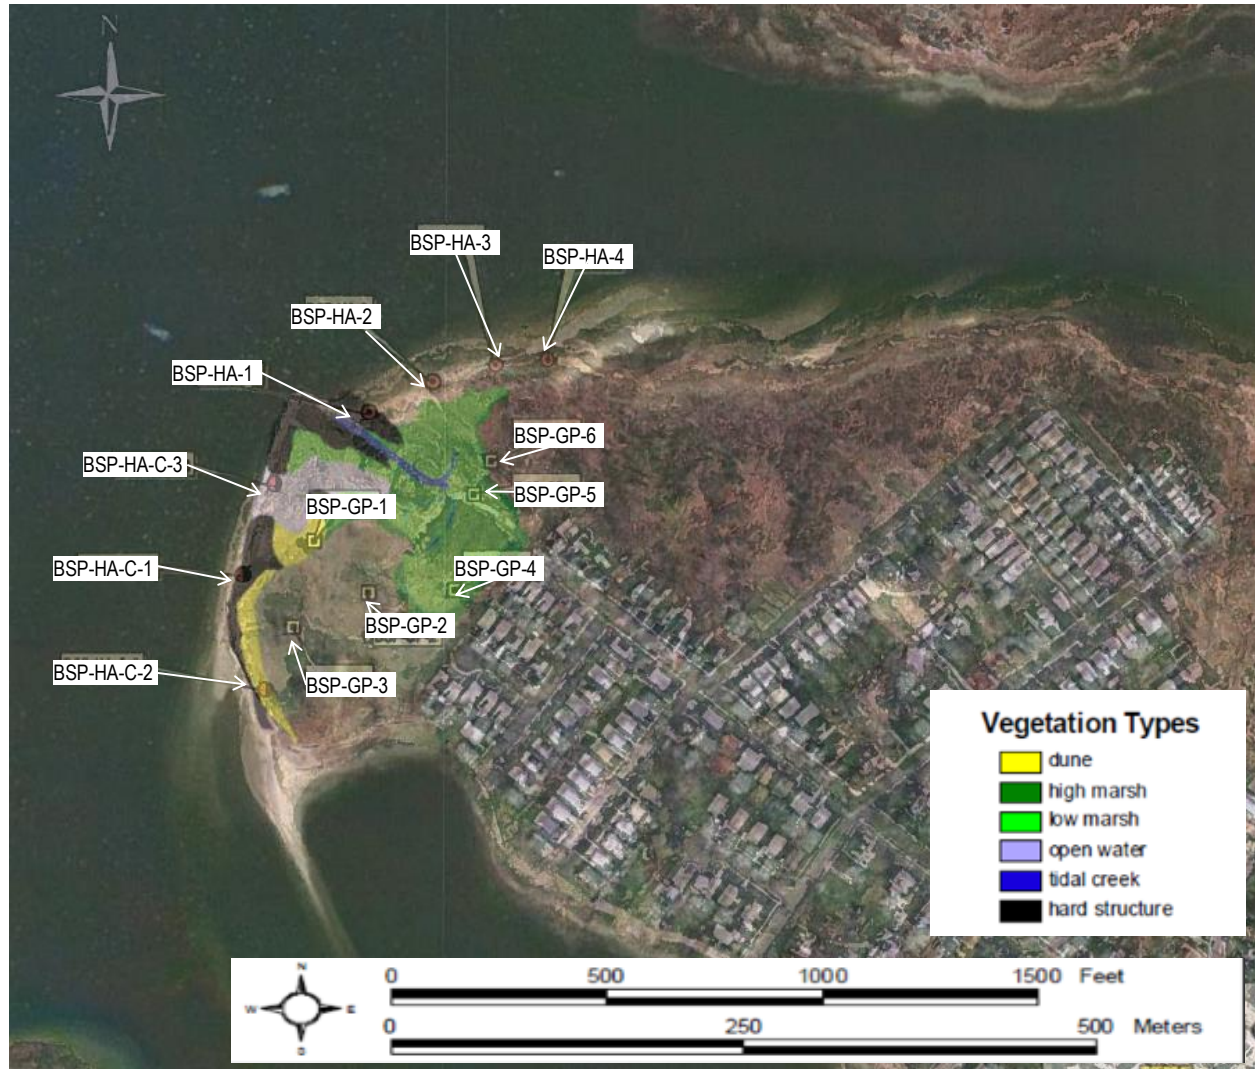
**Figure 1: Sample Locations and Recommended Plan - Bayswater State Park (Alternative 2)**

- Restoration totals 4.8 acres including 2.9 acres of low marsh, 0.4 acres of high marsh, 0.8 acres of creek/pool and 0.7 acres of dune.
- While the number of acres is not as great at Bayswater State Park as in other areas, in the absence of any action, this site will continue to experience severe erosional forces which have already caused the existing seawall to fall into disrepair. This could lead to the continued loss of existing marshes, beaches, and grasslands.

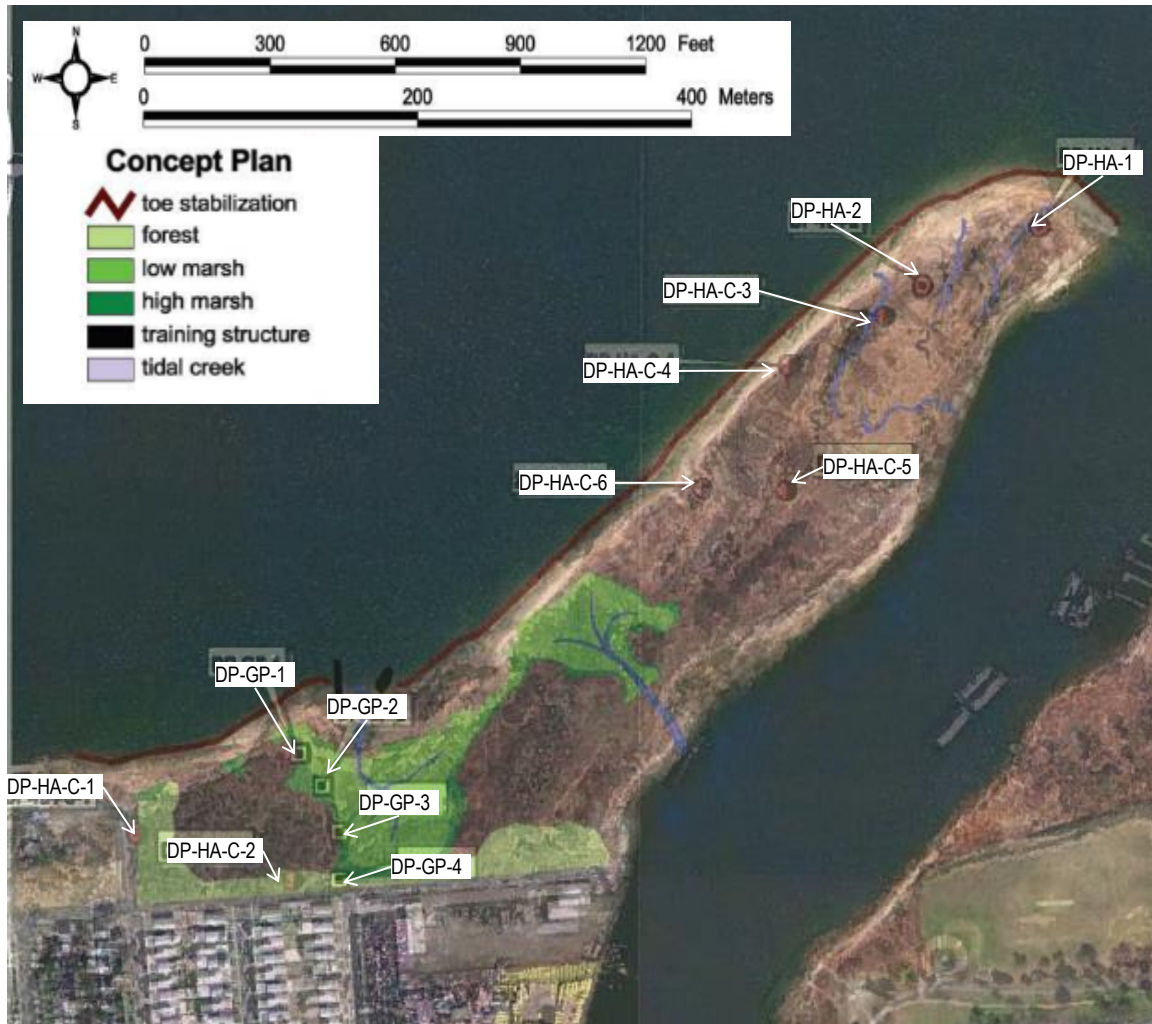
Figure 2: Sample Locations and Recommended Plan for Dubos Point (Alternative 3)

- A total of 6.8 acres will be restored at this site including, 3.5 of low marsh, 0.6 of high marsh, 0.7 of creek or pool, and 2 acres of maritime forest.

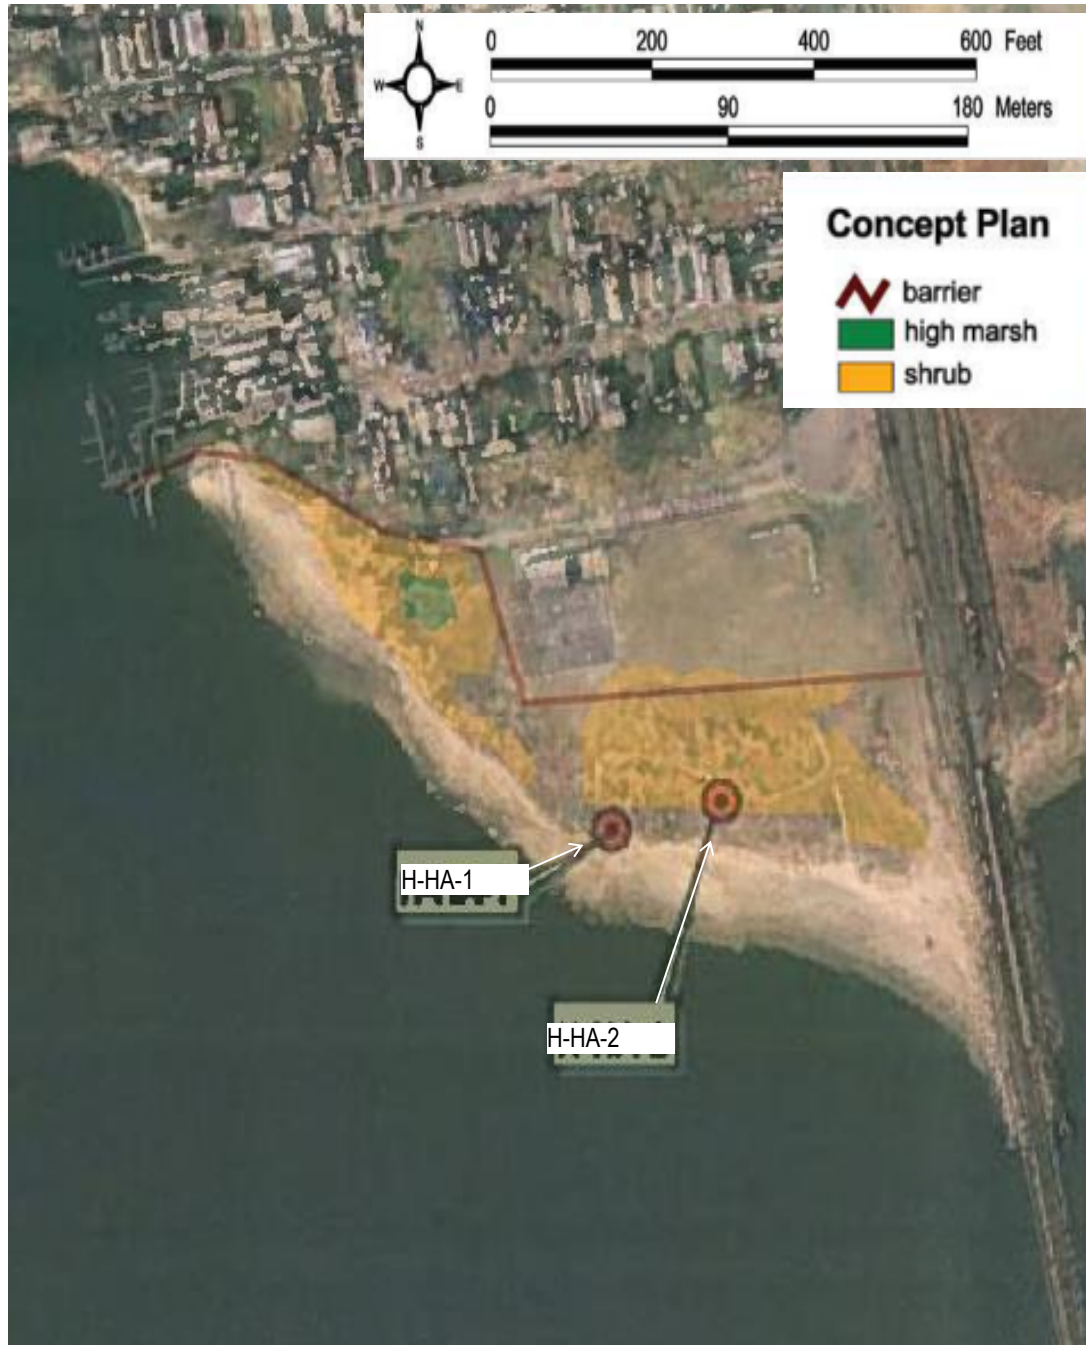
Figure 3: Sample Locations and Recommended Plan for Hawtree Point (Alternative 1)

- COPCs (HQ) exceeding NYSDEC Unrestricted Use and Protection of Ecological Resources SCOs include:
  - Hexavalent chromium (20.7, assuming 100% Cr Hex; trivalent chromium (0.7) is more likely present), copper (1.3), lead (5.3), mercury (1.3), zinc (1.4) and DDT (3.3).
- DDT (1.6) exceeded the sediment ER-M for 1 sample (H-HA-2) (Figure 3).
- Potential exposure to COPCs is minimal and the proposed recommended alternative would not result in increased risk.
- Recommended alternative protects remaining marshes by replacing invasive dominated areas with 1.7 acres of coastal shrub and grassland habitat.
- Creation of a barrier to motorized vehicles by placing boulders along the boundary of the restoration area.
- The newly created habitats as well as the preserved existing marshes will be protected from vehicle access, but will still be accessible to pedestrians.

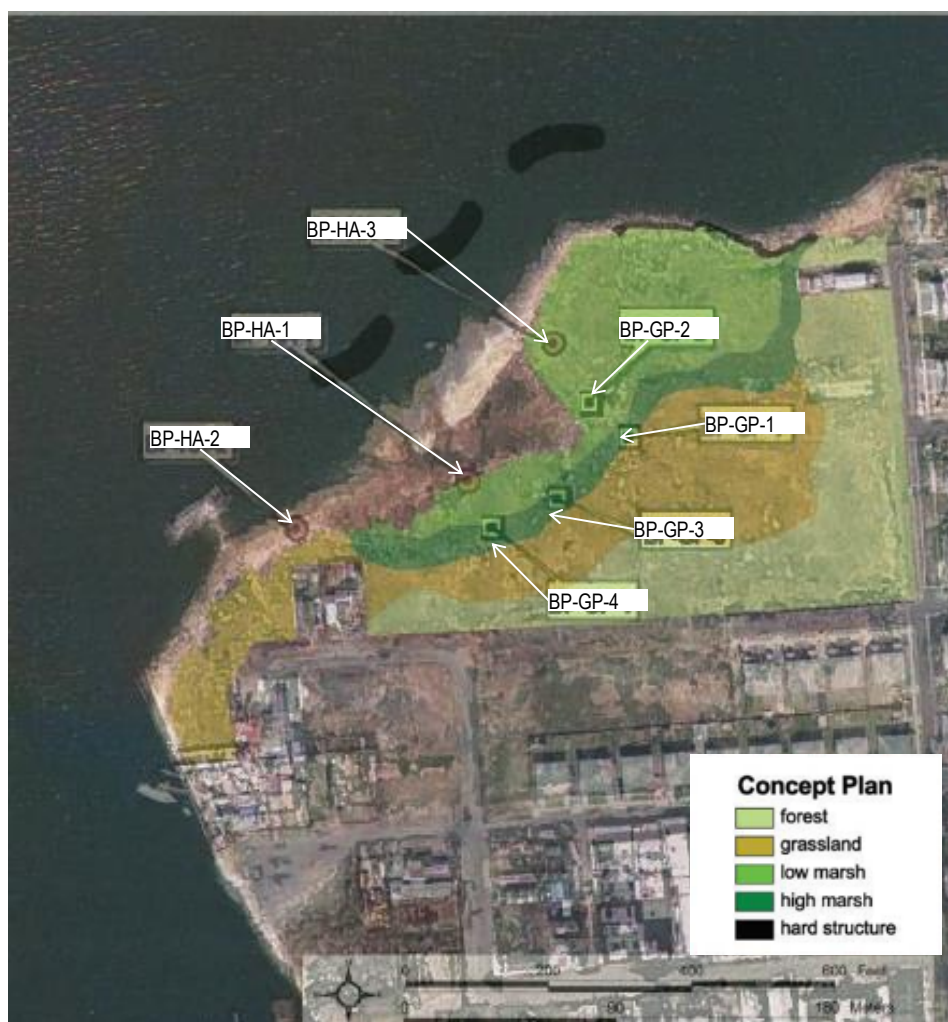
Figure 5: Sample Locations and Recommended Plan for Brant Point (Alternative 2)

- The recommended alternative (Figure 5) maximizes marsh habitat protection and creates macroinvertebrate habitat by creating offshore rubble mounds, restores 7.5 acres of marsh and associated habitat that includes 1.9 acres of low marsh, 0.7 acres of high marsh, 2.4 acres of maritime forest and 2.5 acres of meadow of marsh and associated habitat and protects an already existing 1.2 acres of marsh

- Avoidance of elevated concentrations of COPCs at location BP-GP-C-4 (Figure 5) should be considered during re-grading and movement of subsurface soils to surface soils. The use of cleaner soils for surface grading would significantly reduce exposure to receptors and improve exposure at the site.
