**Westchester County Streams,  
Byram River Basin  
Flood Risk Management  
Fairfield County, Connecticut and  
Westchester County, New York**

**Draft Integrated Feasibility Report &  
Environmental Impact Statement**

**Appendix B2 – Hydraulics**

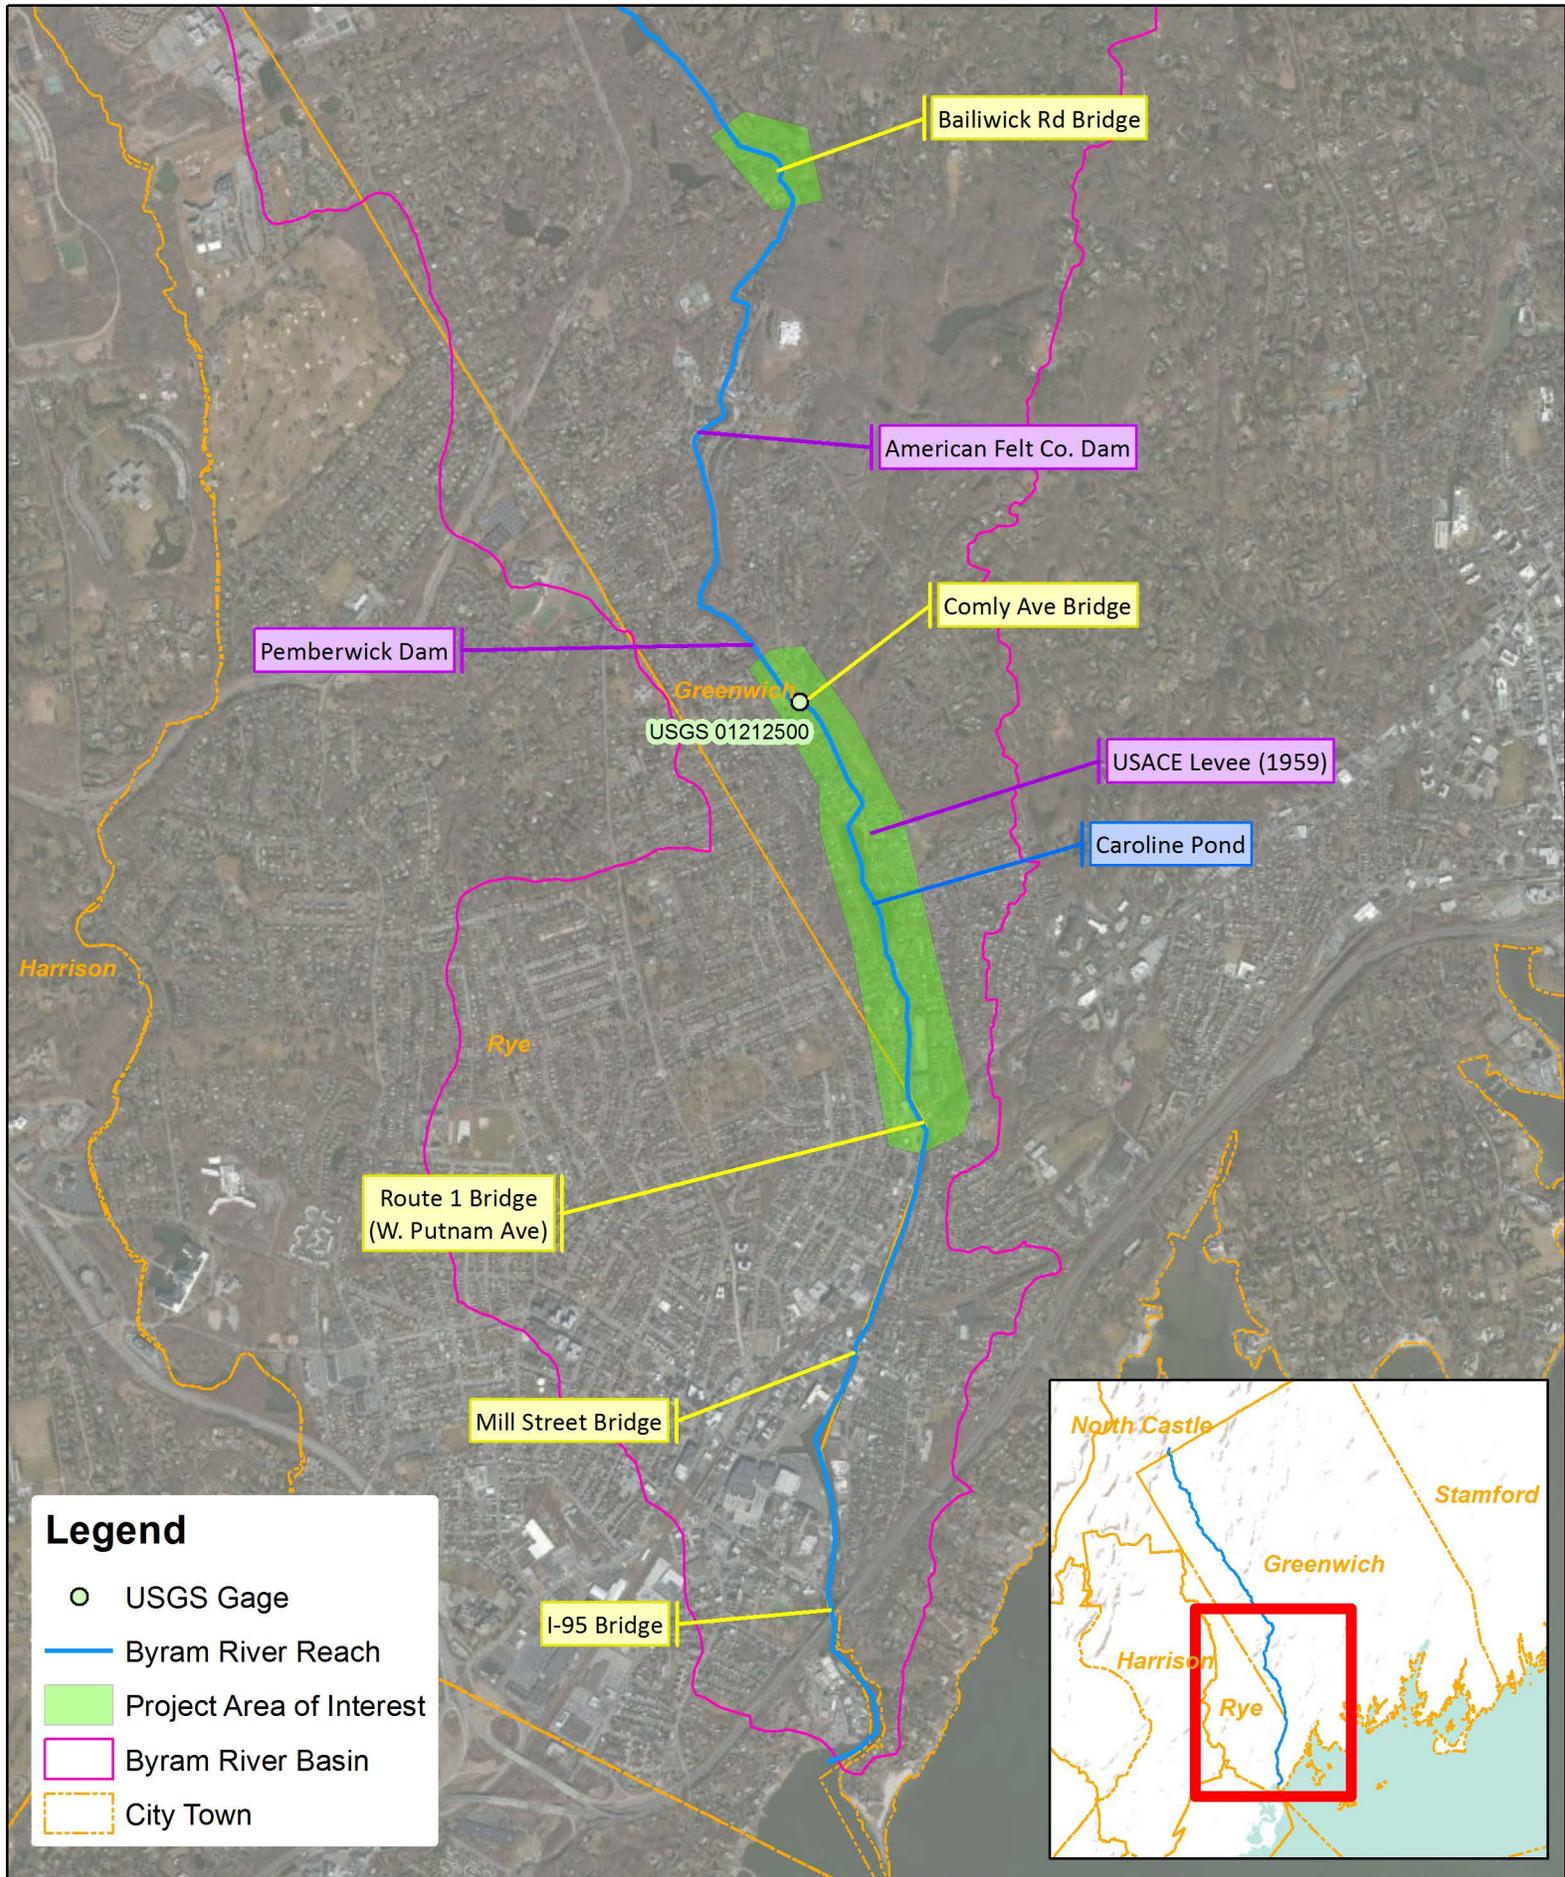
**Figure 1**  
Project Area of Interest  
Byram River Watershed

The project area of interest is the main branch of the Byram River from the Route 1 bridge crossings upstream to the Comly Ave bridge and the area directly upstream of the Bailiwick Ave bridge. There has been historic flooding during extreme rainfall events in the Caroline Pond area just upstream of the Route 1 bridges. **Figure 1** shows the area of interest.

A flood control levee completed by the U.S. Army Corps of Engineers (USACE) in August 1961 on the east bank of the Byram River downstream of the Comly Ave bridge and adjacent to Halock Drive is also shown on **Figure 1**. The flood control project includes an earthen levee and approximately 3,000 feet of channel widening and deepening modifications. It was constructed under Public Law 685, 84<sup>th</sup> Congress.

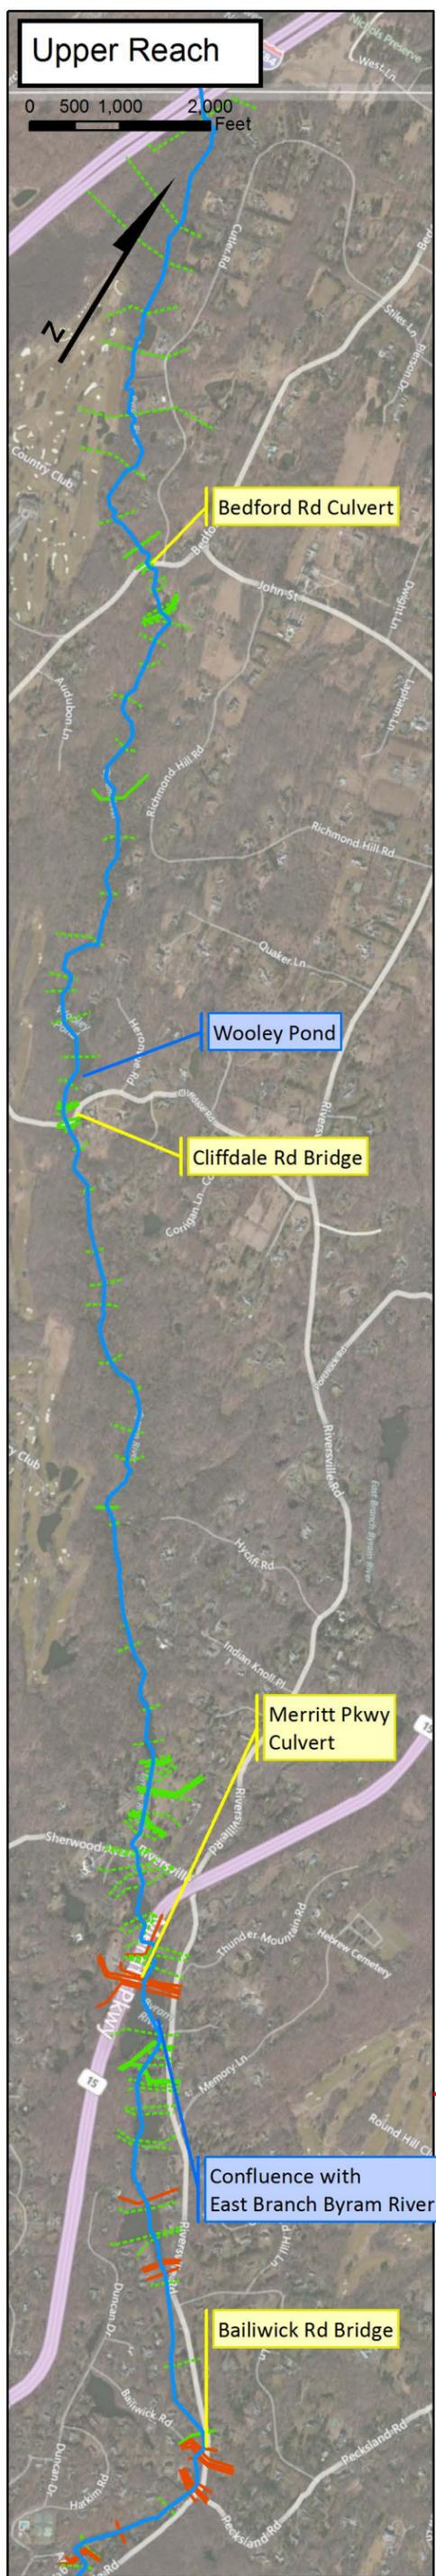
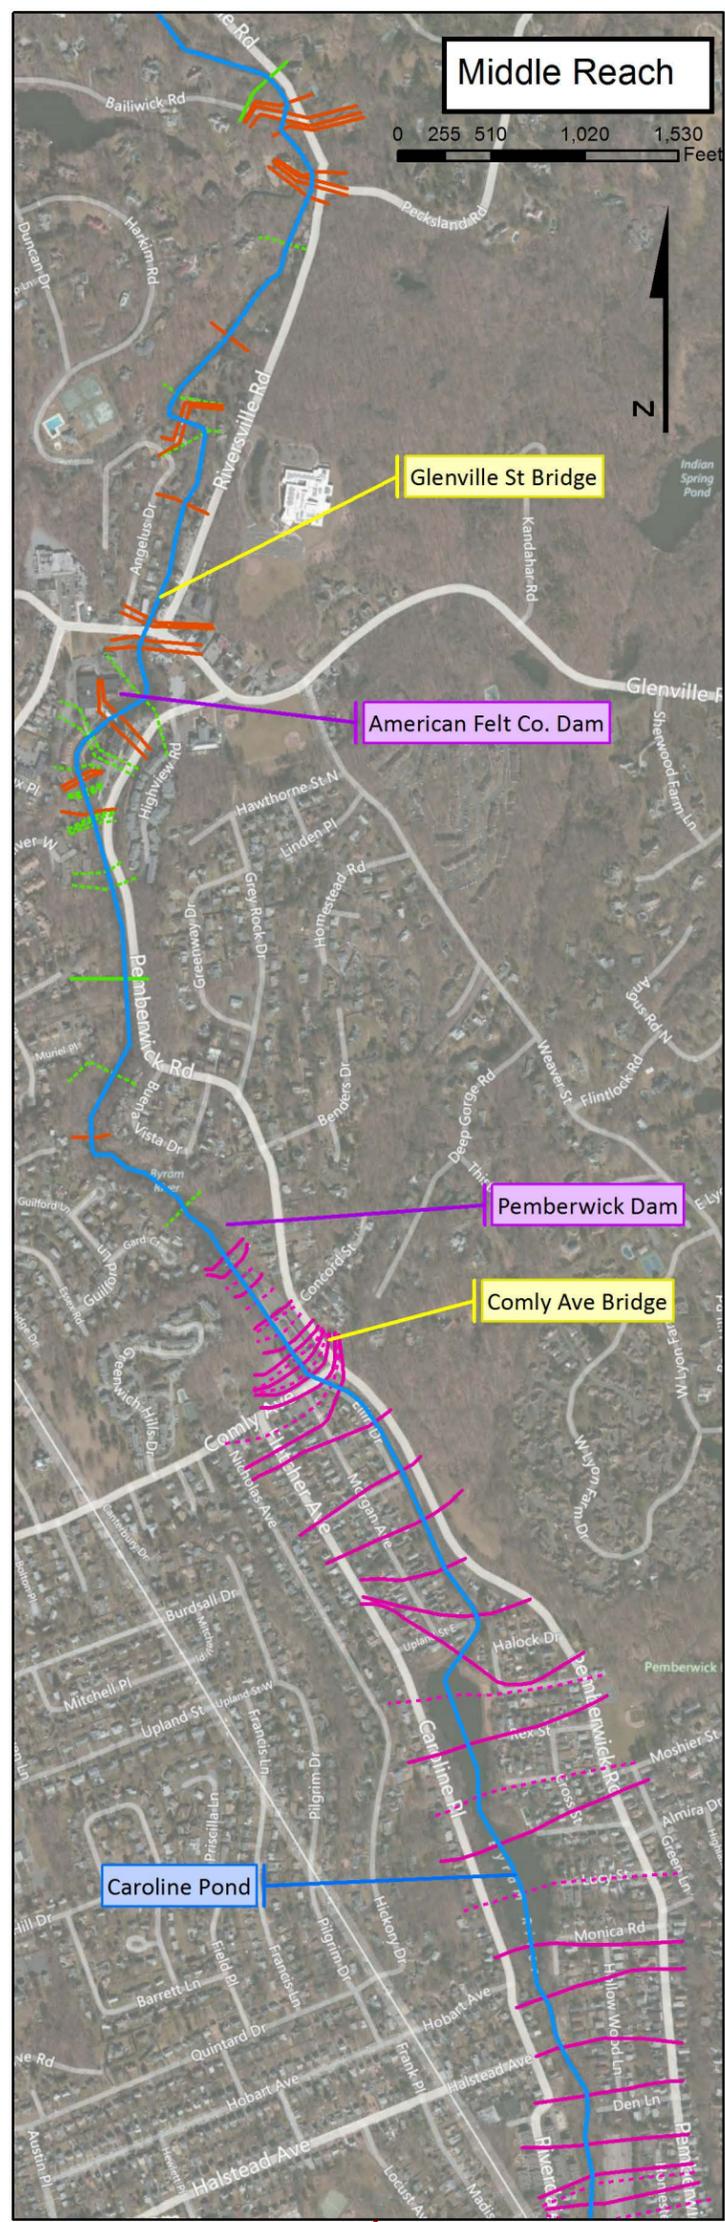
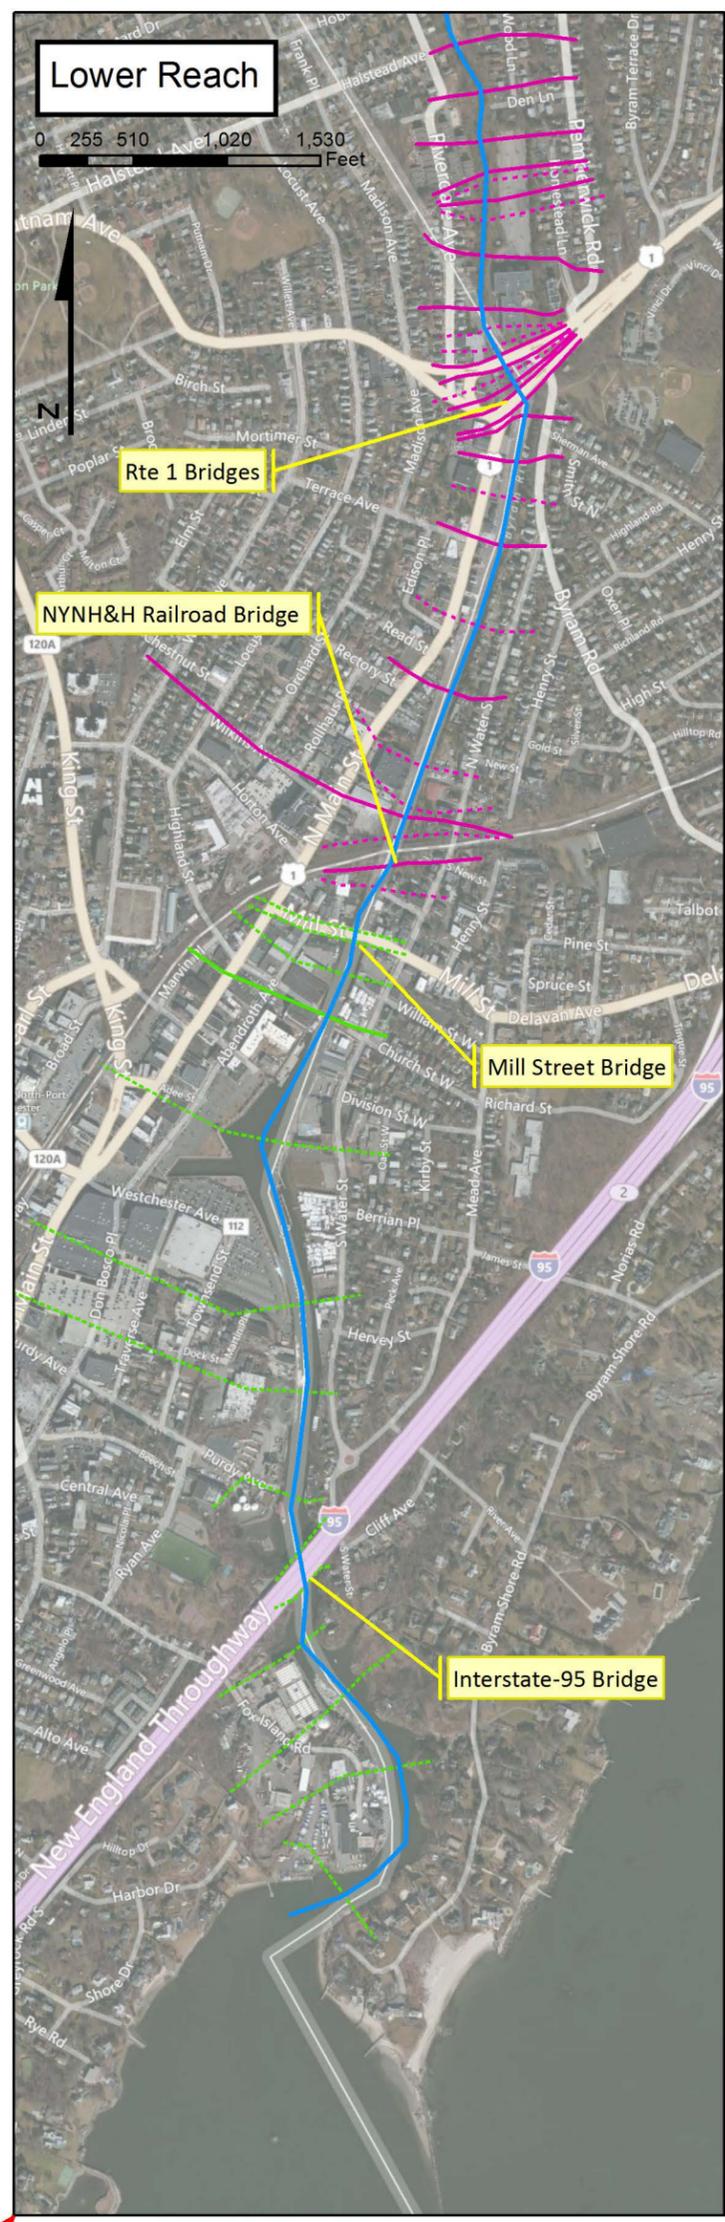
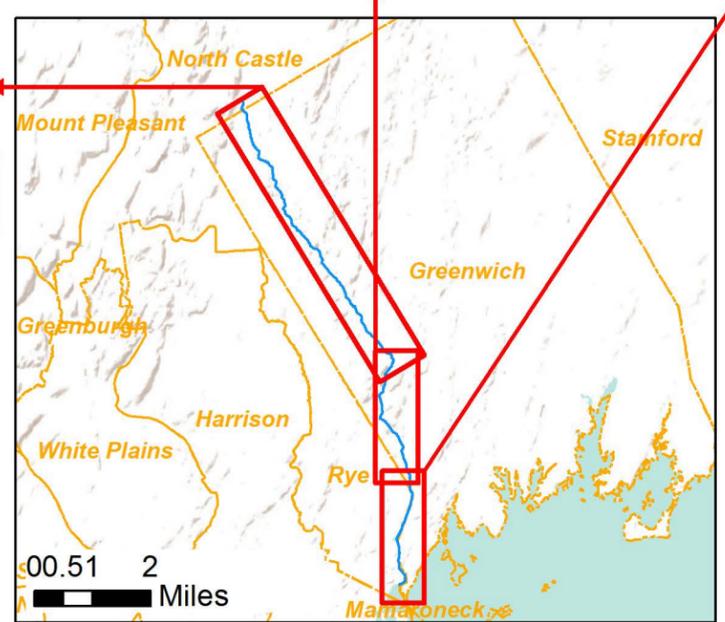
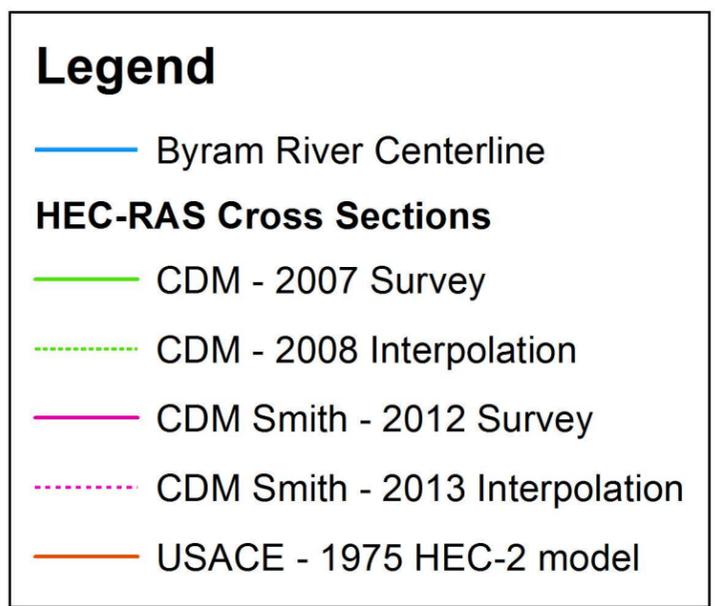
**Figure 2**  
HEC-RAS Cross Sections  
Byram River Main Branch

**Figure 2** shows a map of all cross sections in the updated HEC-RAS model.

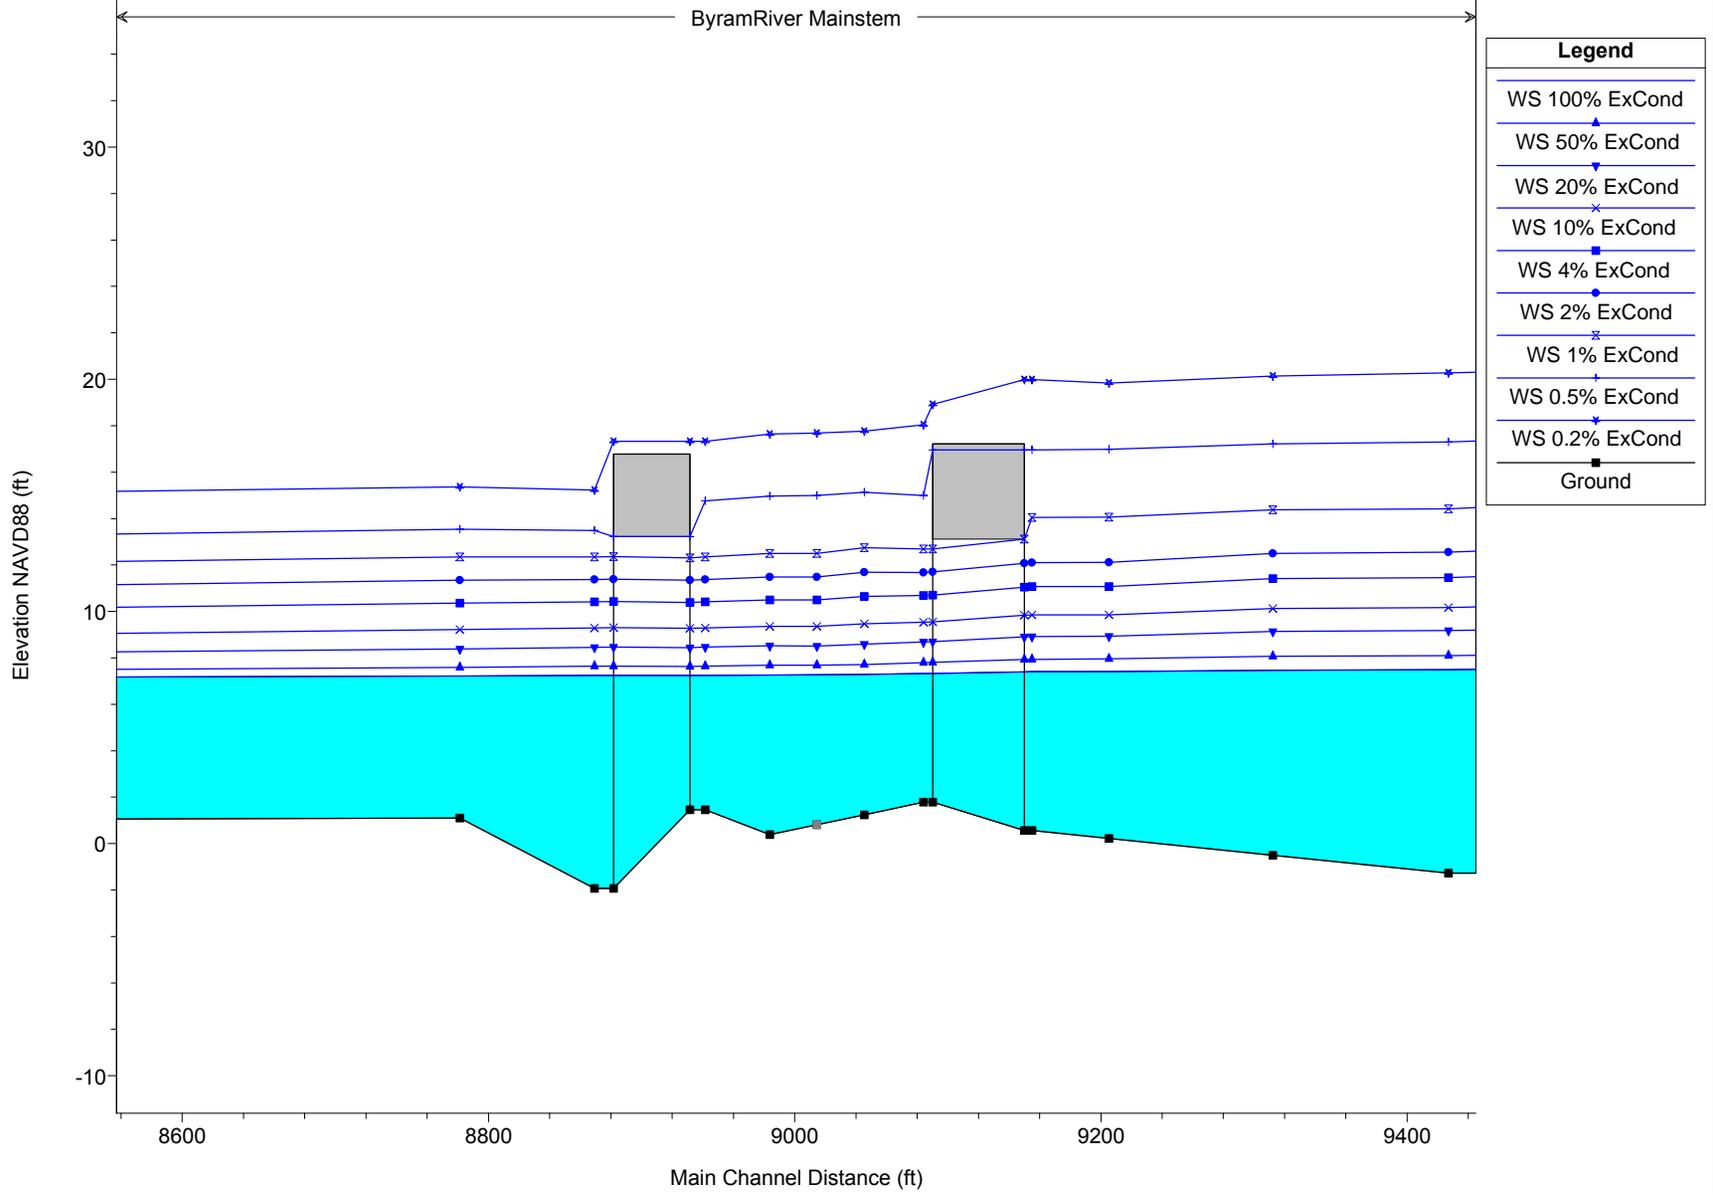
Figure 4 - Existing vs Proposed Flood Profile at Route 1 Bridge

As reflected in **Table 5**, on the following page, the Route 1 bridge replacements will significantly reduce peak stages in the vicinity of the bridges. There are negligible increases on the downstream side of the bridge as a result of the proposed bridges. All stage comparisons are with respect to vertical datum NAVD88 and are based on the existing condition flows. **Figure 4** displays the below information in a water surface profile.

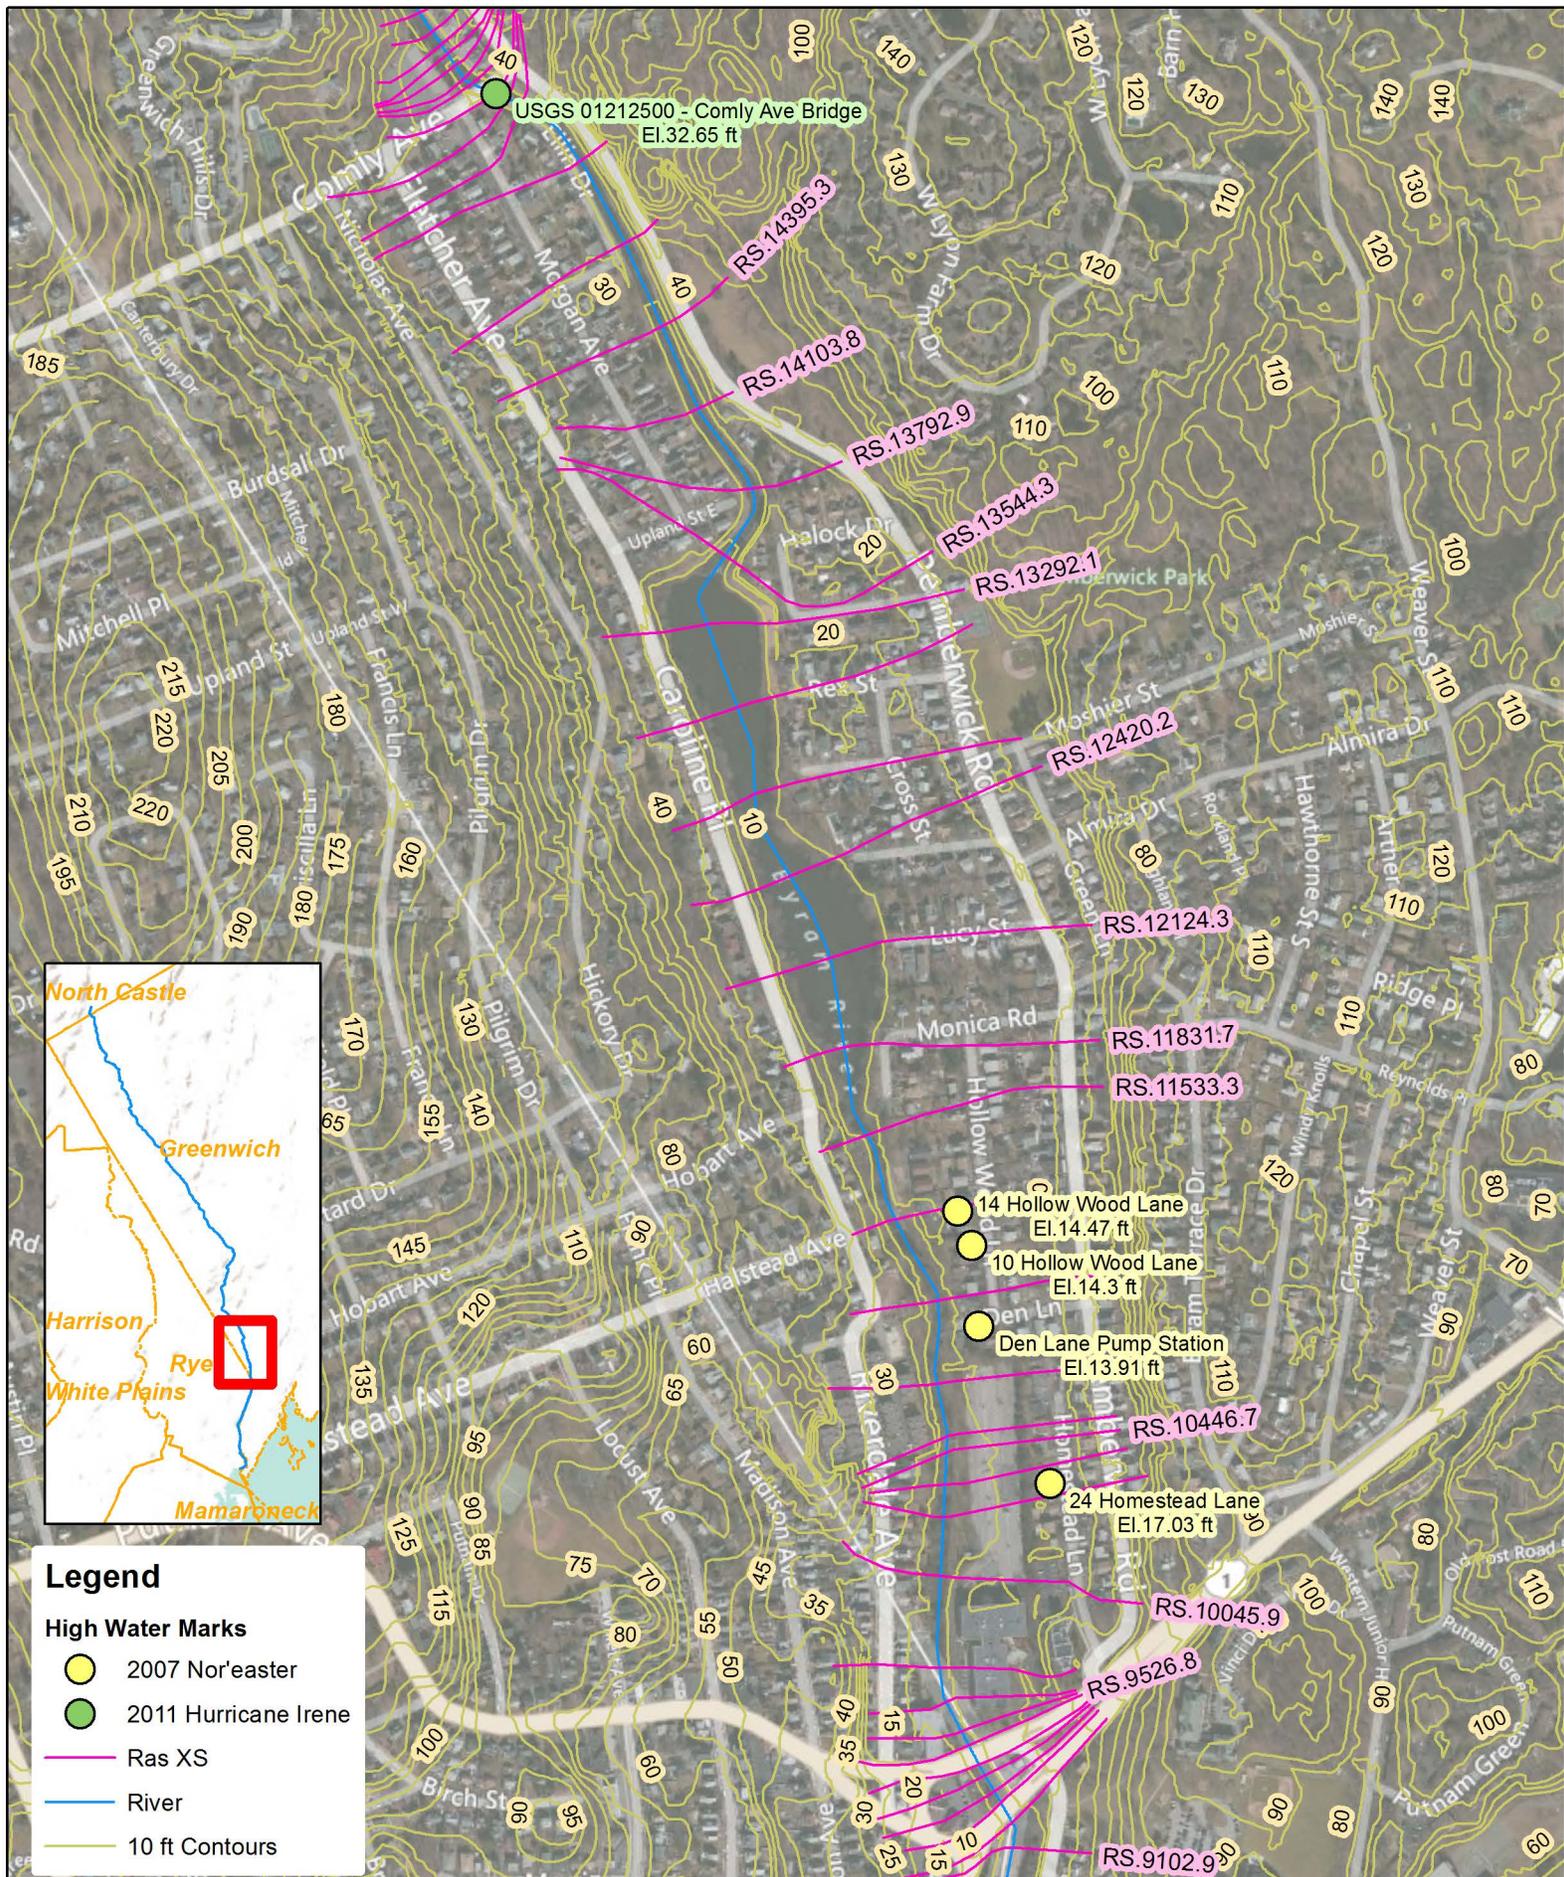
**Figure 5**  
High Water Marks - April 2007 Nor'easter  
Byram River Caroline Pond Area

The April 2007 Nor'easter caused major flooding along the banks of the Byram River. Milone and MacBroom collected high water marks at 5 locations listed in **Table 6**.

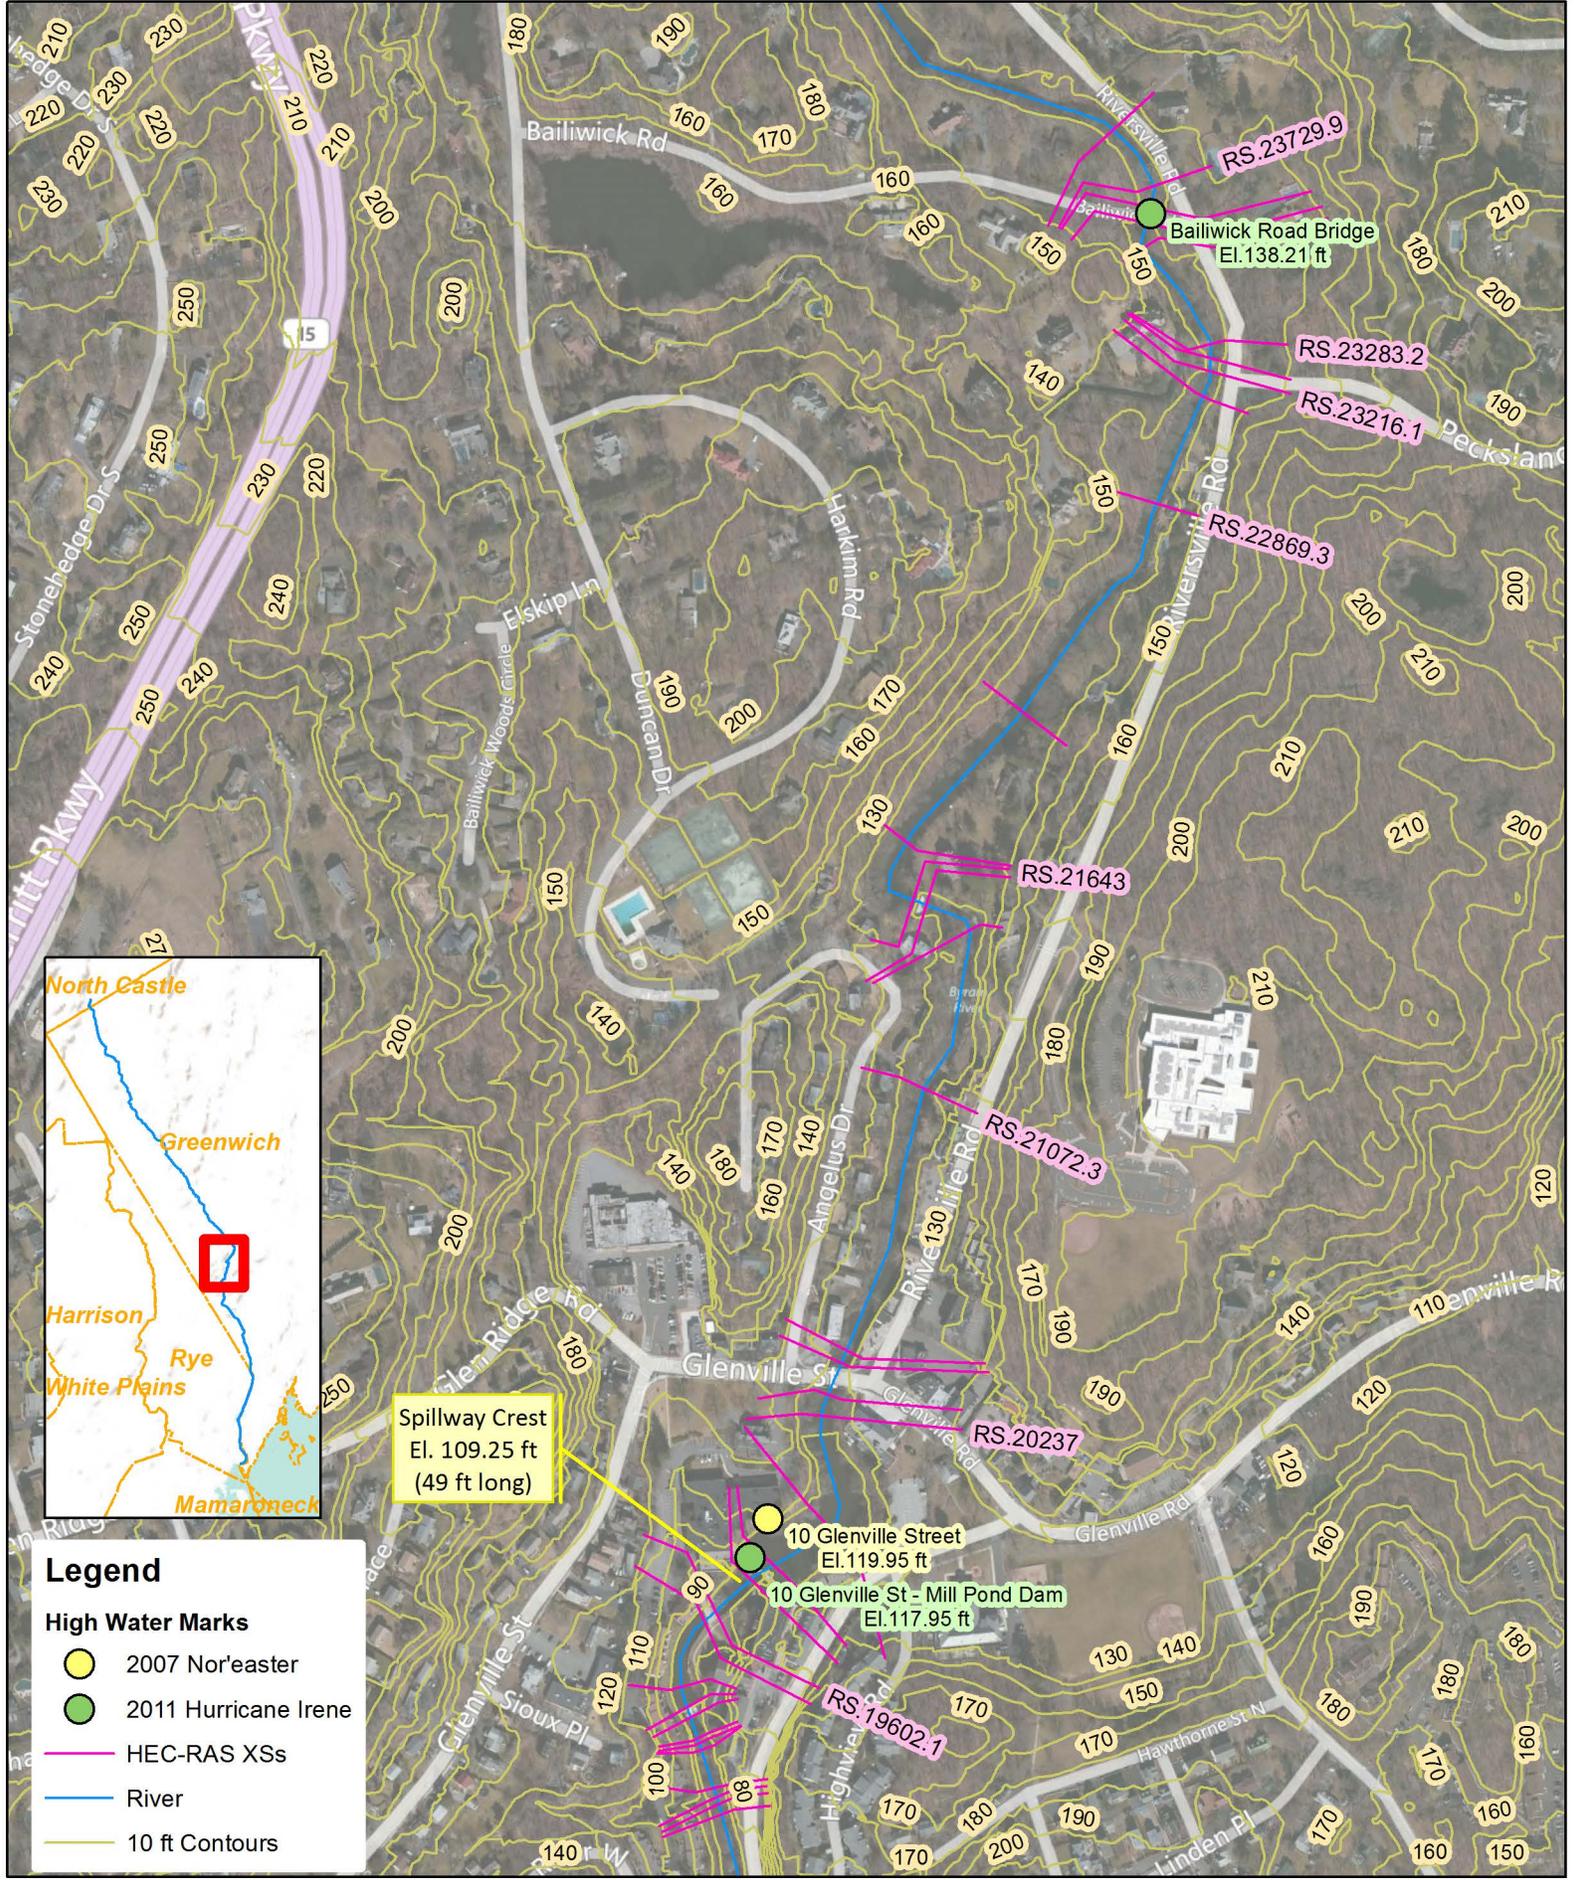
**Figure 6**  
High Water Marks April 2007 Nor'easter  
and 2011 Hurricane Irene

In August 2011 Hurricane Irene caused major flooding along the banks of the Byram River. Milone and MacBroom collected high water marks at 2 locations listed in **Table 7**.

Additionally, the exact location of the flood mark for Location 6 is unclear. The surveyor recorded the elevation “on top of the [embankment] structure” approximately 3.7 feet higher than the top of the embankment. If the high-water mark was reported from debris observed on the railing, it is possible that this represents wave action or debris pushed up higher than the actual water surface elevation. This study assumes that the elevation with Location 6 does not represent the 2011 peak flood profile.

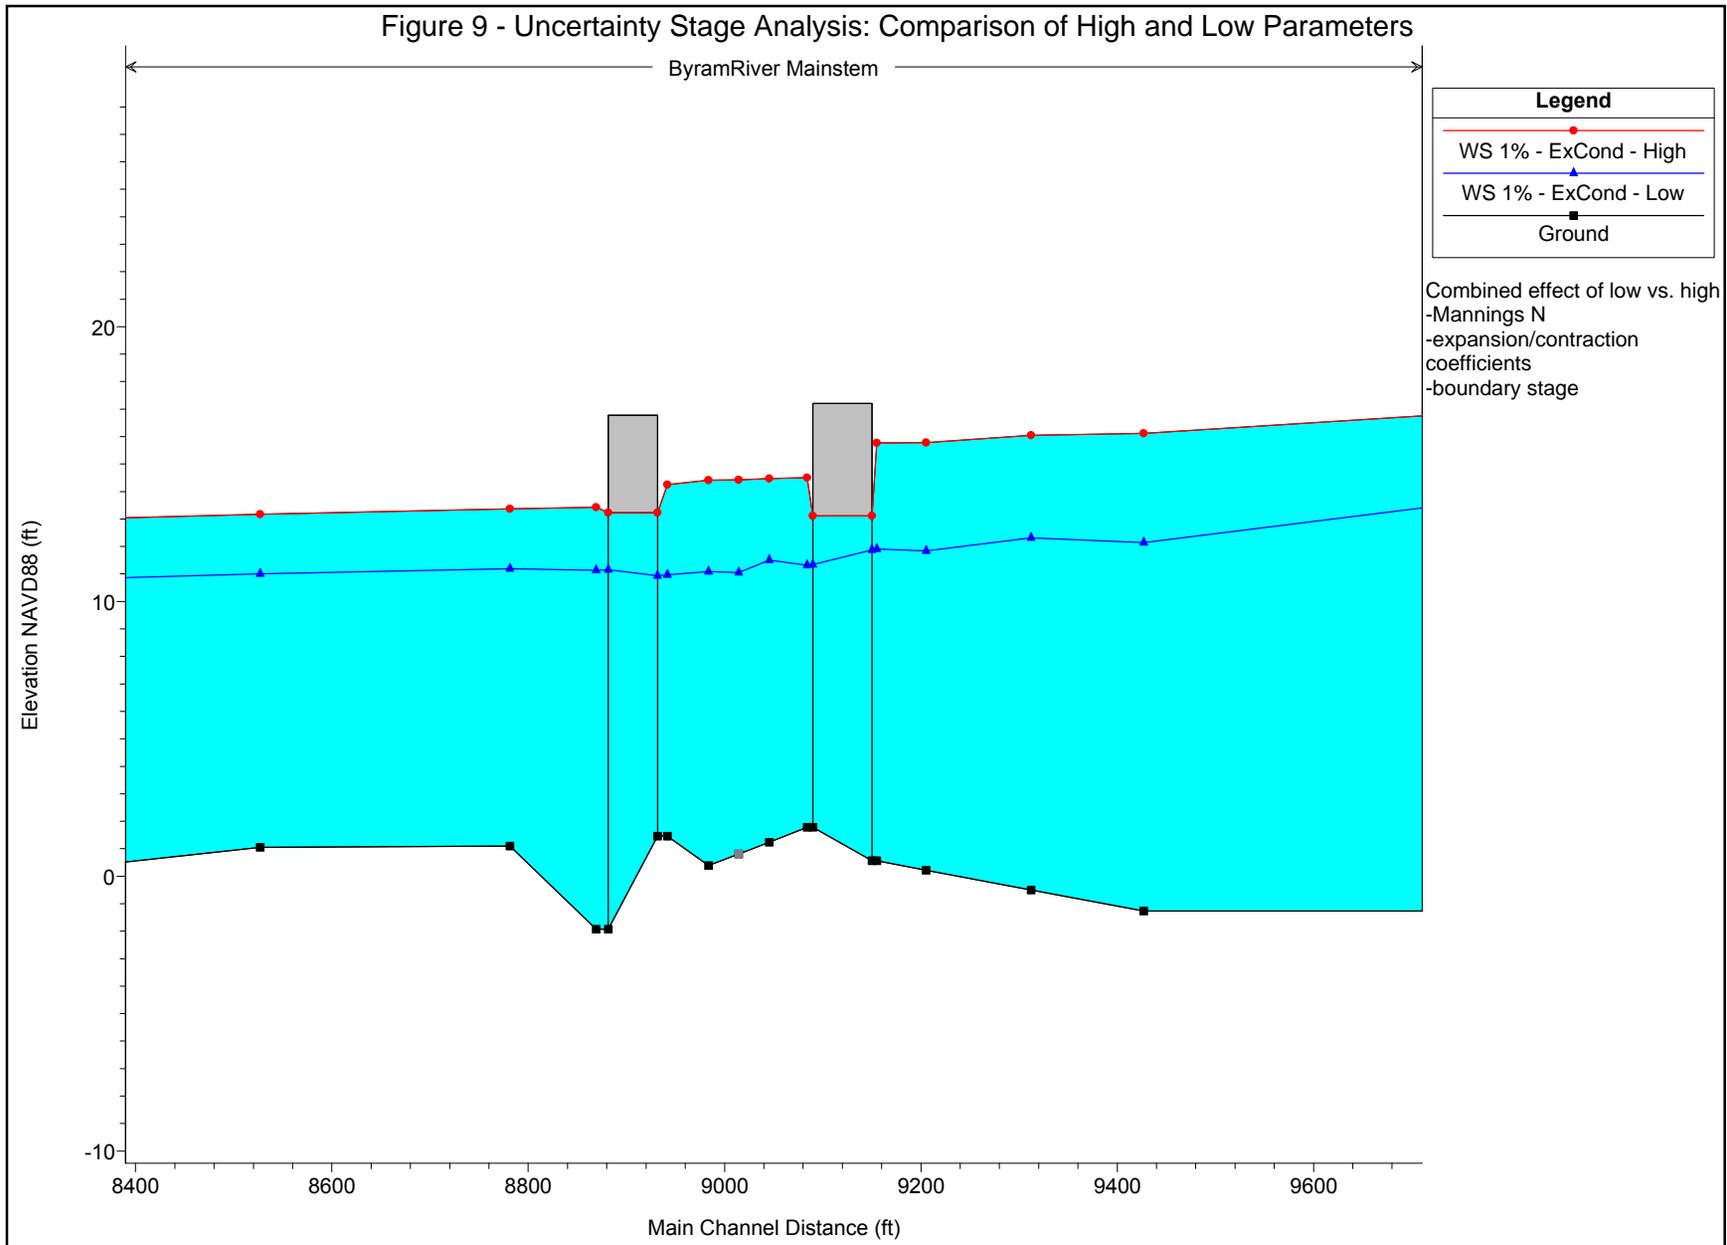
Figure 9 - Uncertainty Stage Analysis: Comparison of High and Low Parameters

In reviewing the independent effects of the low and high roughness coefficients, contraction and expansion coefficients, and boundary conditions, it was determined that the boundary condition adjustments had the least effect on the stages at Route 1. Adjusting the Manning's coefficients to the low end of the range had the greatest effect on lowering the stages while adjusting the expansion and contraction ratios to a higher parameter had the greatest effect on increasing the stages.

Results have been tabulated in **Table 8** with respect to the 1-percent flood stages. **Figure 9** displays the below information in a flood profile. All stage comparisons are with respect to vertical datum NAVD88 and are based on the existing condition flows.

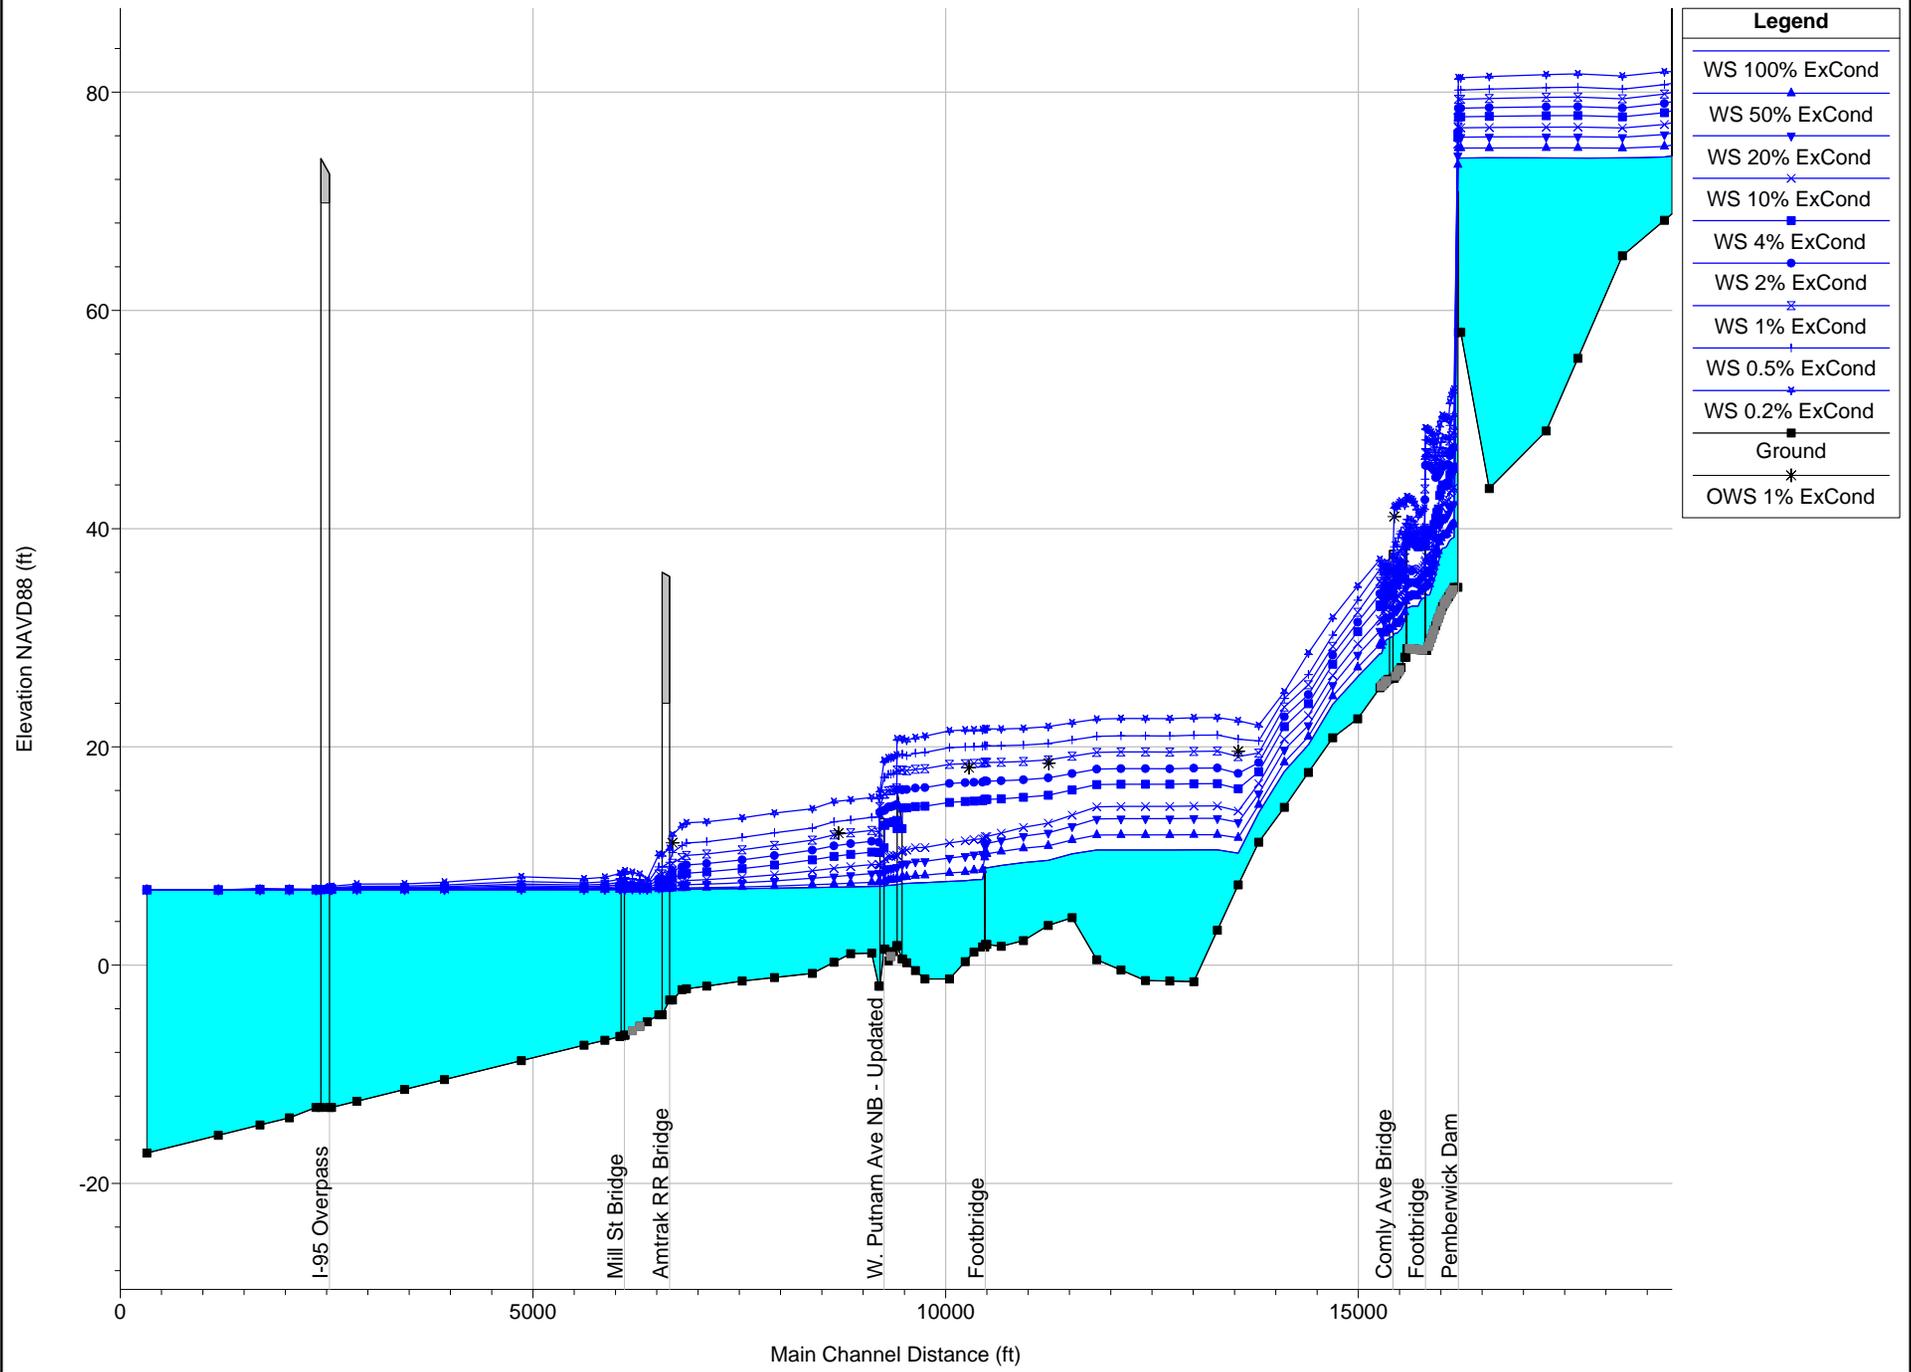
Figure 10 - Design Flood Profiles

**Figures 10** through **12** show the water surface profiles for the existing conditions 10-, 2-, 1-, and 0.2-percent design floods along the entire extents of the HEC-RAS model of the Byram River from Long Island Sound to the I-684 crossing near the corporate limits of the Town of Greenwich. **Table 9** shows water surface
