**Westchester County Streams,  
Byram River Basin  
Flood Risk Management  
Fairfield County, Connecticut and  
Westchester County, New York**

**Draft Integrated Feasibility Report &  
Environmental Impact Statement**

**Appendix B2 – Hydraulics**

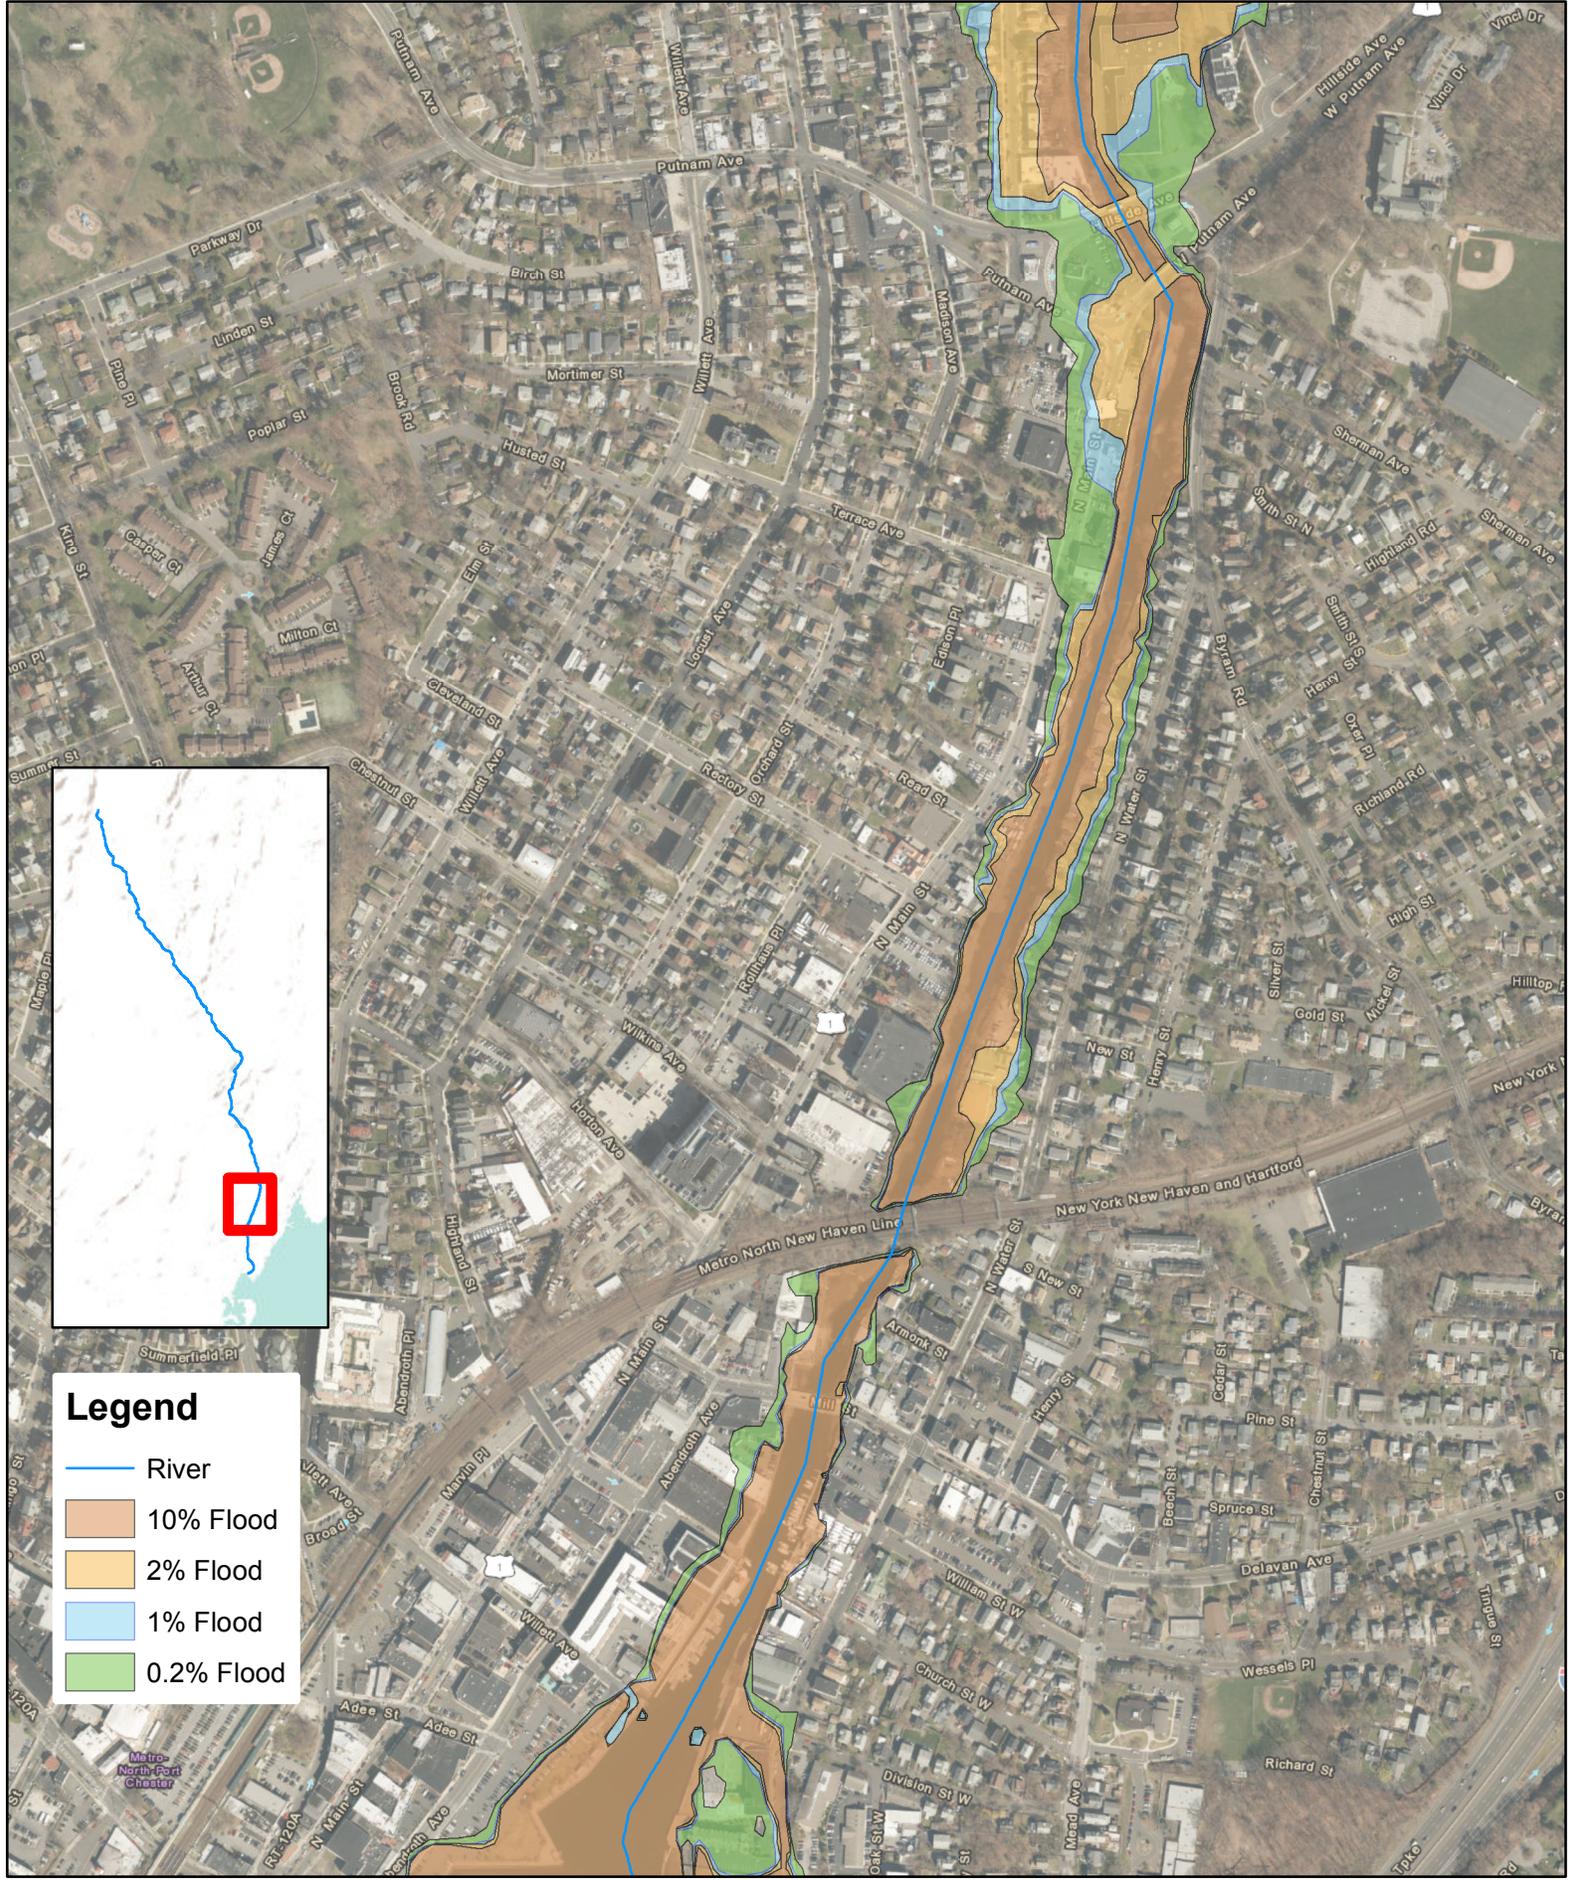
**Figure 13**

**Figures 13** through **16** show the peak flood inundation on the Byram River for the existing conditions 10-, 2-, 1-, and 0.2-percent design floods from the Mill Street Bridge to the Bailiwick Road Bridge.

Design Flood Inundation  
Existing Conditions  
Byram River 1 of 4

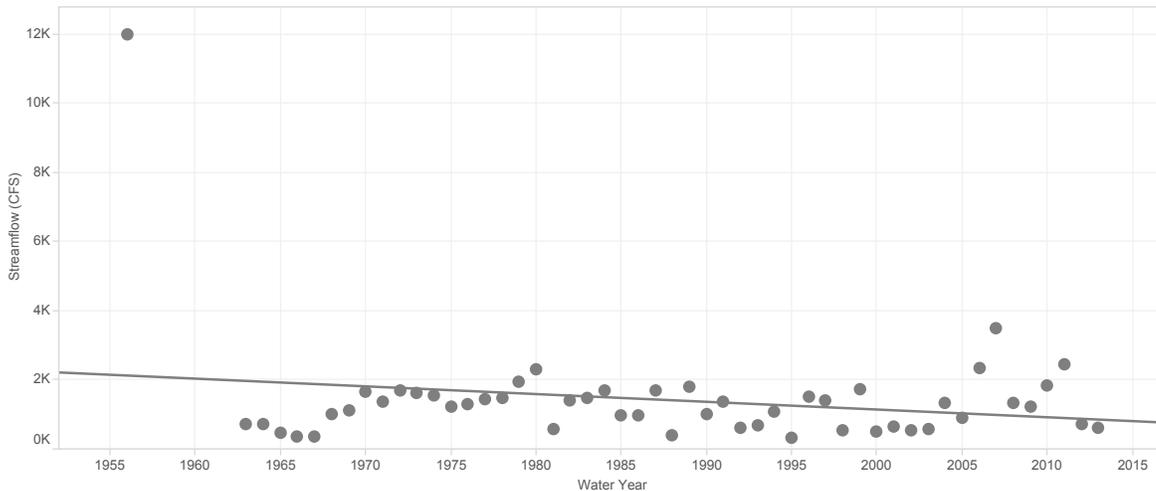
Figure 17 - USACE Climate Assessment Tool: USGS Gage 01209700

The p-value is for the linear regression fit drawn; a smaller p-value would indicate greater statistical significance. There is no recommended threshold for statistical significance, but typically 0.05 is used as this is associated with a 5% risk of a Type I error or false positive.

p = .132, R-squared = 0.045

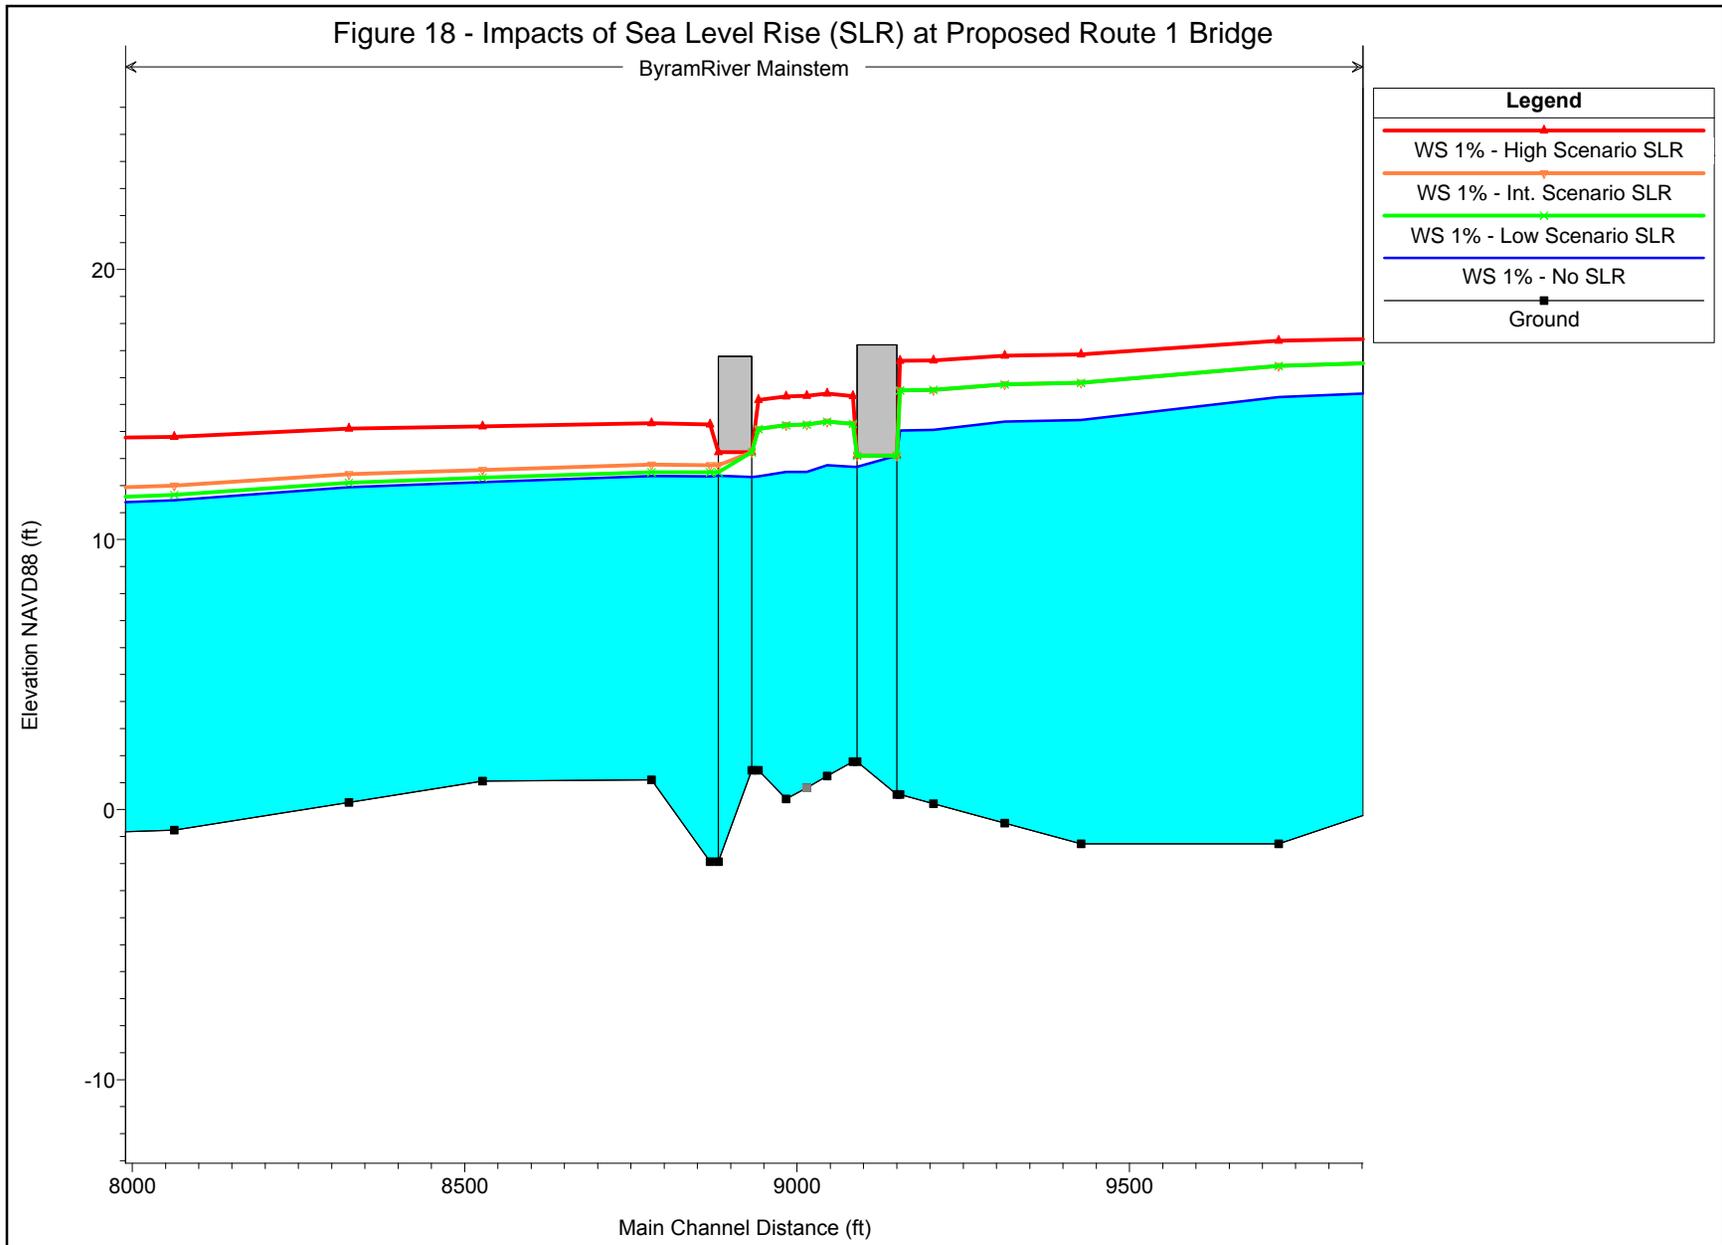
Figure 18 - Impacts of Sea Level Rise (SLR) at Proposed Route 1 Bridge

Results of the SLC indicated an expected rise of 0.84 feet, 1.88 feet, and 5.16 feet for the low, intermediate, and high scenario, respectively, by 2100. The boundary condition of the Byram River outlet was increased by these values within HEC-RAS to simulate potential future conditions of the Byram River. The output was specifically reviewed within the vicinity of the Route 1 bridge replacements to determine whether sea level rise will impact existing flood behavior at Route 1 over the lifetime of the proposed north and south bridge.

The analysis indicates the Route 1 bridges are close enough to the Byram River outlet that tailwater fluctuations will influence water elevations. 1-percent flood stages in the vicinity of Route 1 increase between 1.48 and 1.76 feet under the SLC low scenario. The high scenario demonstrates stage increases up to 2.58 feet higher. Under both a “no SLR” condition and low SLC scenario, the Route 1 bridge replacements will not experience overtopping until the 0.2-percent flood event. In both the intermediate and high SLC scenario, the north proposed bridge will experience overtopping in the 0.5-percent flood event but the south bridge will not experience overtopping until the 0.2-percent flood event.

Results have been tabulated in **Table 11** with respect to the 1-percent flood stages. **Figure 18** displays the below information in a flood profile. All stage comparisons are with respect to vertical datum NAVD88 and are based on the existing condition flows.
