U.S. ARMY CORPS OF ENGINEERS

PRELIMINARY ASSESSMENT

Staten Island Warehouse Formerly Utilized Sites Remedial Action Program (FUSRAP) Site,
Richmond Terrace, New York

January 2012

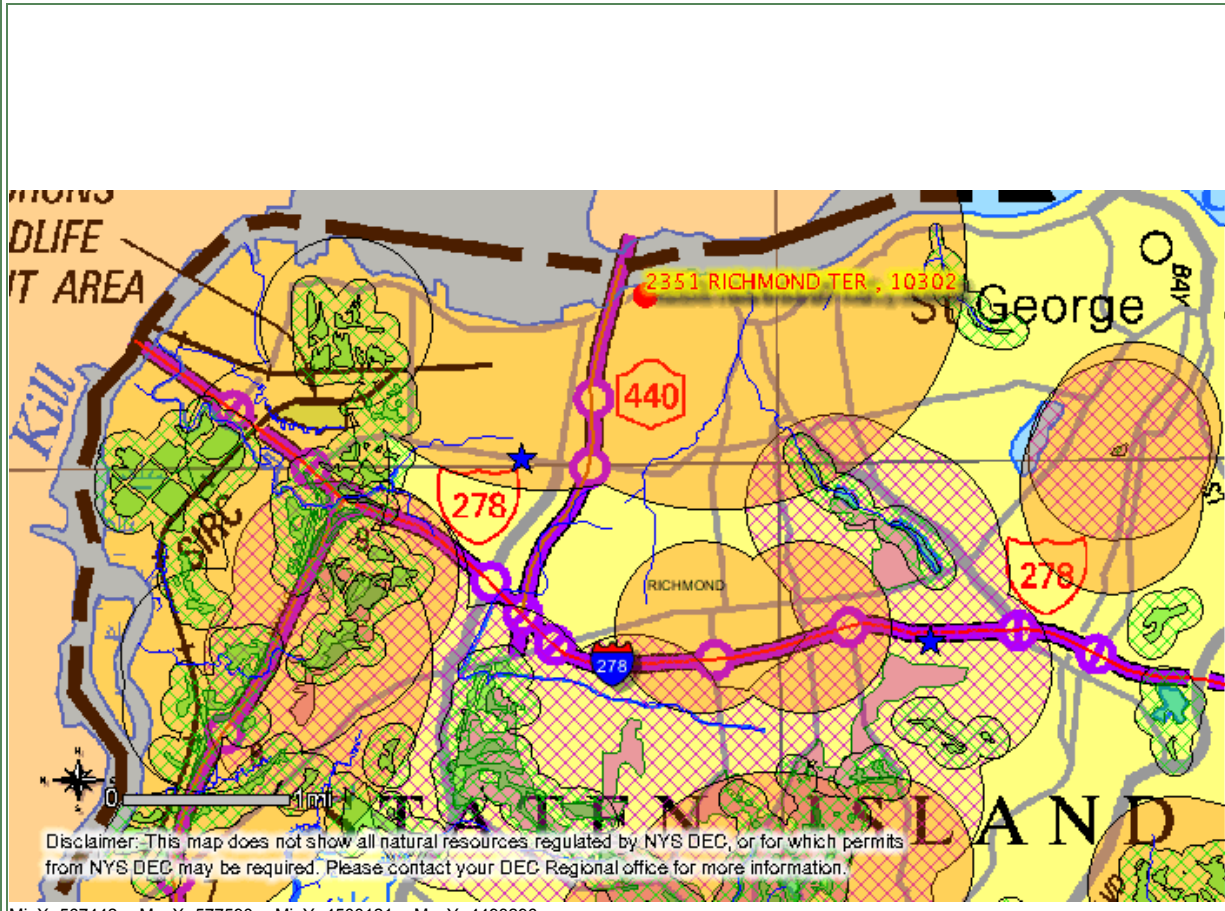
Figure 10 SIW PA; NYSDEC Environmental Resource Map

SIW PA Figure 10 ERM NYSDEC

A review of the NYSDEC Unique Geologic Features database shows the nearest such feature is approximately 1 mile east-southeast of the Site (NYSDEC 2011). See Figure 10.

There are no State designated wetlands within a half mile of the Site (NYSDEC 2011). Approximately 1 mile west of the Site are the non regulated Richmond Terrace Wetlands (Google maps 2011). There are no state Regulated Freshwater Wetland Act areas within 1 mile of the Site (NYSDEC 2011). See Figure 10.
